# BUILDING ENVELOPE TECHNOLOGY SYMPOSIUM

## ADDRESSING ROOF LEAKS BY FIXING A WALL PROBLEM

# ADDRESSING ROOF LEAKS BY FIXING A WALL PROBLEM

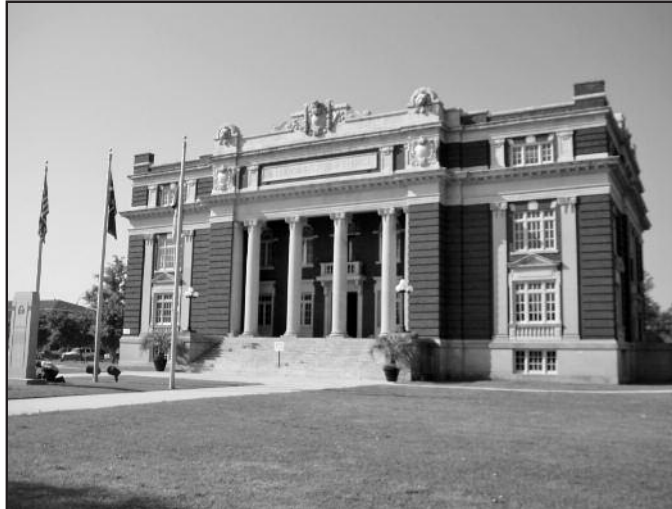
During the initial fieldwork, façade distress was noted at numerous locations, mainly associated with the parapet wall. The roof membrane had been extended up the back side of the masonry parapet wall. No through-wall flashings were installed at the parapet. Numerous blisters and other deficiencies were noted in the roof system, and leaking drains and gutters were also evident. The contractor and engineer deter-

*Photo 1 – Overview of building façade.*

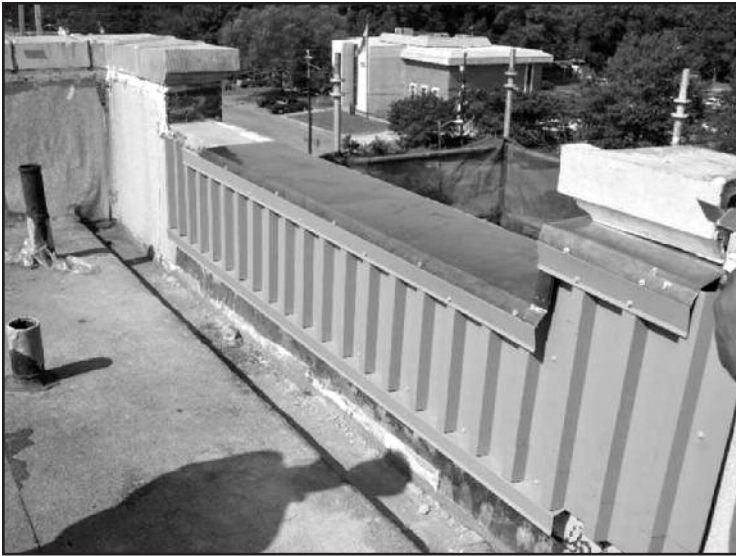
**Photograph 16 – Rainscreen mock-up.**

In many cases, the mock-up must be expanded to include a series of mock-ups: a prototype. A prototype typically includes a mock-up of several items and their interaction with each other representative of the project and is used to solve a problem or provide answers to questions before the building process begins. Prototypes help to identify challenges with regard to constructability as well as to better determine how all the components will work together. In essence, a prototype allows for testing the way in which a system will physically work. In this case, a prototype of the rainscreen system was installed (*Photo 16*).

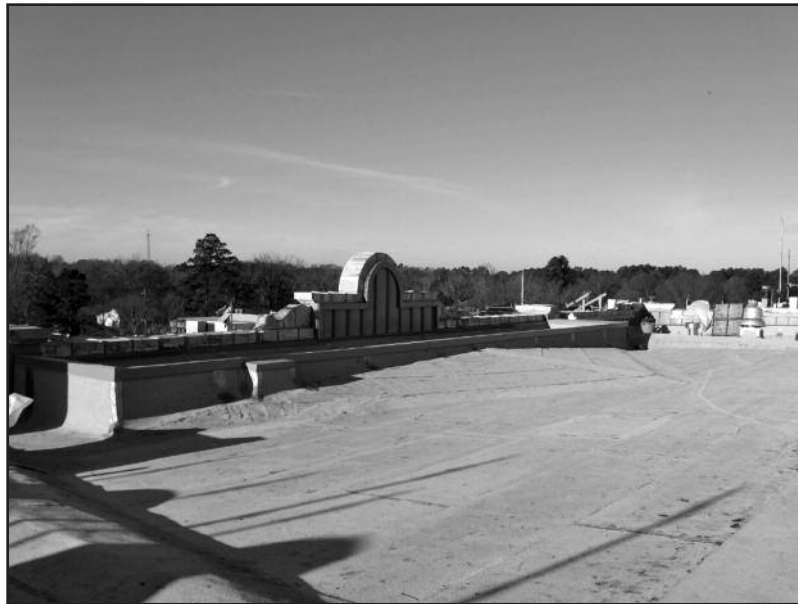
*Photo 20 – Completed roof system.*

The Dillon County Courthouse project was completed in January of 2010. The project that took nearly two years to plan took only about four months to complete, including the mock-up process. By working as a design-build team, the engineer and contractor expedited the process by removing a bidding stage and addressing uncovered conditions as a team during construction. The result of the project included the replacement of a roof system (*Photo 20*); however, the replacement of the roof alone would not have addressed the problem.
