# BUILDING ENVELOPE TECHNOLOGY SYMPOSIUM

## RAPID BUILDING FAILURE

# RAPID BUILDING FAILURE

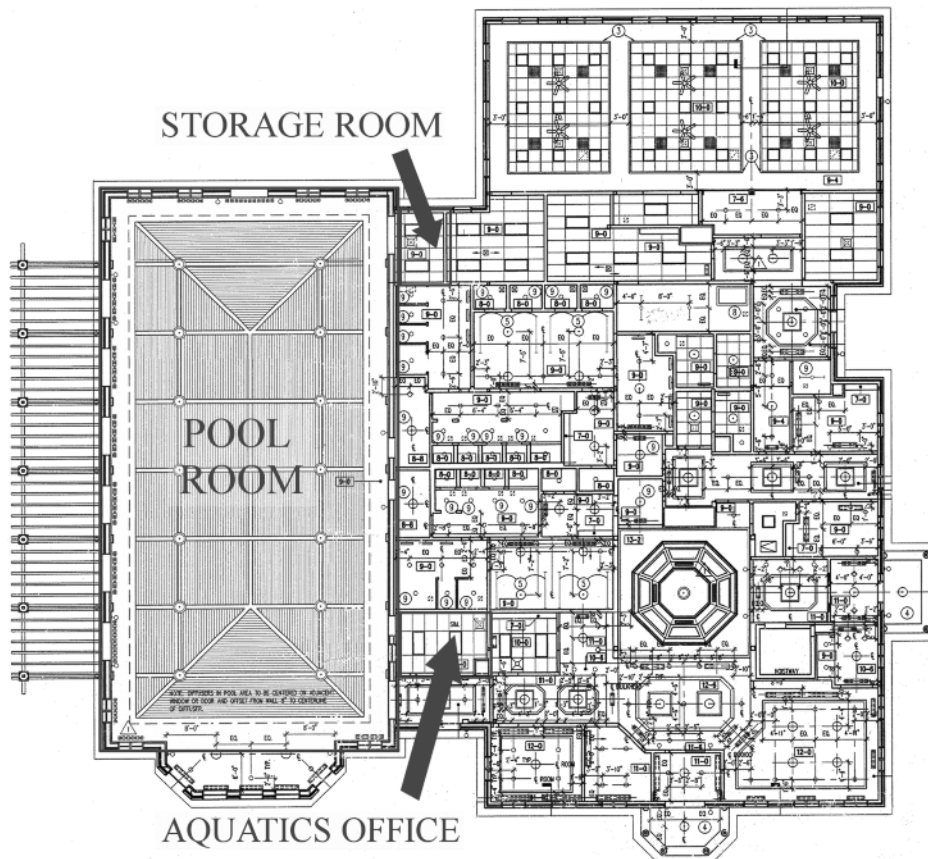
Figure 1 – Reflected ceiling plan with delineation of pool spaces, including the aquatics office and equipment storage room.

In addition to the large pool room, the pool spaces also included an adjacent equipment storage room and an aquatics office (Figure 1). The pump room was located in the basement, and the ducted pool HVAC equipment was located in a roof well above the adjacent locker-room spaces (Figure 2).

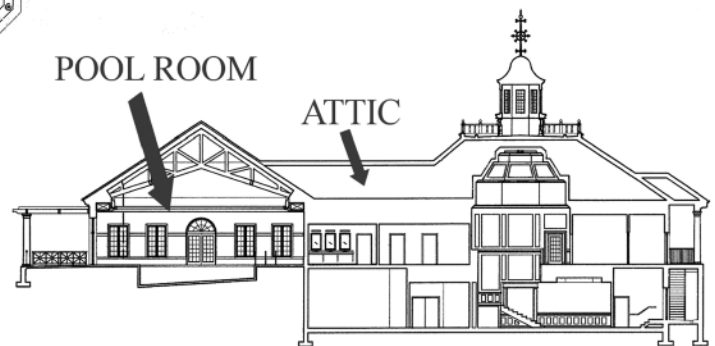
Figure 2 – Building cross section with pool room on left and two-story building on right.

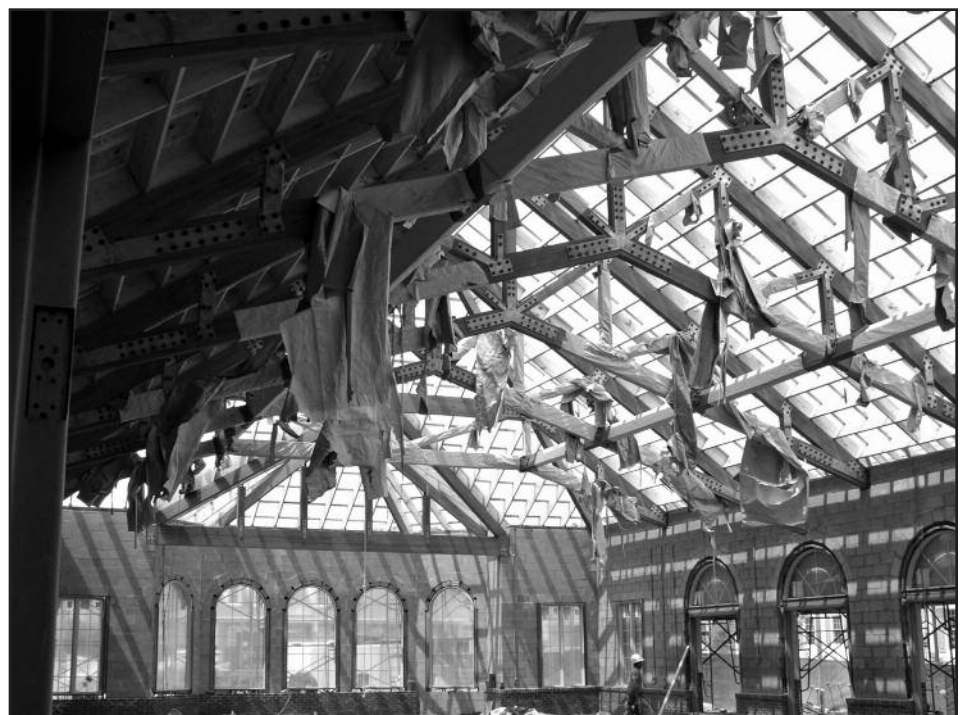
The pool room portion of the building was designed and constructed with load-bearing masonry cavity walls and heavy timber roof trusses (Figures 3 and 4). The adjacent nonpool spaces had a conventional wood-truss system on a steel frame with asphalt shingle roofing as well as precast concrete plank structure with insulated EPDM single-ply roofing. The adjacent construction included attic spaces that abut

Figure 3 – View of original pool building roof structure under construction with truss protection wrap partially removed.

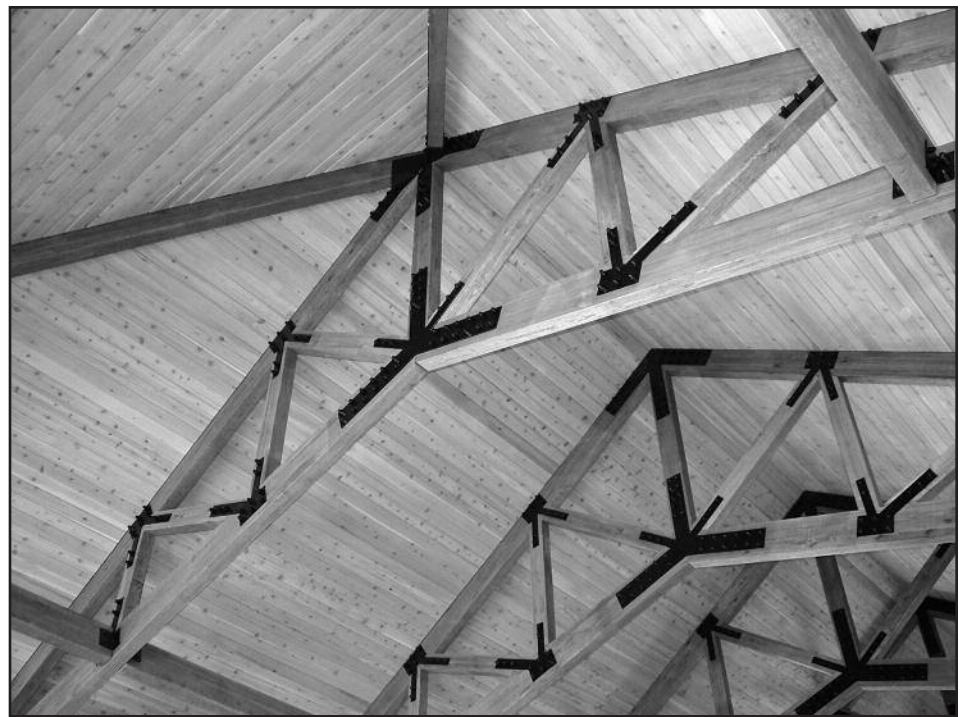
**Figure 4 – View of the pool roof heavy-timber trusses and cedar-ceiling finish.**

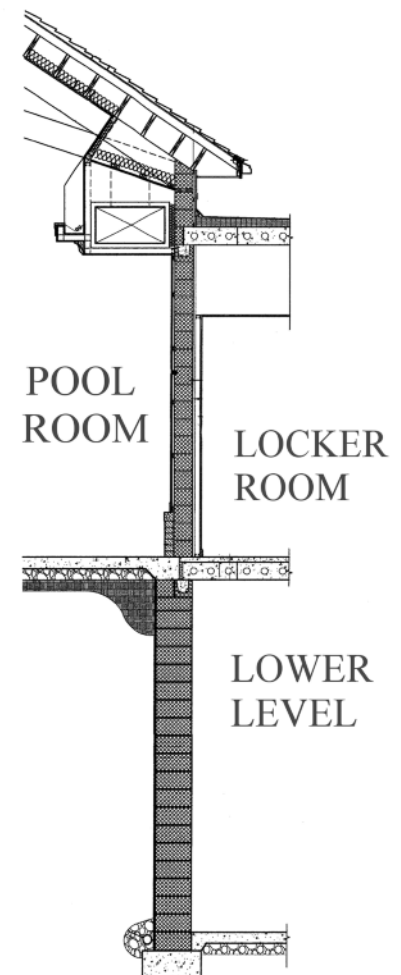
The design of the pool room roof assembly included heavy timber Glu-Lam trusses bearing on the masonry walls with 2-in x 12-in dimensional lumber rafters spanning between the trusses (perpendicular to the roof slope) with plywood roof sheathing, felt paper, and architectural-grade fiberglass roofing shingles. The design also called for a compact roof assembly including an interior ceiling finish of natural beveled cedar-board siding over 2-in x 4-in furring strips over a polyethylene vapor barrier with fiberglass batt insulation placed between the rafters. This compact roof assembly was ventilated with continuous slotted soffit vents and a continuous ridge vent (Figures 5 and 6).

**Figure 5 – Original wall section at the demising wall separating the pool room from the adjacent locker rooms and lower level spaces.**
