# ASPHALT COMPOSITION SHINGLE DAMAGE —

## *Hail or Manufacturing Defect?*

BY DARRELL L. SMITH, RRC, PE

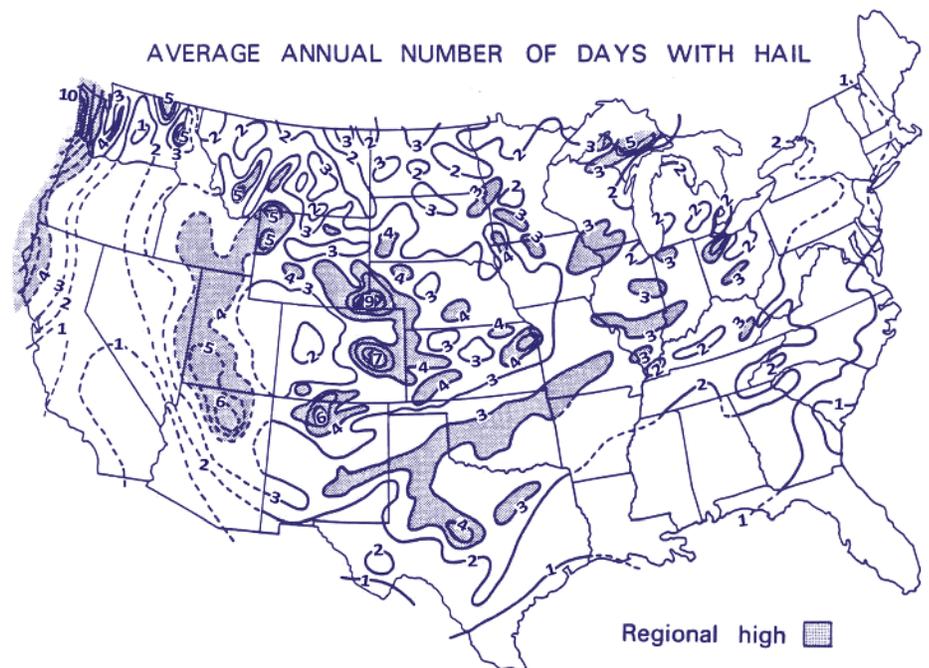
The area of the United States that receives the most hail is limited to a relatively small area east of the Rockies and west of the Mississippi River. *Figure 1* is a map from “The Climatology of Hail in North America” by meteorologist Stanley A. Changnon, Jr., published in Monograph No. 38 by the American Meteorological Society (107-128, 1996), showing the number of days of hail for the United States for an average year.<sup>2</sup>

*Figure 1 – The average number of days with hail across the United States.*
