Missing Paint and Escargot

By Mitchell Wright, RWC, IACT,
and Robert J. Bitterli, AIA, NCARB, LEED GA

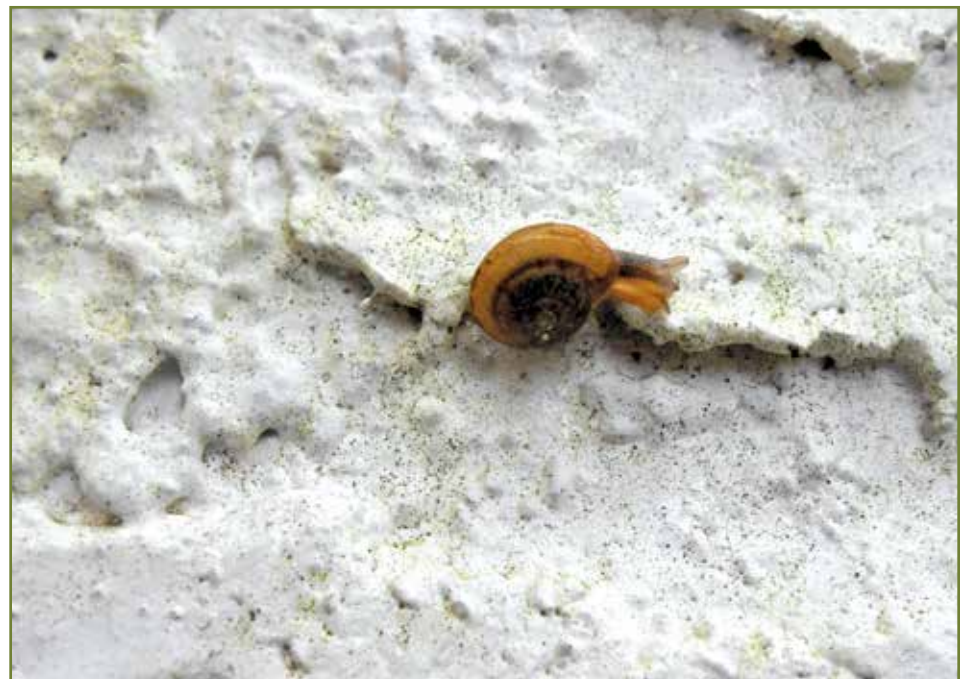
Figure 1 – Conventional wisdom says that you can set out a small dish of beer to catch and rid your garden of snails. Unfortunately, you may attract local varmints as well. What does this have to do with building envelope science? Read on.
