Composite Metal Panels as a Rehabilitation Cladding

By Marcus Dell, PEng

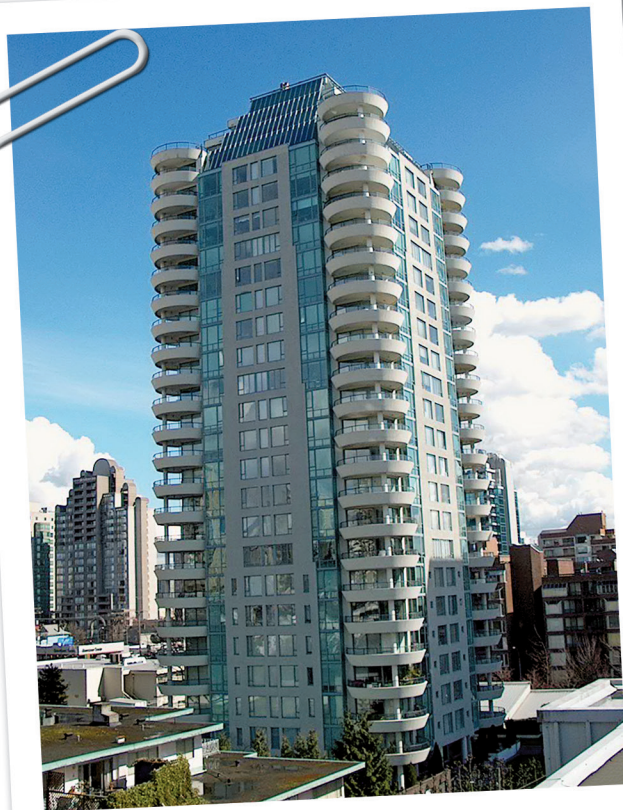
Figure 1 – View of building as originally constructed.

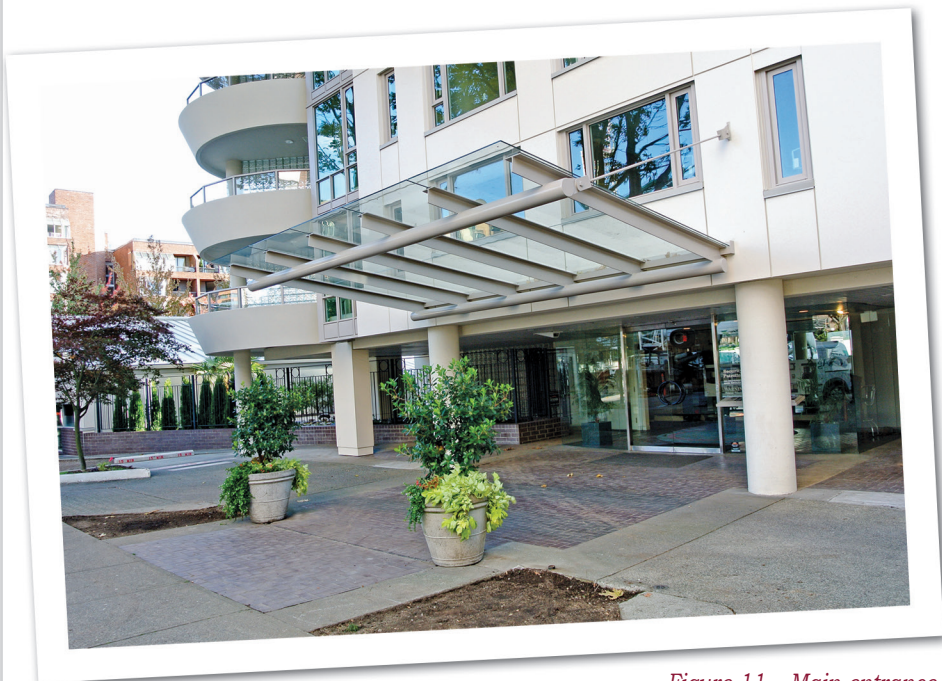
Figure 11 – Main entrance.

the completed project, while *Figures 9 and 10* offer a comparison between the original cladding and the rehabilitated cladding. *Figure 11* illustrates the new building entry canopy. Importantly for the owners, the panels have remained clean and unstained since the rehabilitation was completed in 2013.
