WATERPROOFING UNDER GREEN (GARDEN) ROOFS

Part 2 of 2

By Justin Henshell, FAIA, CSI, FASTM

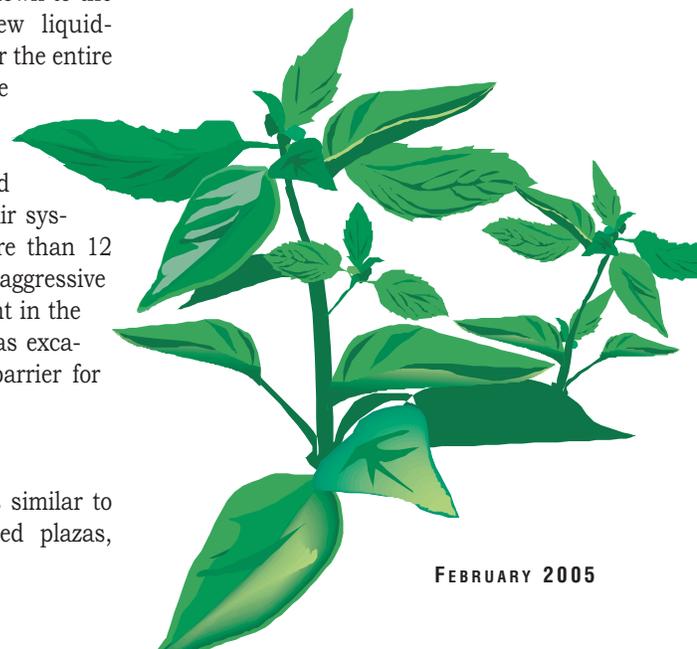
When leaks are caused by root intrusion into the membrane, the investigation can be a major undertaking. Where intensive planting includes trees and large shrubs that must be removed, wholesale excavation becomes extremely difficult and costly. Stockpiling plants and soil assumes a major logistical challenge. Sometimes, in order to avoid overloading the structure, the entire overburden—soil, shrubs, trees, and all—must be removed and lowered to grade. Patching becomes further complicated by the need to prevent water from flowing into the area to be patched, keep wind-blown soil off adhesive applications, and seepage from surrounding soil away from patches.

To overcome this problem, Haisley has attempted, with some success, to stop leaking in an intensively planted plaza by injecting the slab from below. Injection might mend holes in an existing membrane if it is

in reasonable condition. This probably works better with adhered membranes than with those that are loose-laid and is of limited use where leaks are due to root intrusion. In these areas, Haisley has recommended excavation and removal of larger trees and plants with aggressive root systems before patching the membrane from above. Unless root intrusion is permanently corrected, this form of remediation simply defers patching or replacing the membrane.
