DUTCH LAP SLATE ROOFING

By Jeffrey Levine

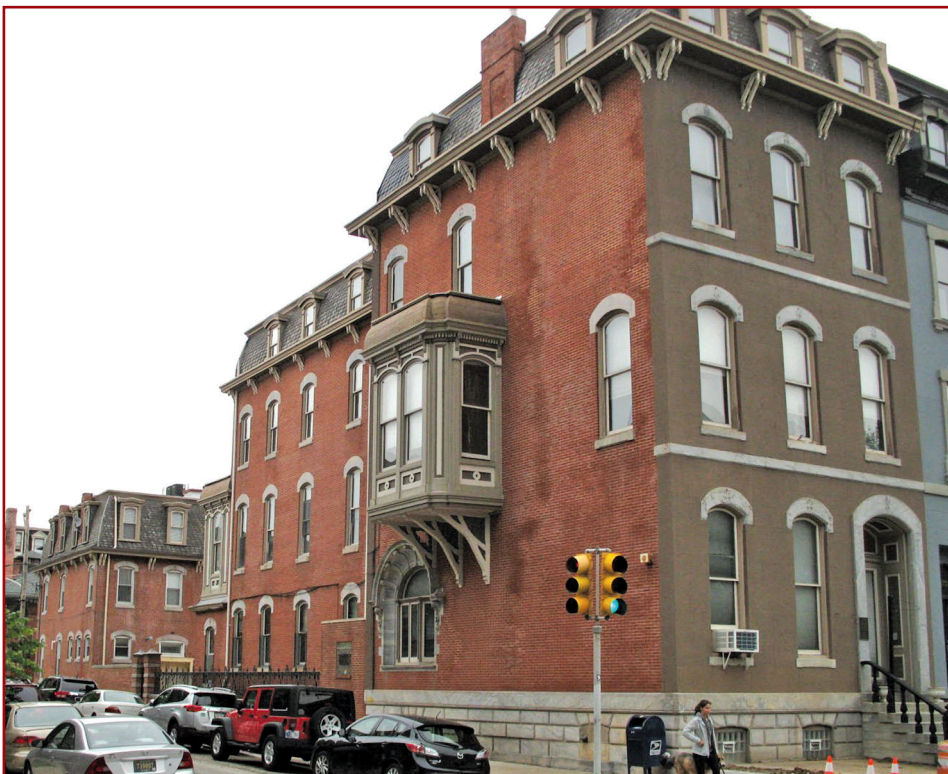
Figure 1 – Main House (foreground) and Carriage House (lower left) of the Hoopes mansion.

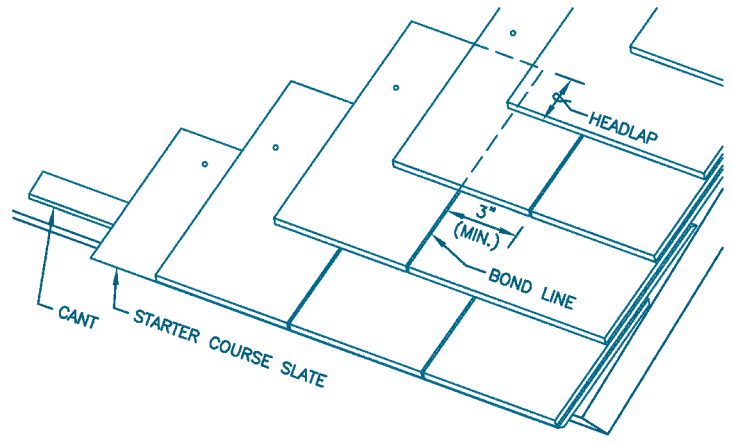
Figure 3 – Headlap is the amount by which the head of slate in a given course is lapped by the butt of the slate two courses above and is the key to keeping a traditional slate roof weathertight. Side lap is what allows the Dutch Lap method to have only a single lap at the heads of the slates.

That last sentence is interesting, given that all slate shingles are rather flat and the angled cut on the slates of the Hoopes mansion direct rainwater toward the laps (see Figure 3).

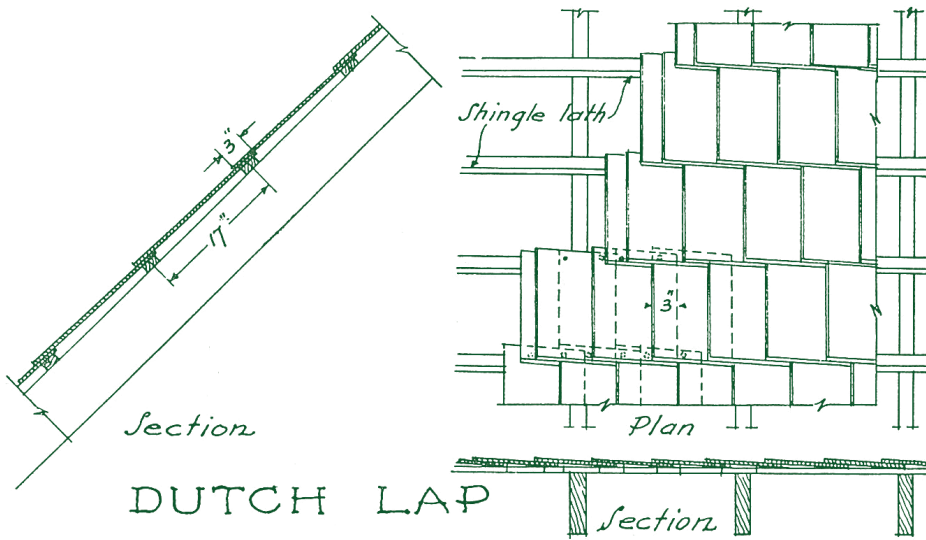
Figure 4 – Detail drawing of the Dutch Lap method as shown in the first edition of Architectural Graphic Standards.
