# Hail Events and Structural Decking

– A CASE STUDY –

By Dziugas Reneckis, PhD, PE, MStructE; and Remo Capolino, PE, RRC

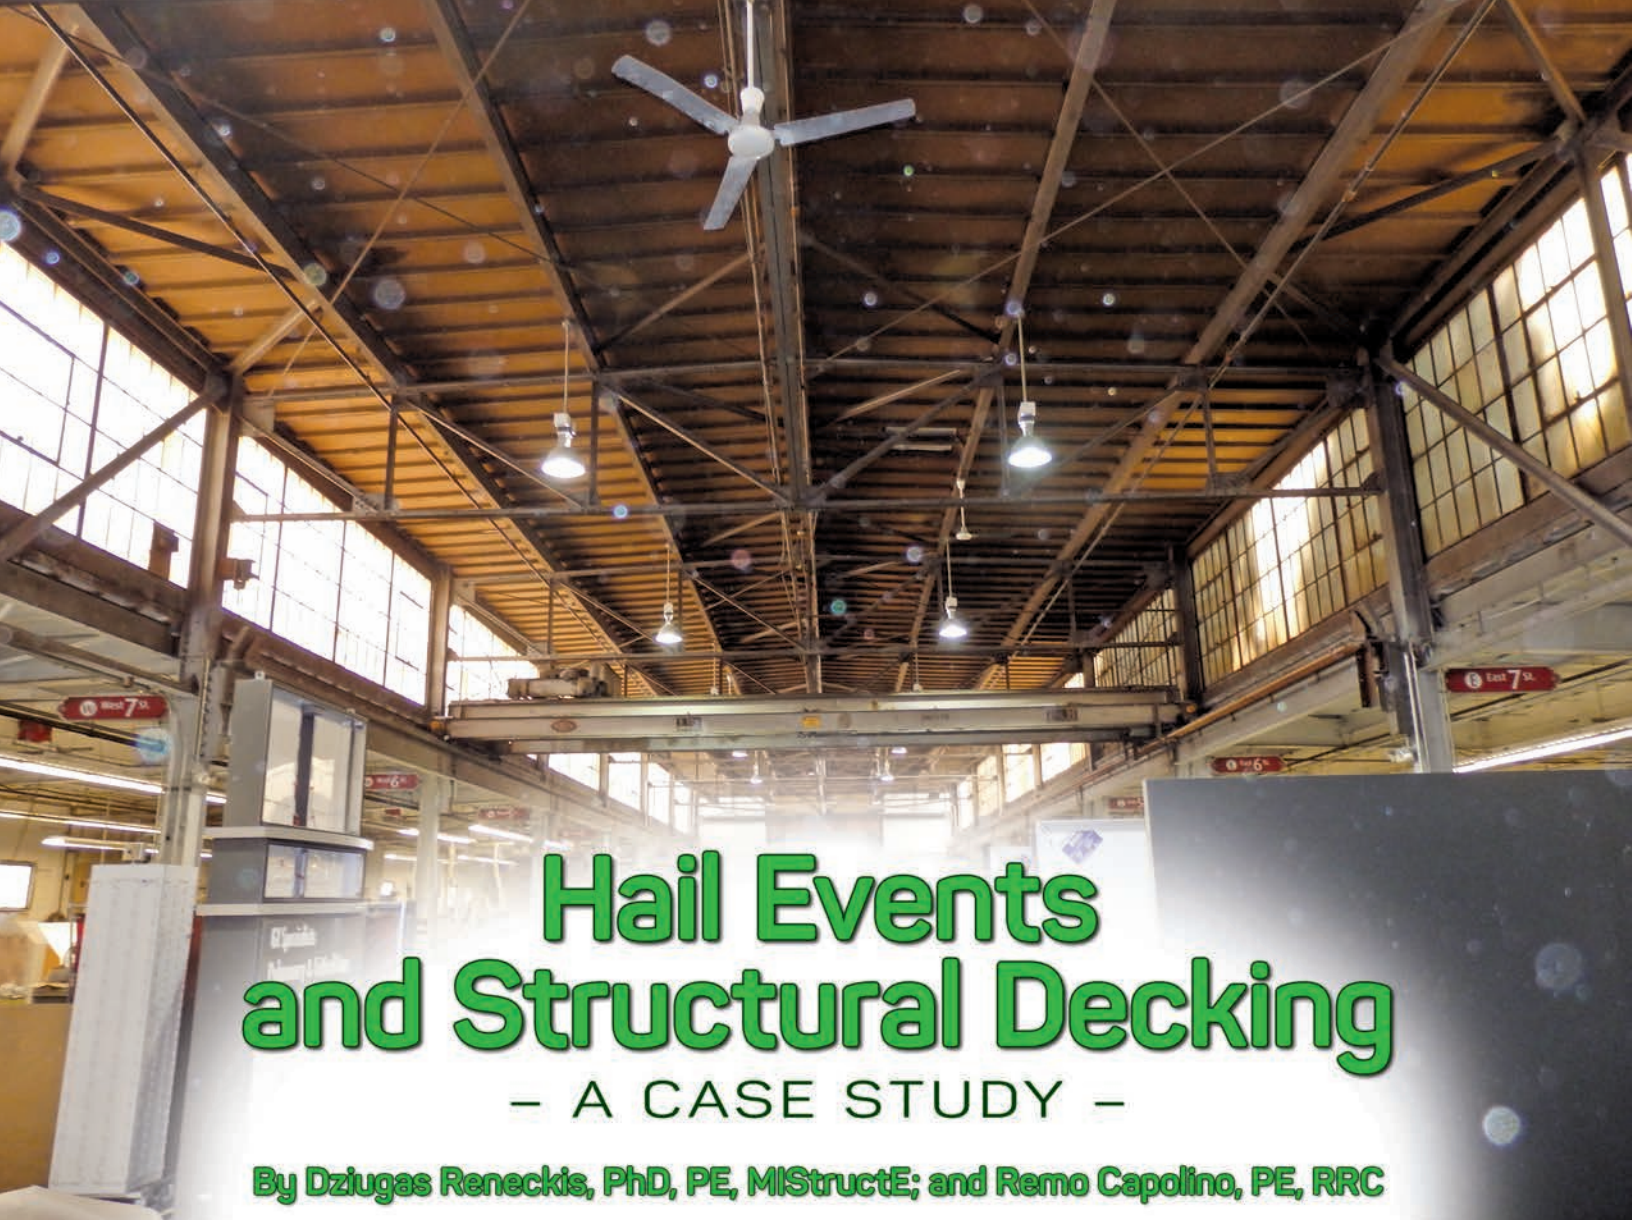
Figure 2 – Interior of building showing low bay and high bay with clerestory windows.

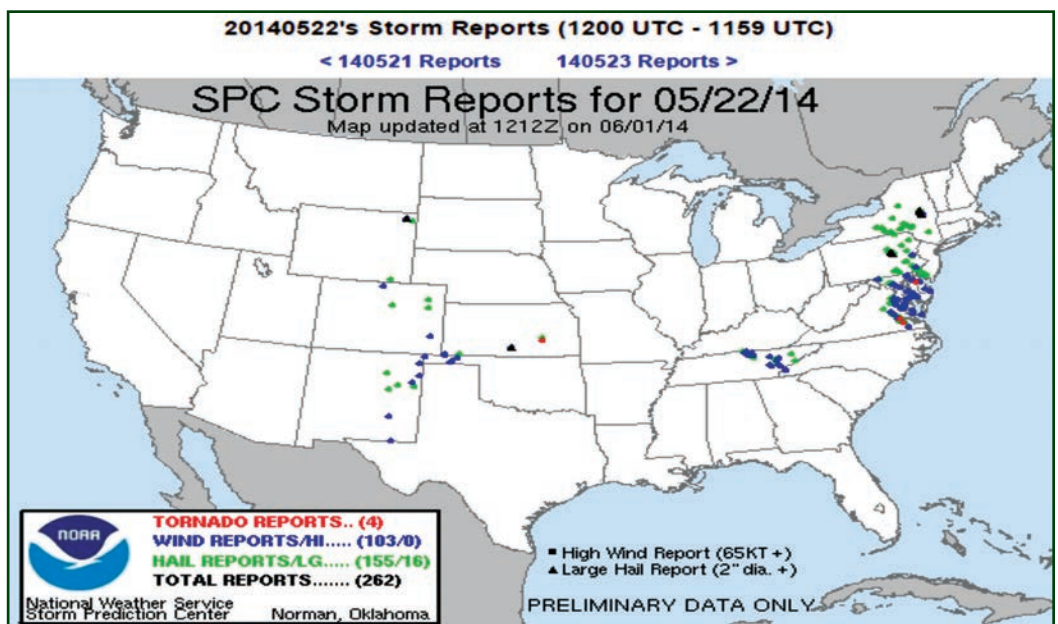
**R**ading, Pennsylvania, experienced two hailstorms on May 22, 2014 (Figure 1). These hail events caused significant and widespread damage to property around the area. Damage was reported to vehicles, sheet metal, and windows, as well as roofs and rooftop equipment.

Figure 1 – National Weather Service storm report for May 22, 2014.

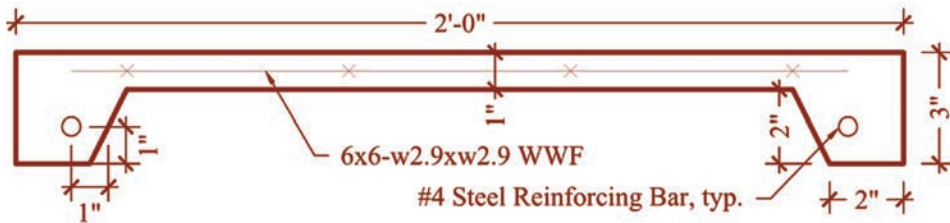
Figure 8 – Design of concrete planks.

The roof decking below the EPDM and coal tar pitch is precast concrete channel slabs that are gravity-set with retaining clips, spanning approximately seven feet between steel purlins (Figure 7). These precast planks are common throughout the roofing industry—not because they are typically installed today—but rather because they were often installed prior to World War II and they are so durable that if the building remains, so, too, do the precast concrete planks. The concrete planks on this building are two feet wide by seven feet long and are one inch thick at all areas except the two long edges where the concrete was thickened to three inches thick. This effectively gives the planks the shape of a blunted “C.” The planks in question were weighed and measured and were determined to have been made with lightweight structural concrete with #4 reinforcing steel bars located at the thickened edges (Figure 8).

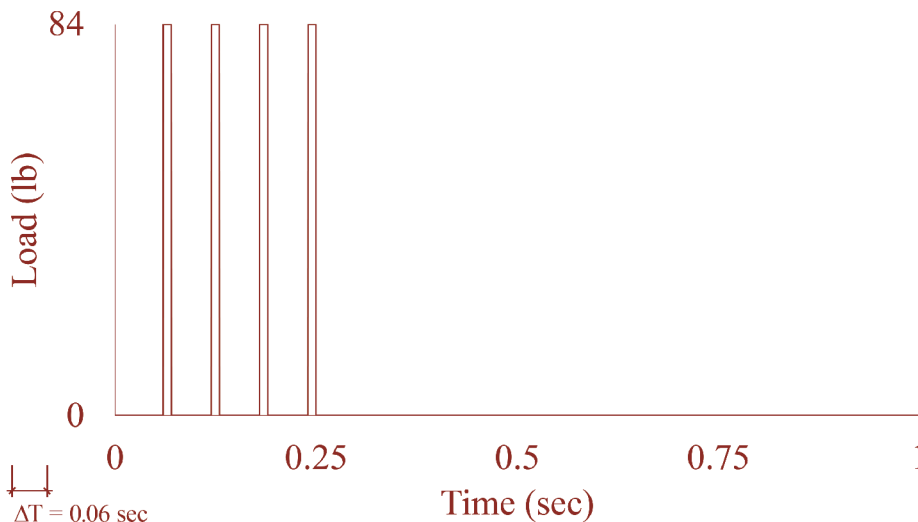
The concrete planks were modeled using CSI SAP2000 structural analysis software with 84-pound loads applied at 0.01-second intervals. Based on the above statistical analysis, four impact forces were applied at intervals equal to the period of vibration of the planks (which we calculated to be equal to approximately 0.06 seconds), resulting in a cumulative application of impacts, adding to the amplitude of the precast concrete plank response (Figure 12). This approach is considered to be somewhat conservative because during the hailstorm event, it is likely that half of the hailstones landed on the roof surface in sync, while the other half landed out of sync, which thereby reduced the amplitude of the dynamic response of the planks.

Figure 12 – Idealized impact force history.
