# Low-Slope Roofs Are Rotting: Case Study Resolution

By Dwight D. Benoy, PE;  
Pamela Jergenson, CCS, CCCA, BECxP, CxA+BE;  
and Gary C. Patrick, RRC, AIA

The buildings that were repaired were actually two four-story, wood-framed buildings called Coborn Plaza Apartments in St. Cloud, MN. Each building has retail space on the first floor with student housing for nearby Minnesota State University on the upper three floors. J.A. Wedum Foundation is the owner of the complex. Granite City Roofing, Inc. of St. Cloud was the reroofing contractor. Inspec was the architectural/engineering firm. This reroofing project proved to be one of the most challenging in Inspec’s 45-year history from a design and constructability standpoint.

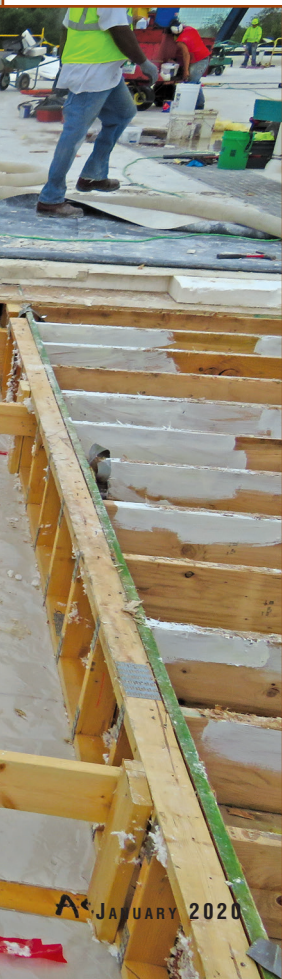
Figure 15  
– Perimeter  
safety rails.

Perimeter safety was primarily accomplished with rails attached to the parapet (Figure 15). A safety monitor was also assigned to work with the crew applying the low-rise foam adhesive for the insulation attachment.
