“Shake-Style” Asphalt Shingles

Design Defect Prone to Hail Damage

By Dustin Smoot, RRC, RRO

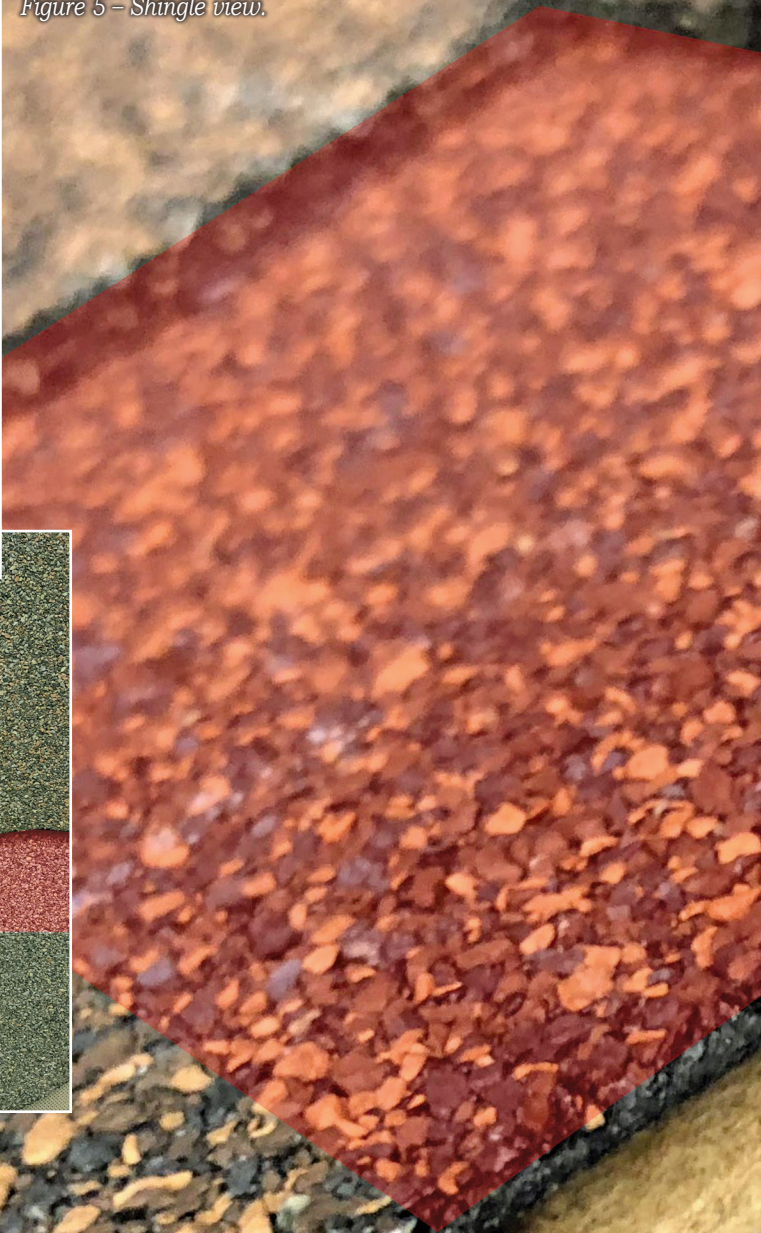
Figure 6 – Highlighted view.

the shingles have been highlighted to illustrate that there is impact damage in every notch, while no damage is present at the tabs.
