Testing Field-Aged TPO Roofs; Demonstrating Real-World Performance

By Thomas J. Taylor, PhD and Jennifer Keegan, AAIA

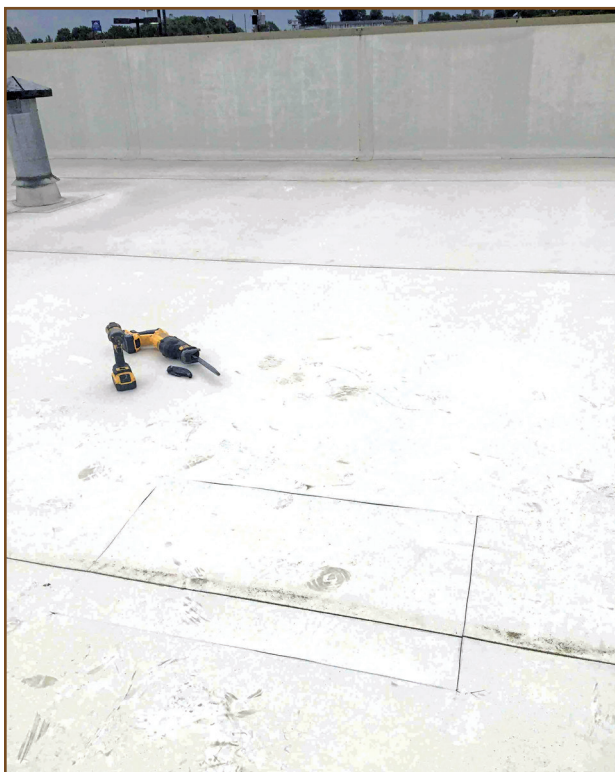
Figure 2 – Typical field sample (2 x 3 ft.).

Two samples were taken from each roof whenever possible. Each sample was approximately 2 x 3 ft. and captured a field-welded seam. One sample was taken from the field of the roof (Figure 2) and another was taken in a location that resulted in increased heat exposure by being near a south-facing parapet wall (Figure 3).

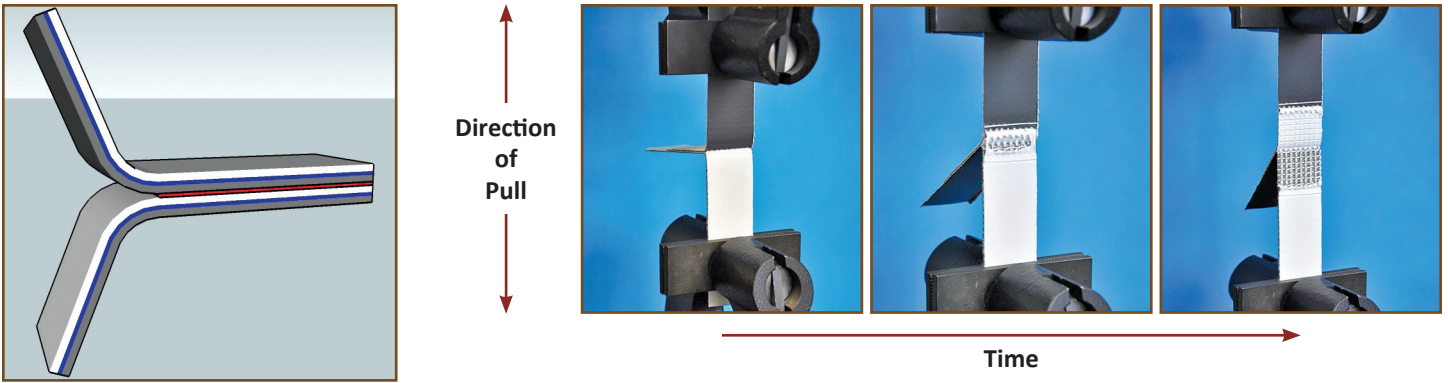
Figure 4 – Illustration of the ply adhesion test and a full film-tearing bond, indicating a complete weld.

Ply adhesion testing of a proper seam weld will fail cohesively within one of the plies, exposing the underlying scrim. This is referred to as a “film-tearing bond” and indicates the integrity of the weld. For the purposes of this evaluation, anything over 70 percent film-tearing bond was considered a proper weld. Figure 4 shows a 100

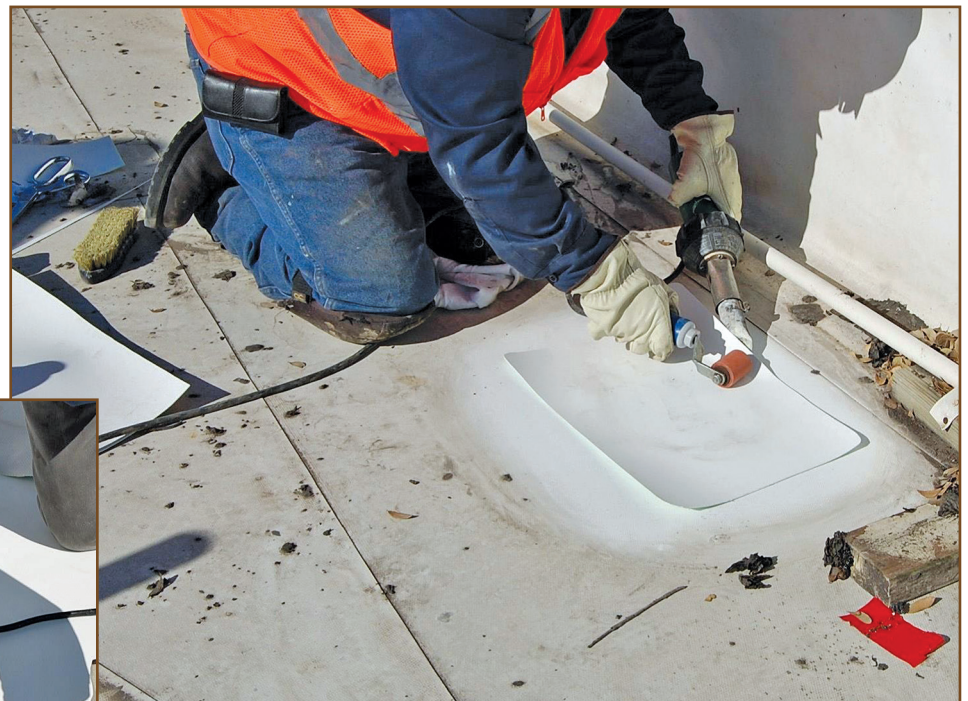
Figure 5 – Repair of aged TPO membrane with a new patch welded to the aged cap. Image courtesy of WSRCA.

top-down repair—were evaluated, with *Figure 5* indicating the general process. While this repair process is the most common, in some instances it is necessary to weld repair membrane to the core (the underside) of the aged roof, also called a bottom-up repair, as indicated in *Figure 6*. Both approaches were evaluated in this study. Note that weld strength to the core was not evaluated for cases of adhered membrane roof samples due to remnants of adhesive and/or facer from the insulation or cover board. Given the remnants attached to the underside of adhered membranes, repairs to the core would not be reliable.

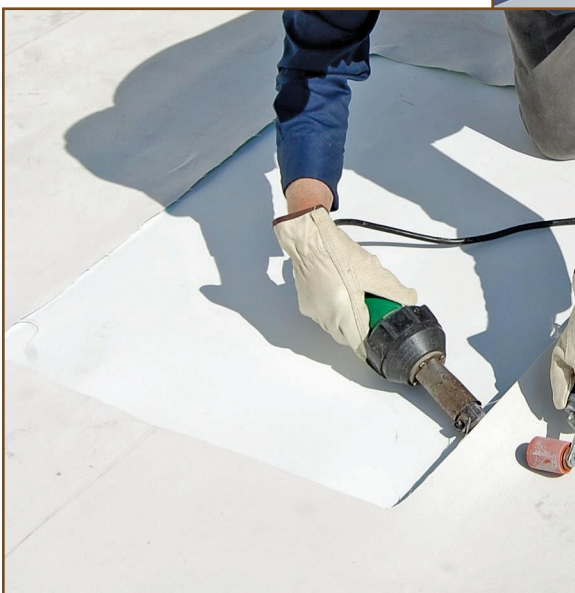
Figure 6 – Repair of aged TPO membrane with a new patch welded to the aged core. Image courtesy of WSRCA.

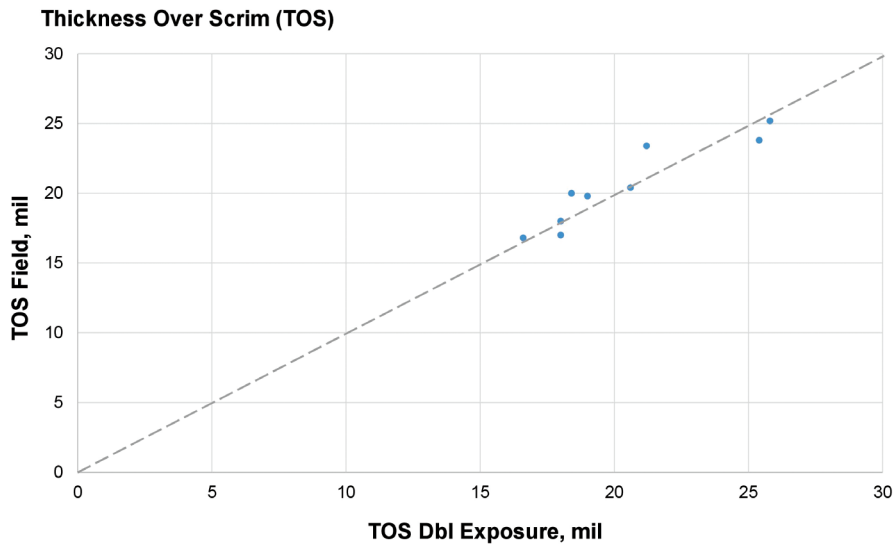
As seen in *Figure 9*—at least for the roofs where permission to obtain field and perimeter samples was granted—no consistent trends in terms of weathering were identified. This is an indication that the data are within the error tolerances of the measurement technique.

Figure 9 – TOS for the field versus perimeter samples. The diagonal line would be the result if no differences in weathering were observed. Samples in the field and perimeter were permitted on nine of the roofs in this study.

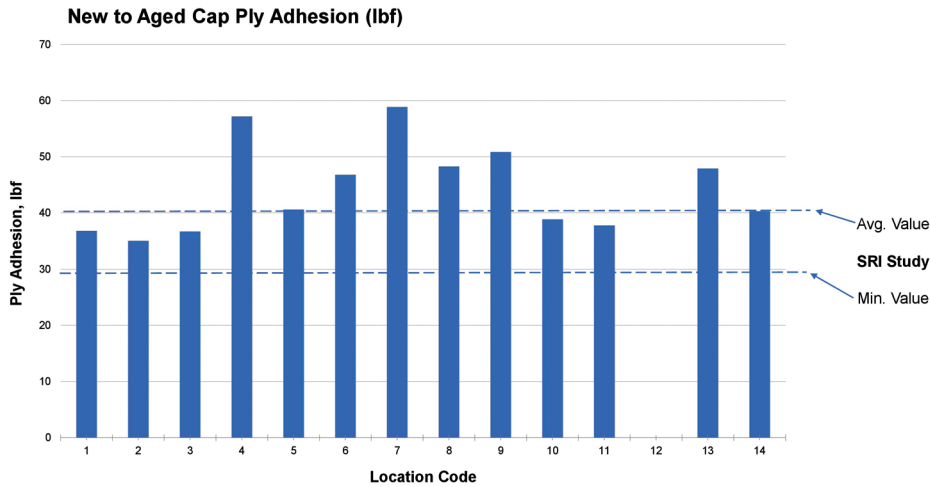
Figure 14 – Ply adhesion of the new membrane to the aged cap. The average ply adhesion was 44.7 lbf/in. Not all samples were tested for ply adhesion.

The ply adhesion of the new membrane to the aged cap averaged 44.7 lbf/in. (standard deviation 8.9 lbf), as shown in Figure 14. For the new membrane welded to the aged core, the ply adhesion averaged 58.8 lbf (standard deviation 7.5 lbf), as shown in Figure 15. Both values represent the combined 45- and 60-mil thicknesses.

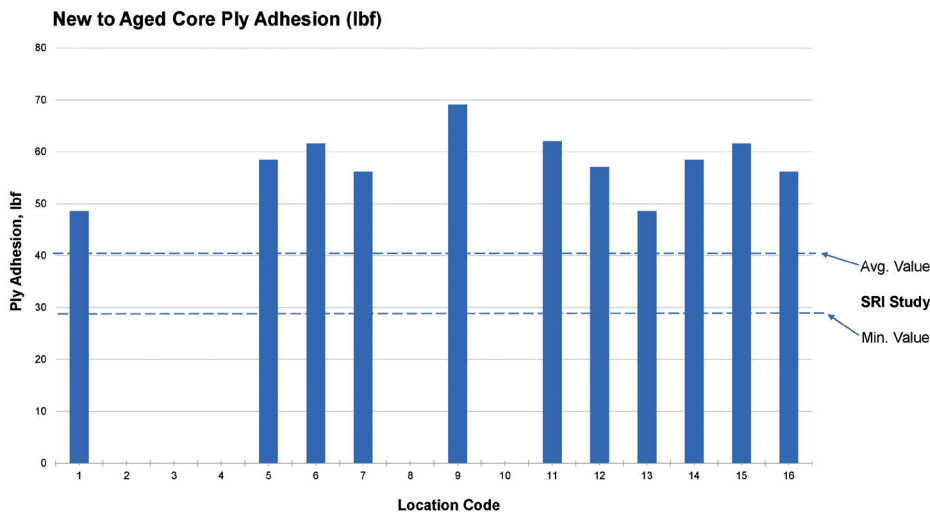
Figure 15 – Ply adhesion of the new membrane to the aged core. The average ply adhesion was 58.8 lbf/in. Adhered membranes were excluded from this evaluation.

The ply adhesion values of new repair membrane to the core of the aged TPO membrane are above the average ply adhesion value of 40 lbf/in. from a large independent study of new 60-mil TPO membranes conducted by SRI.¹⁶ This provides validity to the integrity of repairs to aged TPO membranes and the ongoing maintainability of these roofs. It should be noted that ultimate ply adhesion is mainly a concern for wind uplift of mechanically fastened systems as shown in Figure 16.
