What (Not) to Expect When You Are Expecting New Fenestrations

— A Case Study

By John C. Wylie, REWC, RRD, PE

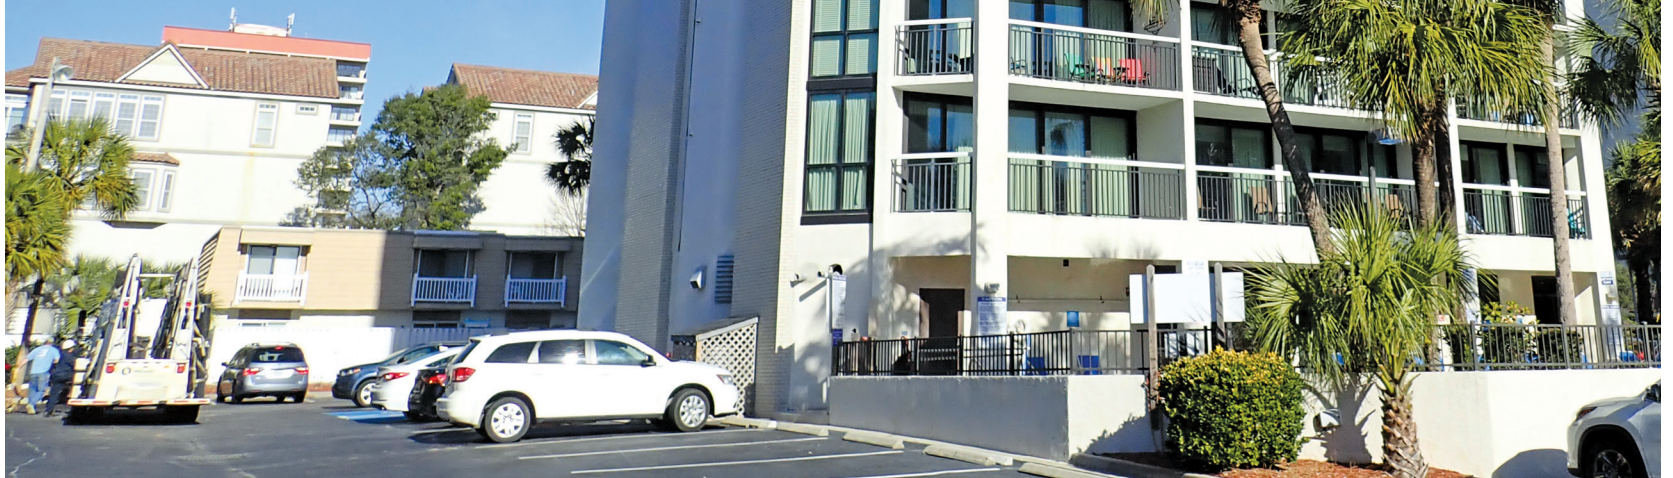
Figure 1. View of the case study building.

For this particular case study, the high-rise structure is located in a harsh oceanfront environment that produces significant hurricane-level wind speeds (Figure 1). Compounded with the high relative moisture and salt-laden air, the new fenestrations will have to be robust enough to not only adequately transfer the load of the code-prescribed wind pressures to the structure, but also minimize

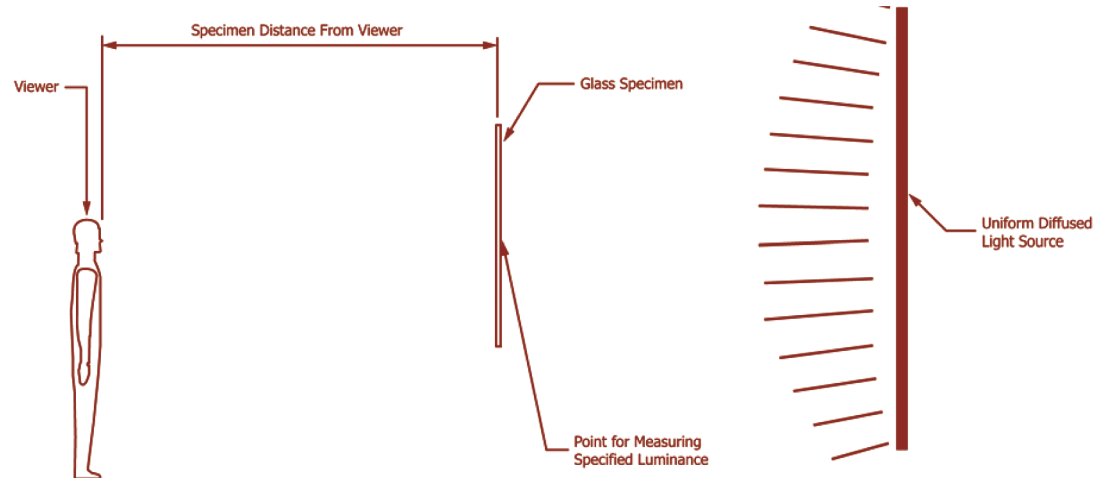
positioned perpendicular to the glass surface using daylight (without direct sunlight) or other uniform diffused background lighting (**Figure 6**). The viewer must have 20/20 vision (naked eye or corrected). Additionally, Section

6.1.1.3 of of ASTM C1036, *Detection for Linear Blemishes (Scratches, Rubs, Digs, and other Similar Blemishes)*, states that the glass shall be viewed at a distance of 3.3 m (130 in. or 10.8 ft.). The inspection of the glass shall progress

Figure 6. Viewer position from ASTM C1036, Standard Specification for Flat Glass.
