# Tornados Versus the Building Enclosure:

## A CASE STUDY

By John C. Wylie, REWC, RRC, RRO, PE

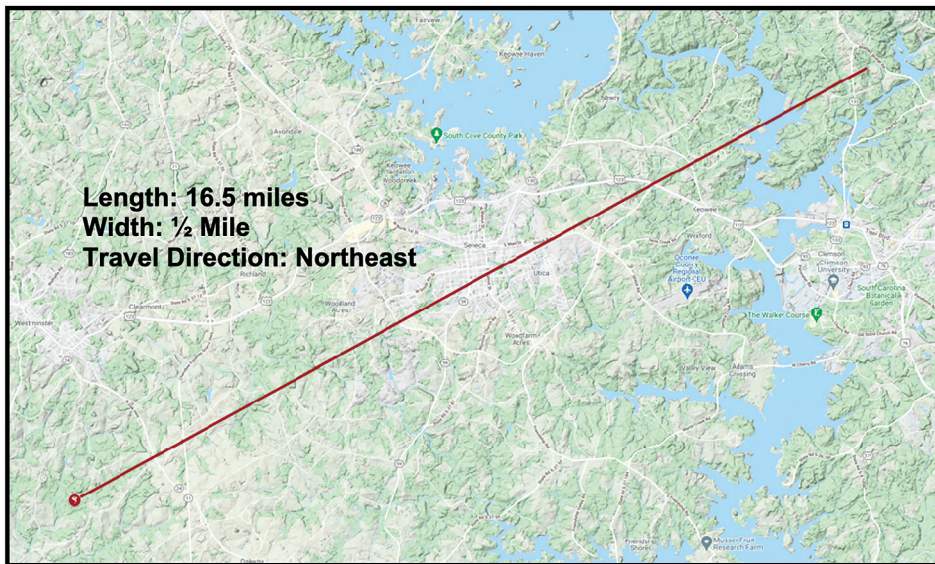
km) in a northeast direction and caused extensive structural damage to structures (Fig. 2).

Figure 2. Approximate path and length of the EF3 tornado.

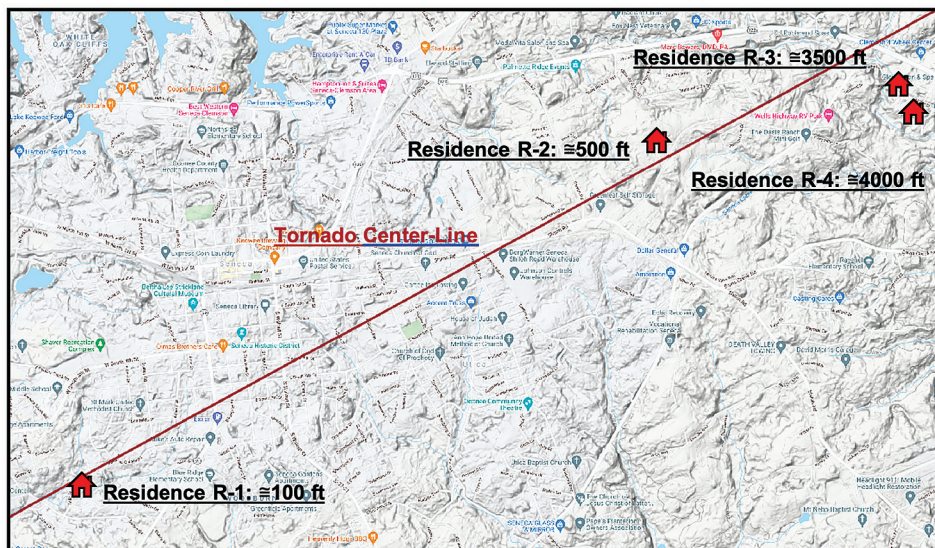
(two townhouses and two single-family houses) located between 100 ft to 4000 ft (30 m to 1200 m) from the approximate centerline path of the EF3 tornado (Fig. 3). Table 2 briefly summarizes the residential property information for the assessed structures. The residential structure

Figure 3. Approximate location and distance of residential properties relative to the tornado centerline.
