Testing Built-up and Modified Bitumen Roofs for Hail Damage

By Stephen L. Patterson, RRC, PE

This paper was originally presented at the 2022 IIBEC International Convention and Trade Show.

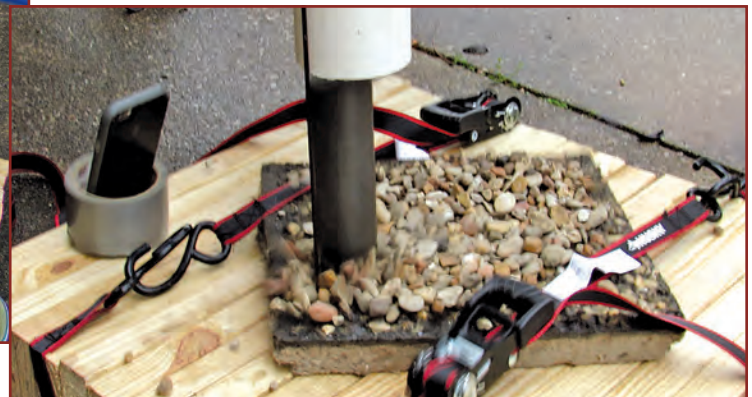
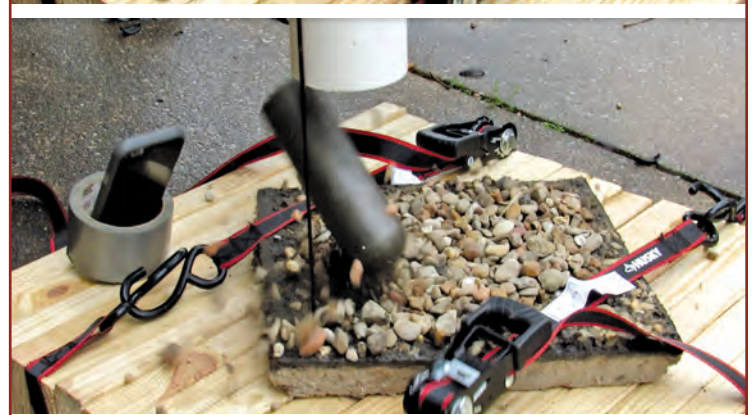
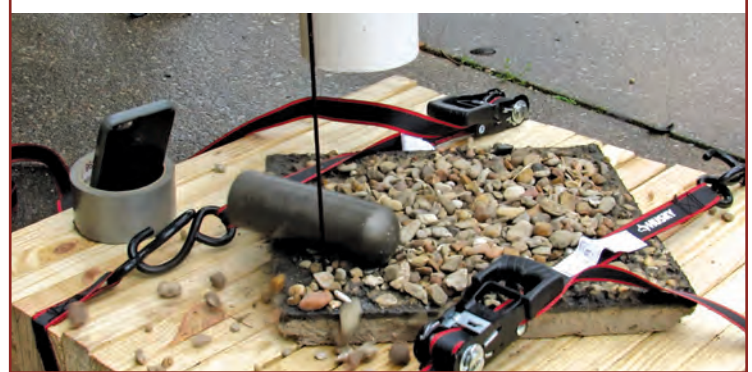
Figure 1. A test sample positioned on the platform.

The modified missile was 2.5 in. (64 mm) in diameter and 6 in. (152 mm) long, and weighed 7.67 lb (3.48 kg). A 24 × 24 in. (610 × 610 mm) testing table was constructed using two-by-fours placed on edge and bolted together in accordance with ASTM D3746. The test sample was placed on the testing table, and the missile was dropped from 87 $\frac{3}{4}$ in. (2232 mm) onto the approximate center of each of the four quadrants. **Figure 1** shows a test sample positioned on the platform, and **Fig. 2** shows how a missile was dropped onto the approximate center of each of the four quadrants.
