Case Study: Common Design and Workmanship Issues Related to Brick Veneer Masonry of a Modern Mid-rise Building

Warren R. French, PE, RRC, RWC, FRCI, CMRS
French Engineering, Inc.
Houston, Texas

This paper will present the findings of a forensic investigation conducted on a 12-story, multi-family residential building recently constructed in New Orleans, Louisiana. We were retained by the owner's representatives to assist in determining a cause for the interior water infiltration being experienced, as well as to develop a plan for cladding system remediation and renovation.

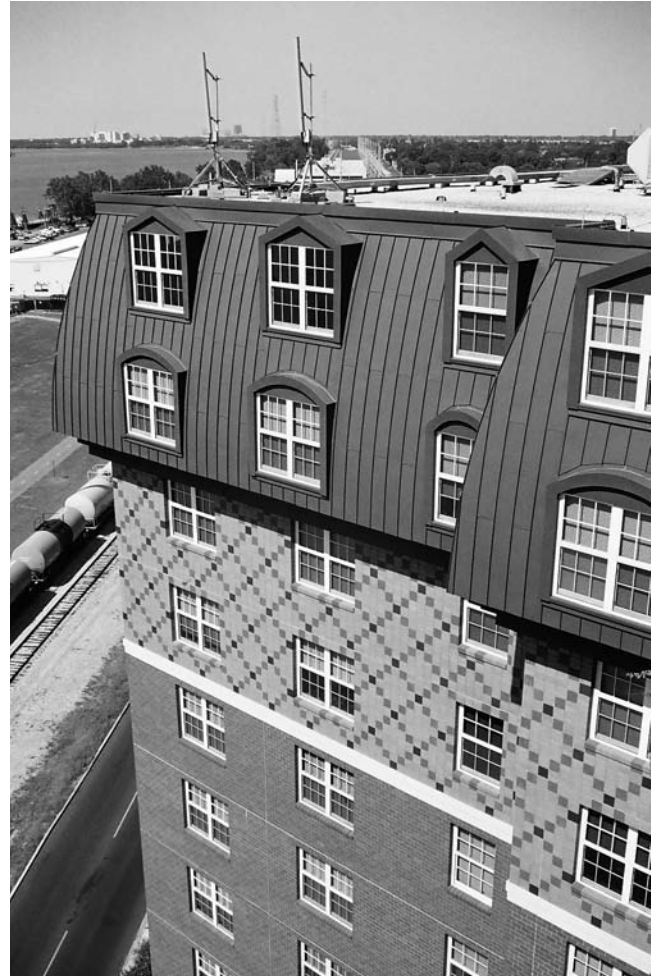
Figure 1 – Typical elevation showing intricate masonry.

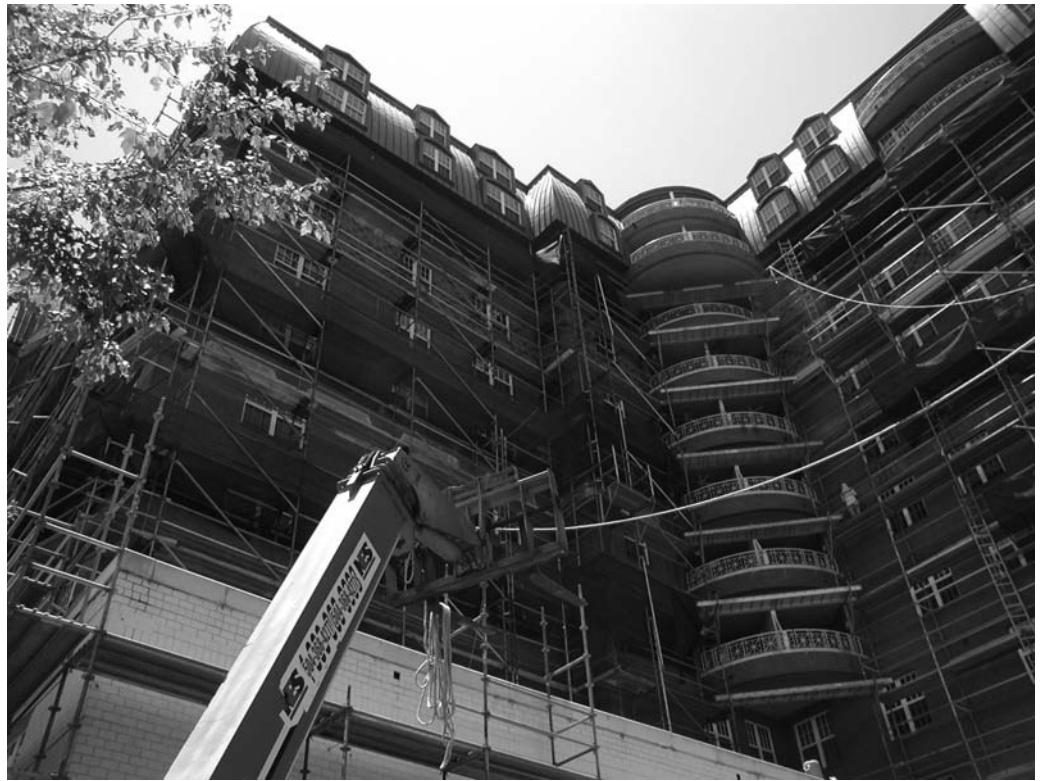
Figure 24 - Extent of scaffolding during renovation for occupied building.

the adjacent windowsills. In our opinion, the combination of these deficiencies was significant and severe enough to warrant complete removal and replacement of this roof system.
