Reviving a Historic Landmark: Restoration and Monitoring of “Detroit’s Largest Art Object,” the Iconic Fisher Building

By Ziad Salameh, PhD, PE

This paper was presented at the 2023 IIBEC Building Enclosure Symposium.

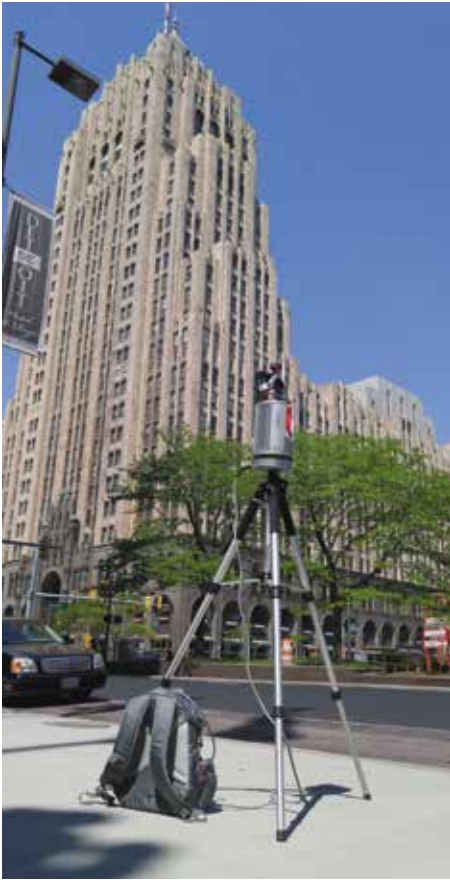
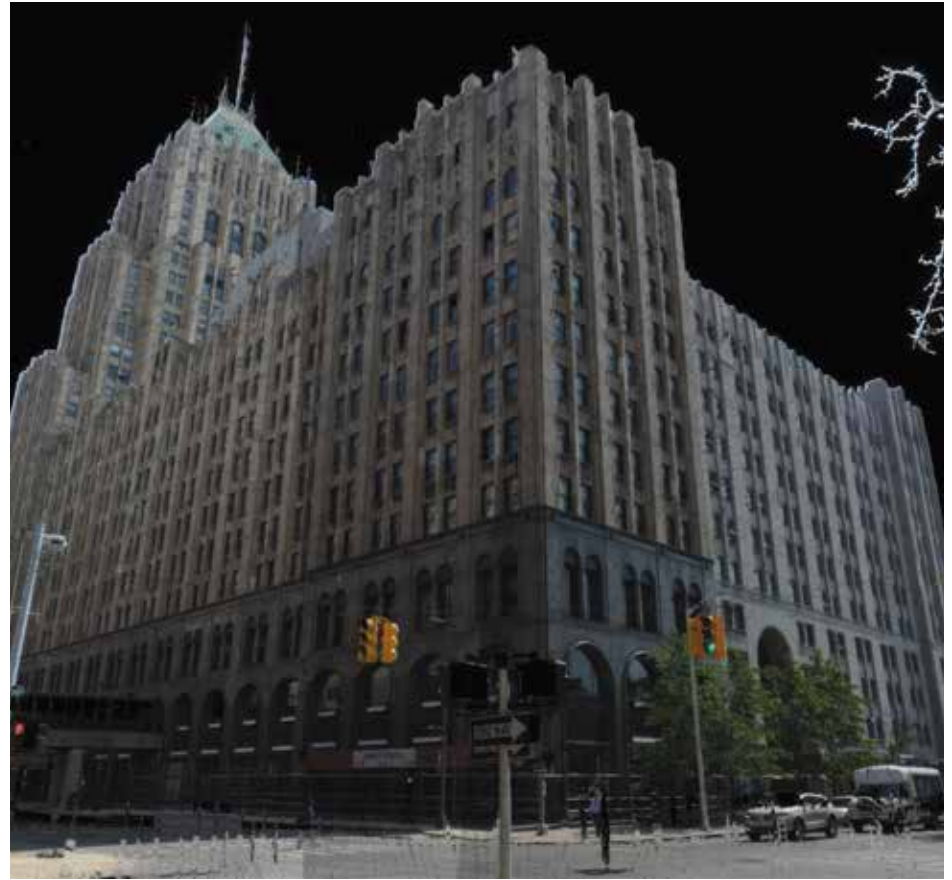
To evaluate the condition of the exterior walls, a combination of three-dimensional (3-D) laser scanning, high-resolution photography, and hands-on examinations were employed. A 3-D laser scanning approach was utilized with a high-speed, infrared laser (coupled with high-resolution photography) to quickly obtain millions of 3-D measurements (Fig. 3).

Figure 3. Laser Scanning utilized during assessment.
