# Microscopic Roof Leaks Destroy Fasteners And Insulation

By John Willers, RRC, FRCI, PE

## The Project

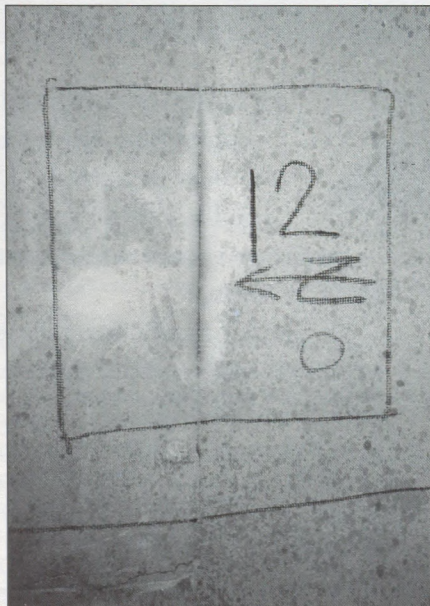
1. (Left) 12" x 12" membrane sample No. 12 before cutting. Note membrane lap and rust stains adjacent to the edge of the overlying membrane. 2. (Above) 12" x 12" membrane sample No. 12 after cutting. Note the large rusty spot in the center of the stress plate which is the rusted fastener head.
