A Deep Dive into Hail-Caused Dents: A Study of Corrosion Resistance within Dents in Galvalume-Coated Steel Roof Panels

By Jordan Beckner, PE, RRC; and
Stephen Patterson, PE, RRC

This paper was originally presented at the 2024 IIBEC International Convention and Trade Show.

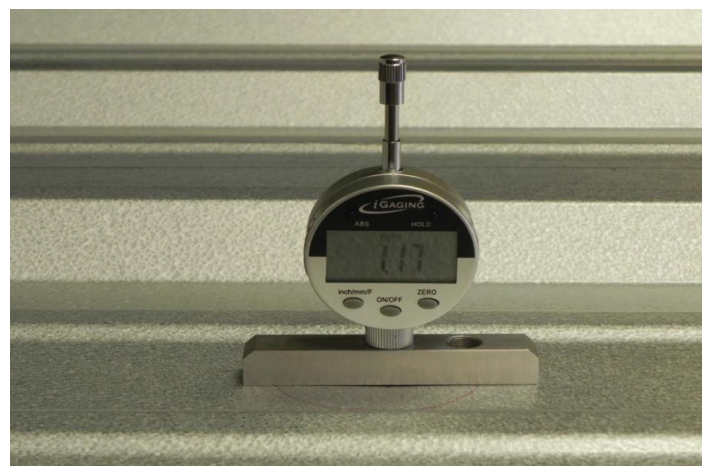
Figure 3. A field dent depth measurement.

The width and depth of the resulting dents were measured. **Fig. 3** shows the measurement of the depth of the dents resulting from the 2.00-inch steel ball impacts to the rib and flat portion of the panel.

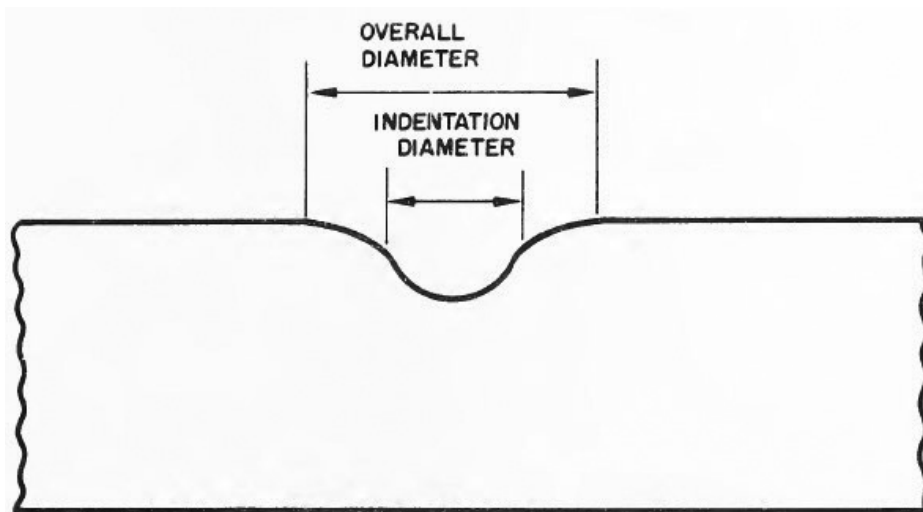
Figure 4. Diagram showing inside and outside or overall diameter of impact dents in metal panels.

Research performed by others and ROOFTECH’s experience had found the impact dents in metal panels typically exhibit an inside diameter and an outside or overall diameter. Mathey⁷ first reported the phenomenon wherein impacts to metal panels form a shallower outside dent and a steeper inside diameter. Mathey⁷ included a diagram showing these diameters,

which are depicted in a diagram of the typical cross section shown in **Fig. 4**.
