Children's Health Skybridges

Condition Assessment and Water Intrusion Investigation

FINAL REPORT

August 7, 2020
WJE No. 2020.2158.0

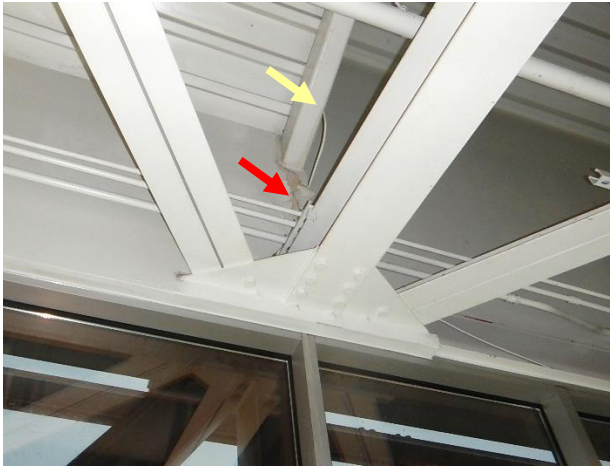
- Water stains and peeling paint were observed on the interior steel framing and drywall finishes below the sidewall-to-roof transition near the west end of the skybridge (Figure 4).
- Water stains were observed along the sill of both smoke exhaust louvers within the window wall on the south facade (Figure 5).

Figure 4. Water stains on steel framing (yellow arrow) and peeling paint on drywall (red arrow) below sidewall roof transition.

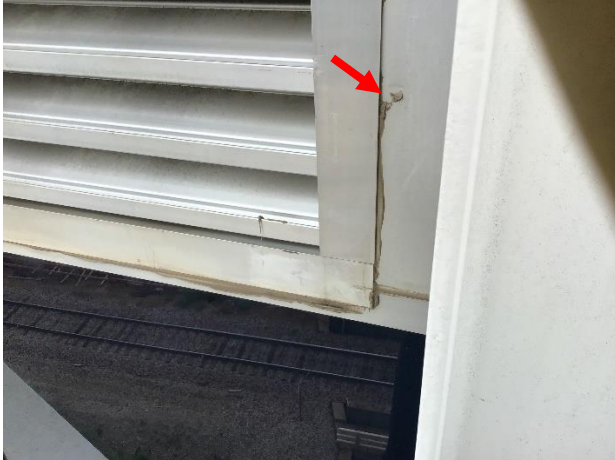
- Two louvers were glazed into the window wall on the south facade (Figure 8). Sheet metal infill panels were observed on each side of the louvers. The flange around the perimeter of the louvers appeared

to have been set in sealant against the infill panels and the window framing at the horizontal mullion and head. Sealant was not consistently observed around the perimeter of the flange.

Figure 8. Louver set into window wall. Sealant around perimeter not consistently observed (arrow).

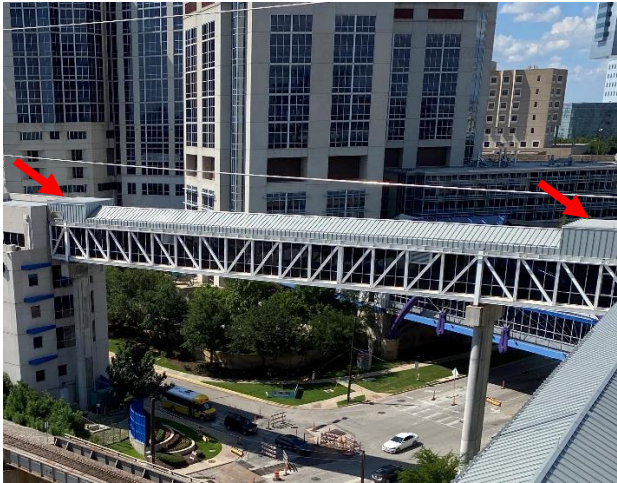
- The gabled metal panel roof transitions to a low slope modified bitumen roofing at each end of the skybridge (Figure 18). Signs of aging, including granule loss and alligator cracking, were observed throughout the modified bitumen roof membrane (Figure 19).

Figure 18. Low-slope roof areas at each end of the skybridge.

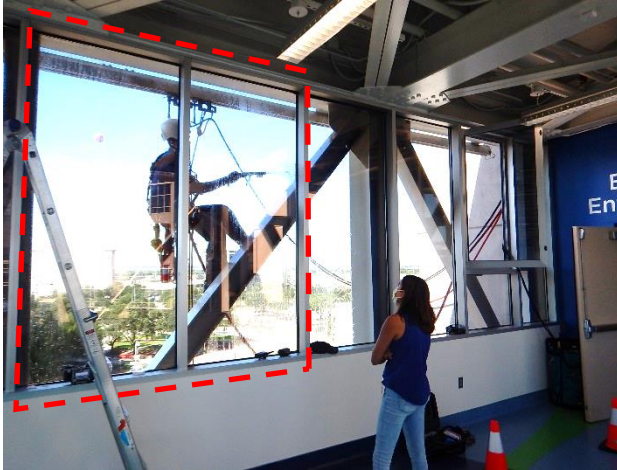
WJE tested the window wall framing surrounding two vision lites near the west end of the south facade of Skybridge A (Figure 26). An infrared camera was used to detect water infiltration behind the short wall in front of the spandrel glass. No water intrusion was observed when testing the horizontal or vertical mullions at each lite. However, water intrusion was observed when testing along the head of both vision lites. (Figure 27). Water was observed at the gasket intersections at the bottom corners of the vision lites (Figure 28). WJE removed a portion of the gasketing at the head and observed that the top of the glass lite was roughly in line with the edge of the day light opening of the curtain wall framing (Figure 29). In addition, it was observed that the interior vertical gasketing was run in between the horizontal gasketing.

Figure 26. Water testing two lites within the south window wall using a spray nozzle.

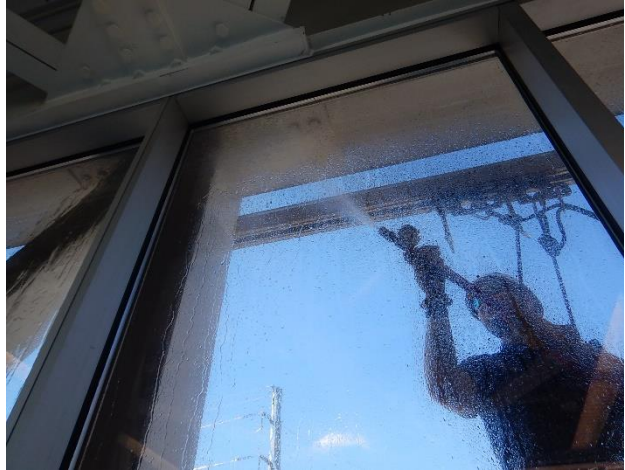
Figure 27. Water spray testing along window head.

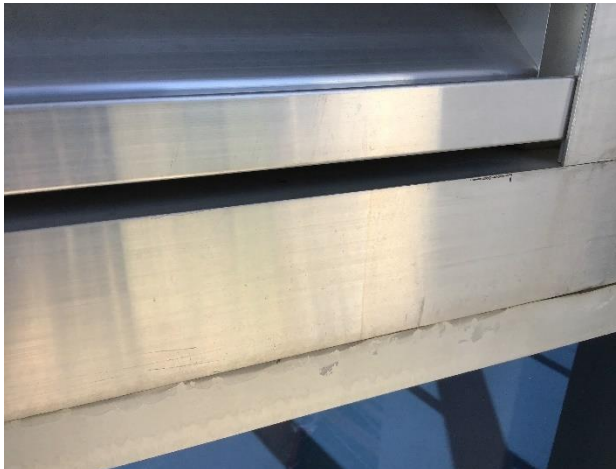
- Observations behind the louver grille showed an internal joint along the base of the louver that appeared unsealed (Figure 32 and Figure 33).

Figure 32. Base of louver within window wall.

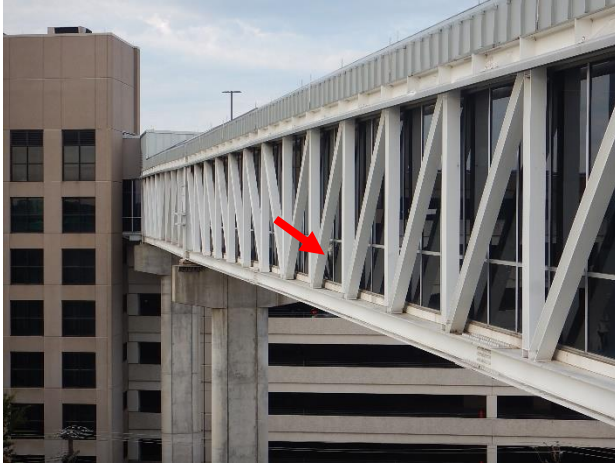
- One of the spandrel lites on the east facade was observed to be shattered with portions of the glass missing (Figure 38 and Figure 39). The lite was located above the railroad track. Spandrel insulation was observed behind the broken lite.

Figure 38. Broken spandrel lite on east facade above rail road track.

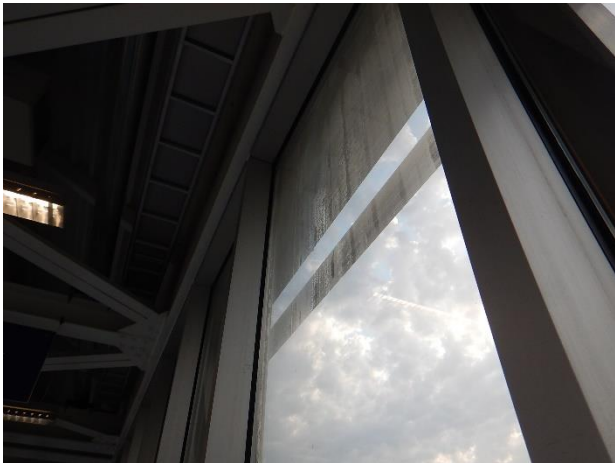
- Evidence of a failed perimeter seal within one of the insulated glass units (IGUs) was observed on the east facade (Figure 40 and Figure 41).

Figure 40. Haze/fogging of glass lite observed indicative of a failed perimeter seal within the IGU.

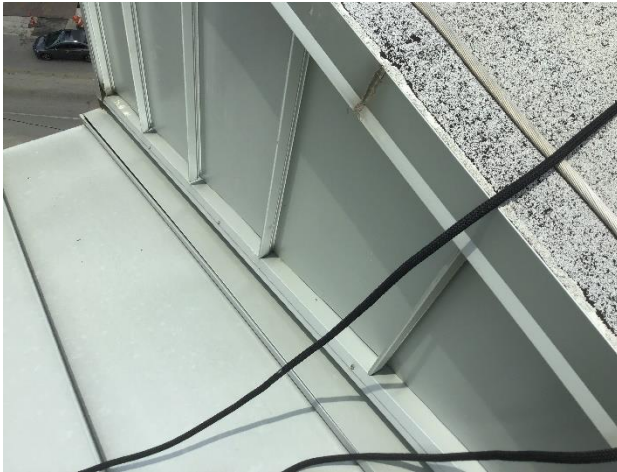
- Similar issues regarding the perimeter sealant joint along the sill at Skybridge A were also observed at Skybridge B.
- No missing counterflashing or other visible deficiencies were observed in the sidewall roof transitions at either end of the skybridge (Figure 42).
- The modified roof membrane at the low slope roofs on both sides of Skybridge B showed similar signs of aging as those on Skybridge A (Figure 43).

Figure 42. Sidewall transition at north end of Skybridge B.

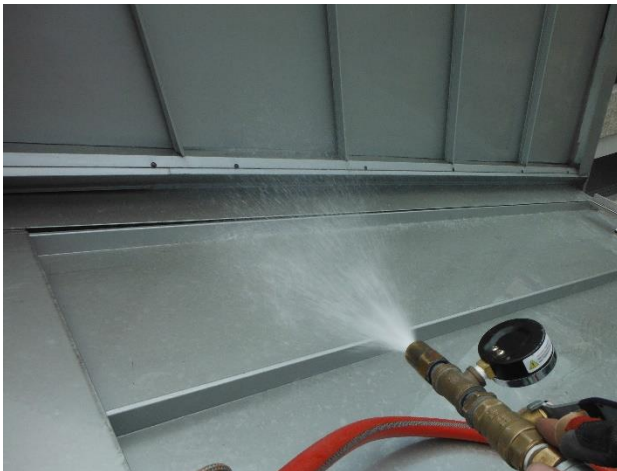
WJE tested the sidewall transition between the gabled metal panel roof and the vertical metal wall panels. No notable staining was observed at the interior framing prior to testing. No water intrusion was observed when testing the sidewall with a spray nozzle on each side of the gable (Figure 44 and Figure 45).

Figure 44. Water spray testing along sidewall transition at west side of gabled metal panel roof. No water intrusion observed.

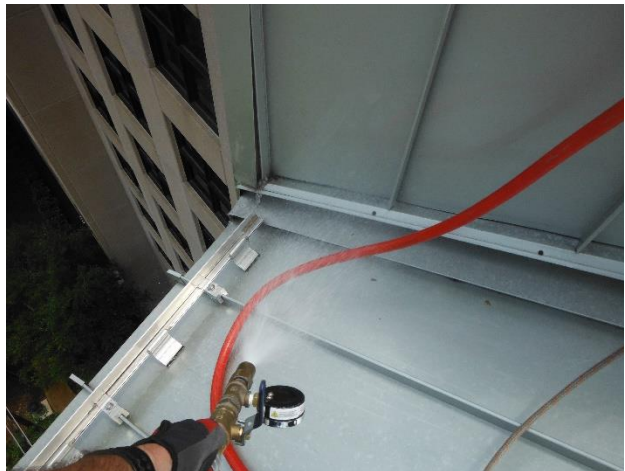
Figure 45. Water spray testing along sidewall transition at east side of gabled metal panel roof. No water intrusion observed.

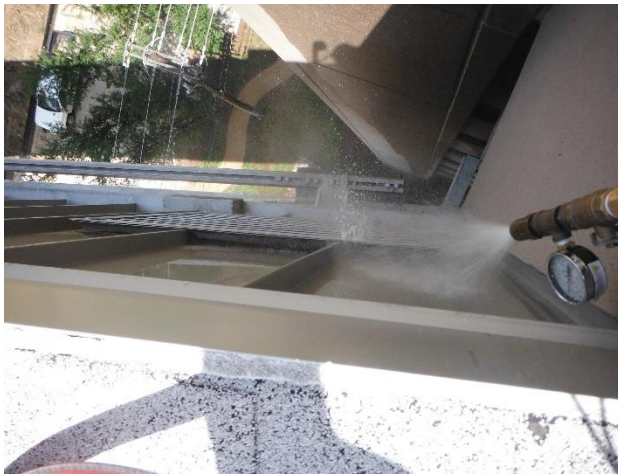
WJE tested two louver vents, one on each side of the south end of the skybridge. Prior to testing, staining was observed below the west louver indicative of previous water intrusion (Figure 30). WJE used a spray nozzle to sheet water down each of the louvers from the flat roof above (Figure 46 and Figure 47). No water intrusion was observed when spraying the louvers from the roof above. WJE repositioned testing and horizontally sprayed the west louver from the top deck of the Purple Garage (Figure 48). Water intrusion was observed after approximately 2 minutes leaking from the joint between the duct work and the wall (Figure 49). Additional water intrusion was observed dripping from a joint in the mechanical duct work near the east louver.

Figure 46. Water spray testing down onto the east facade louver near the Purple Garage. No water intrusion observed.

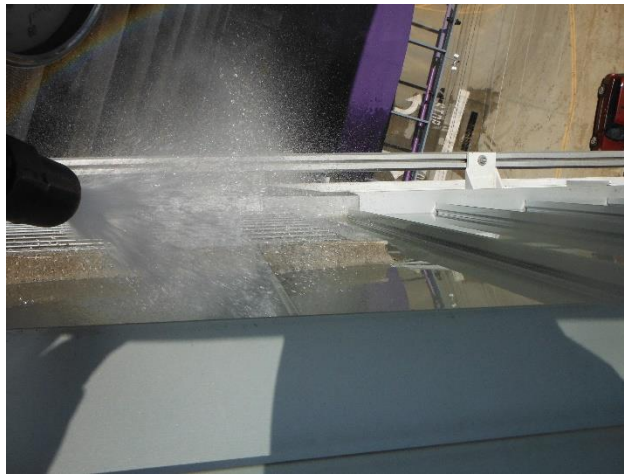
Figure 47. Water spray testing down onto the west facade louver near the Purple Garage. No water intrusion observed.

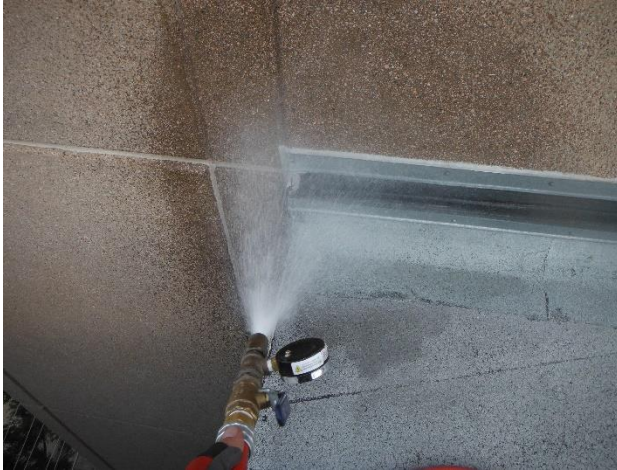
WJE tested the transition between the flat roof at the south end of the skybridge and the precast elevator tower at the Purple Garage. No water intrusion was observed when testing along the roof-to-wall transition flashing (Figure 52 and Figure 53). An adhesive sealant failure was observed within a precast panel joint further up the wall. Water intrusion was observed when testing this failed sealant joint after approximately 4 minutes (Figure 54). Water intrusion was observed below the south end of the roof-to-wall transition within the skybridge (Figure 55).

Figure 52. Water spray testing north end of roof-to-wall transition at the elevator tower for the Purple Garage. No water intrusion observed.

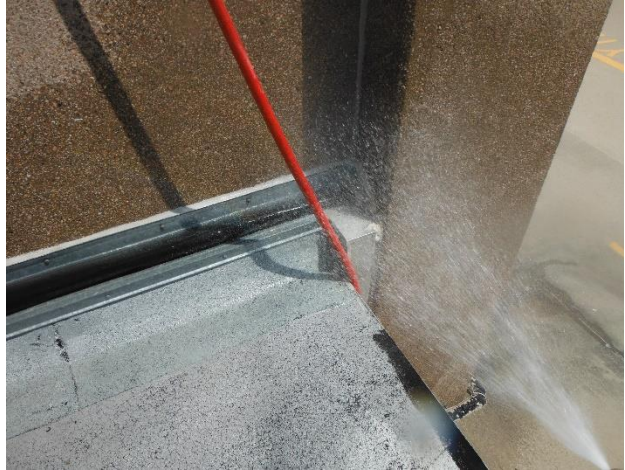
Figure 53. Water spray testing south end of roof-to-wall transition at the elevator tower for the Purple Garage. No water intrusion observed.

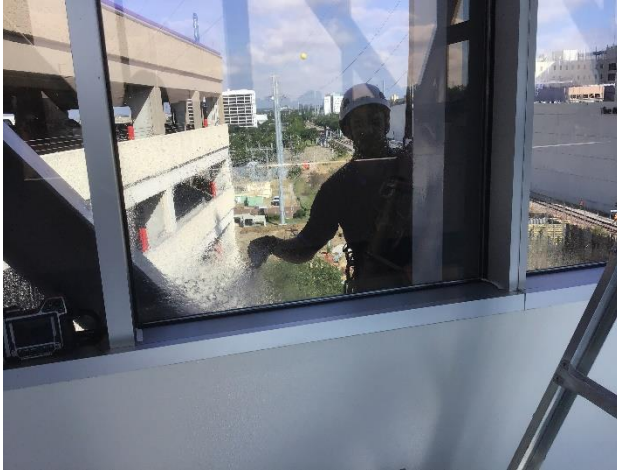
WJE tested the window wall framing surrounding one vision lite near the south end of the west facade of Skybridge B. An infrared camera was used to detect water infiltration behind the short wall in front of the spandrel glass. No water intrusion was observed when testing the perimeter of the lite with a spray nozzle (Figure 56 and Figure 57).

Figure 56. Water spray testing the horizontal intermediate of a vision lite on the west facade of the skybridge near the Purple Garage. No water intrusion observed.

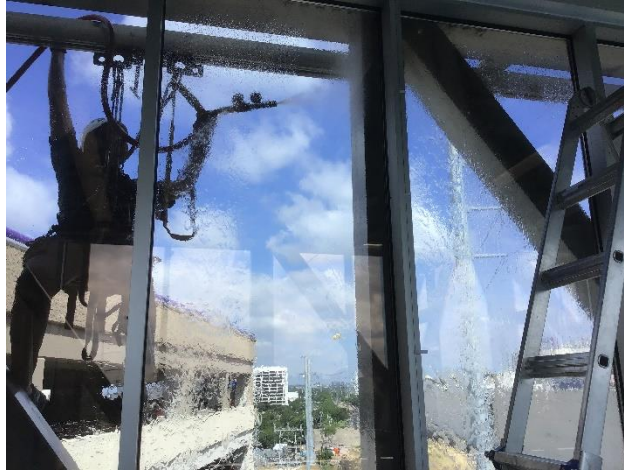
Figure 57. Water spray testing the vertical intermediate of a vision lite on the west facade of the skybridge near the Purple Garage. No water intrusion observed.

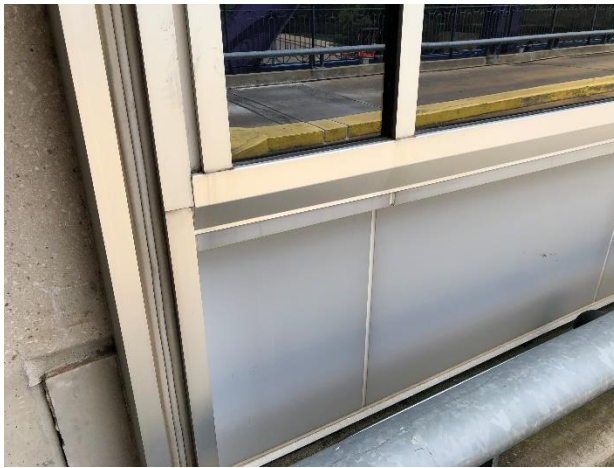
- No adhesion loss or discontinuities were observed within the vertical expansion joints at the east end of the skybridge (Figure 58).
- The observed sealant joints around the perimeter of the window system and between metal panels had consistent profiles with no notable areas of deterioration or adhesion loss (Figure 58 and Figure 59).
- Little to no gasket shrinkage was observed within the window systems.

Figure 58. Vertical expansion joint at east end of Skybridge C. Photo also shows orientation of window system and metal panels below

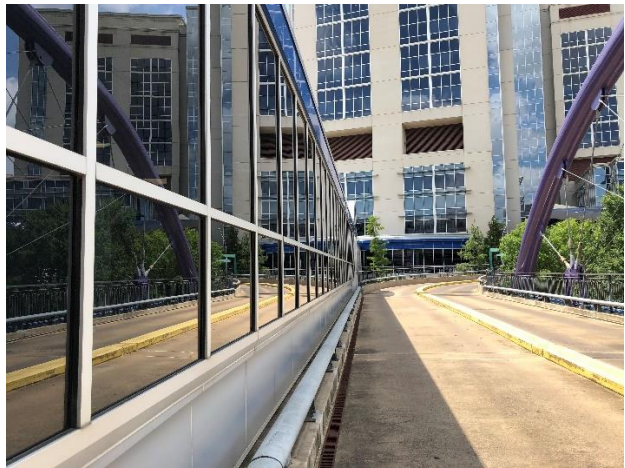
Figure 59. Window system and metal panels along north facade of Skybridge C.

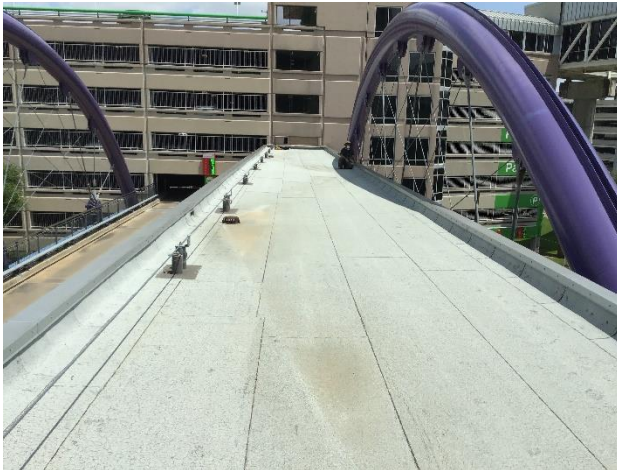
- Granule loss and alligator cracking was observed within the modified bitumen roof membrane (Figure 66 and Figure 67). Various roof sealants were also observed to be deteriorated.

Figure 66. Low-slope roof across Skybridge C.

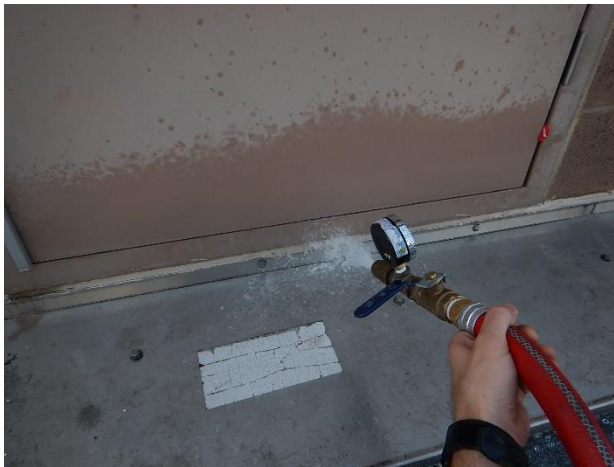
Water intrusion was also observed when spraying the small metal access door to the skybridge roof (Figure 70). Water was observed running down the CMU below the door jamb after approximately 30 seconds of testing (Figure 71).

Figure 70. Water testing metal access door above roof-to-wall transition.

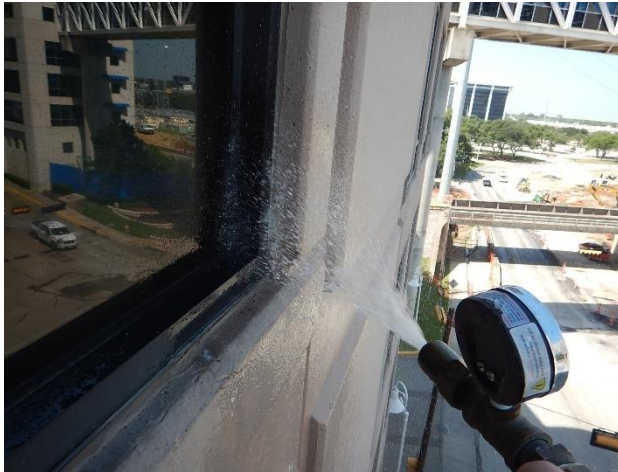
WJE continued testing up the garage wall above the skybridge roof. Water intrusion was immediately observed when testing the perimeter of the punched window on the second floor of the garage (Figure 72 and Figure 73). Discontinuities within the perimeter sealant joint allowed water intrusion.

Figure 72. Water testing perimeter of 2nd floor window sill within Green Garage above roof-to-wall transition.

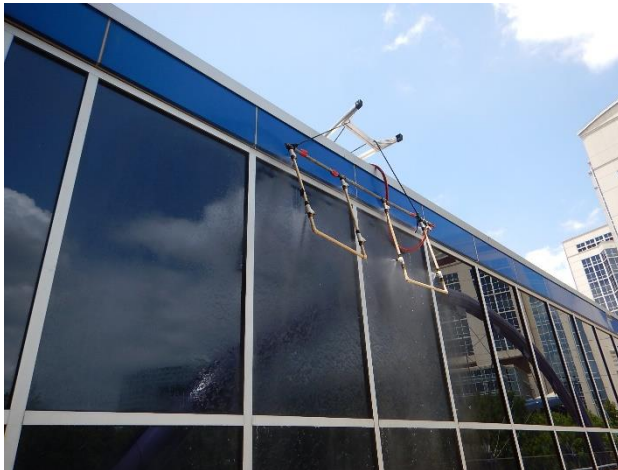
WJE used a spray rack to test the window wall on the north facade of the skybridge behind the location of interior drywall distress at the base of the wall. At this location, the window wall is covered with framing and interior drywall. No interior drywall was able to be removed at the time of our testing. WJE started testing by spraying the middle of the curtain wall. No water intrusion was observed after 45 minutes. WJE moved the spray rack up to test the upper half of the curtain wall and perimeter head sealant joint (Figure 74). Water intrusion was observed after 10 minutes pooling along the base of the wall (Figure 75).

Figure 74. Spray rack testing of windows on north facade.
