BUILDING ENVELOPE COMMISSIONING REPORT

| Project Name | Winooski School - Building Envelope Commissioning |
| Project Number | 21-20-162 |
| Purpose | First Instance Tests - ASTM E 1186 (Fog Testing) |

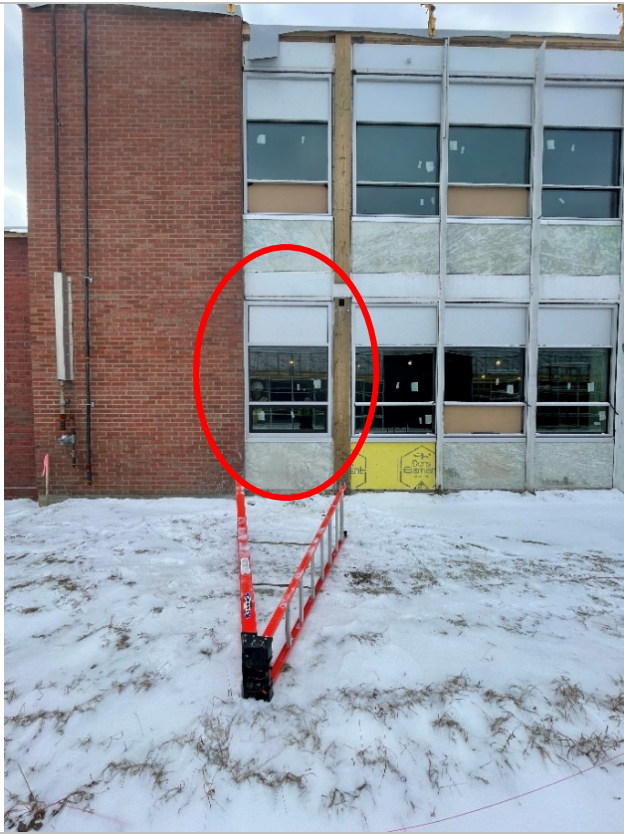
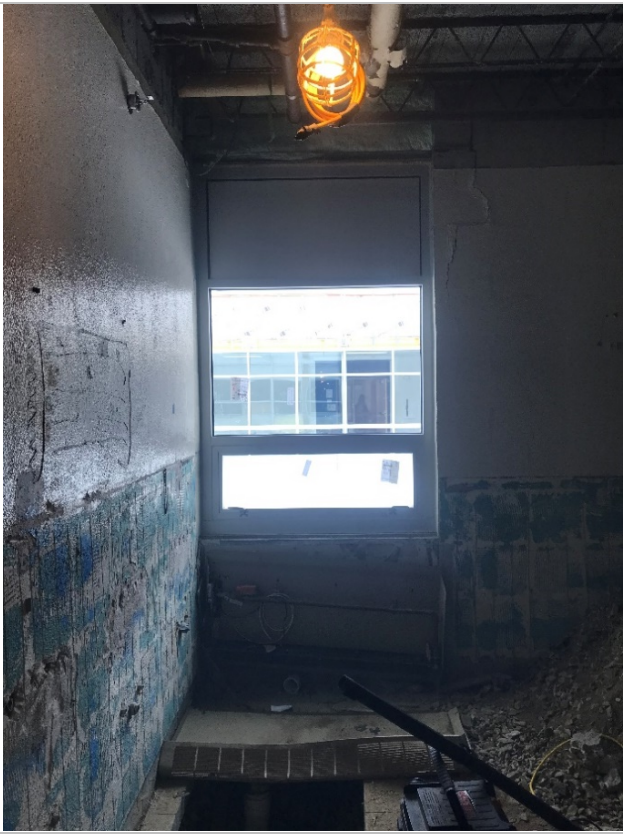
| Curtain wall tested | Curtain wall tested |

| Location: | Restroom A147 |
| Location Description: | Existing construction around new curtain wall |
| Results: We found many leaks in the surrounding existing construction while we were testing the window. The drawings do not appear to call for additional sealant; however, BVH is not always up to date on the latest RFI/SKAs. BVH suggests sealing the leaks in the existing construction while access is still relatively easy. Leaks were found around the granite siding and underneath the sill flashing. We recommend caulk sealing the perimeter of the granite from outside to address these leaks. The head of the granite should seal to the underside of the sill flashing as well to address a large leak described further below. Adjacent to the curtain wall in the existing construction, there is a hole in the wood covering over a concrete column which leaked heavily. How will this be addressed here and at other areas? | |

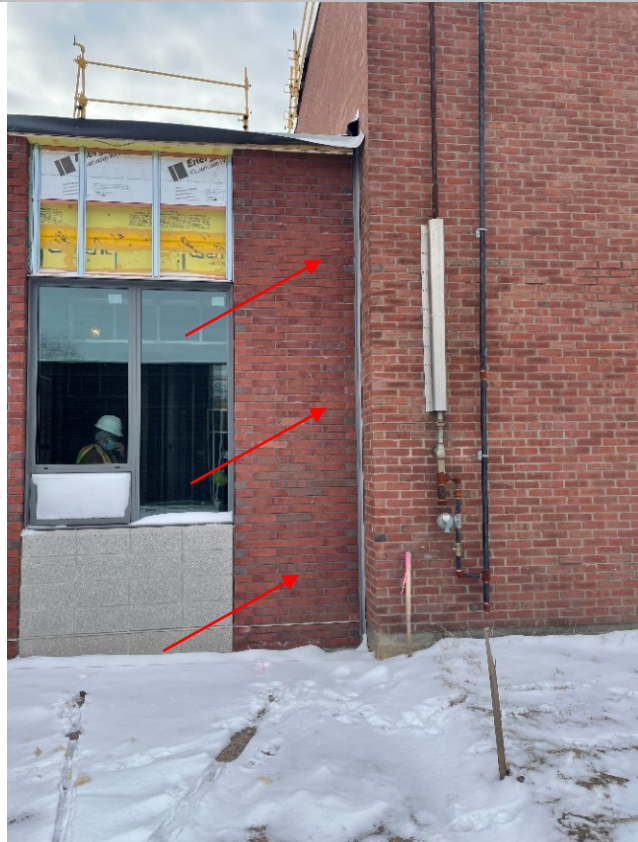
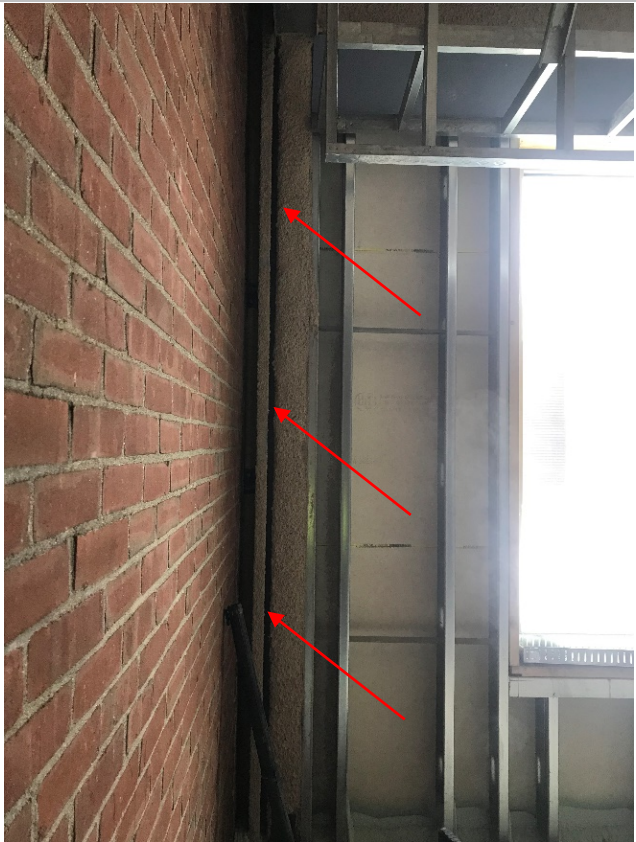
| Location of expansion joint tested | Location of expansion joint tested |

| Location: | Intersection of Column Line A-V and A-42 |
| Location Description: | Expansion joint |

Results: The Stego Wrap on the expansion joint we tested was not sealed to the brick. An exterior cover is blocking from the outside; the only access appears to be from the inside unless the cover is removed. Sealing the Stego Wrap to the brick with caulk/DensDefy Liquid Sealant should address the leaks.

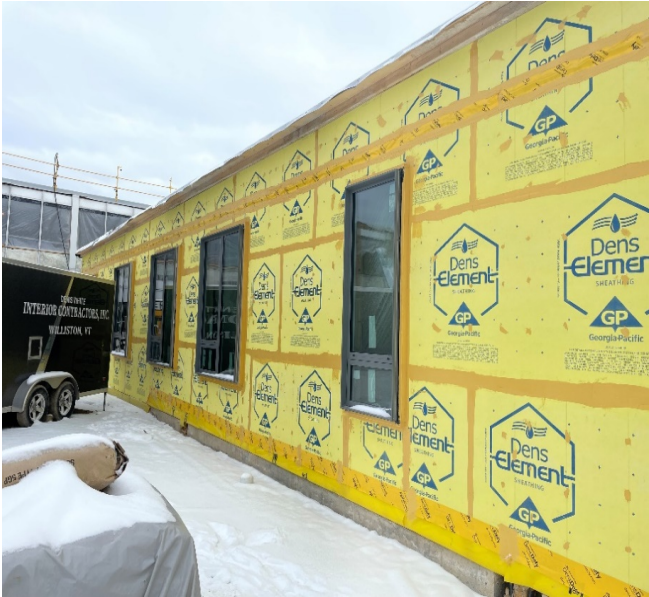
| DensElement applied thinly. The arrow points to some lettering visible through the sealant. | Location of visual inspection |

| Location: | Area C West Elevation |
| Location Description: | DensElement seams |
| Results: We also looked at sealed joints in the DensElement. The majority are sealed well, but there are a few areas that appear to need additional sealant. The lettering on the DensElement sheathing is visible through some of the sealant, implying that the sealant is thin in some areas. BVH recommends inspecting the joints and adding additional sealant as needed. | |

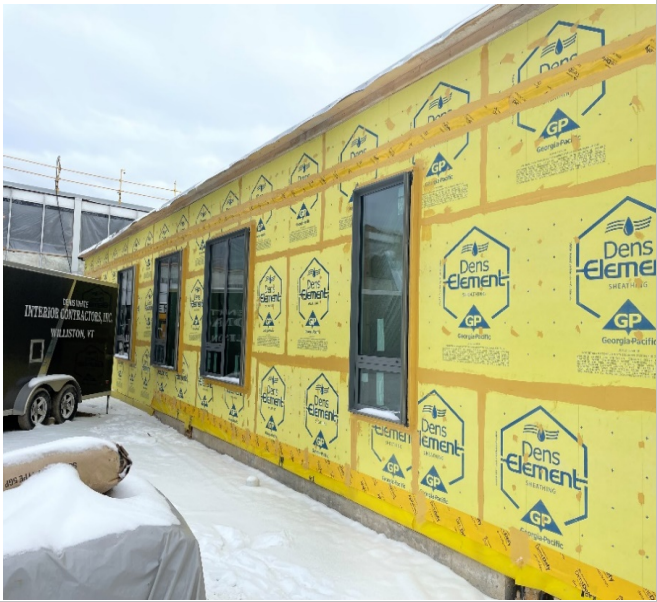
| Fish-mouth opening in control joint is circled above. | Location of visual inspection |

| Location: | Area C West Elevation |
| Location Description: | Control joint |
| Results: Overall the control joint is being air sealed well with liquid sealant and the transition membrane. BVH did observe one fish-mouth opening in a vertical seam which should have additional sealant added. BVH recommends inspecting the control joints as construction continues, looking for similar issues and address as needed. | |
