Using Infrared Thermography to Determine the Presence and Correct Placement of Grouted Cells in

SINGLE-WYTHE CONCRETE MASONRY UNIT (CMU) WALLS

By Gregory R. Stockton and Lee R. Allen

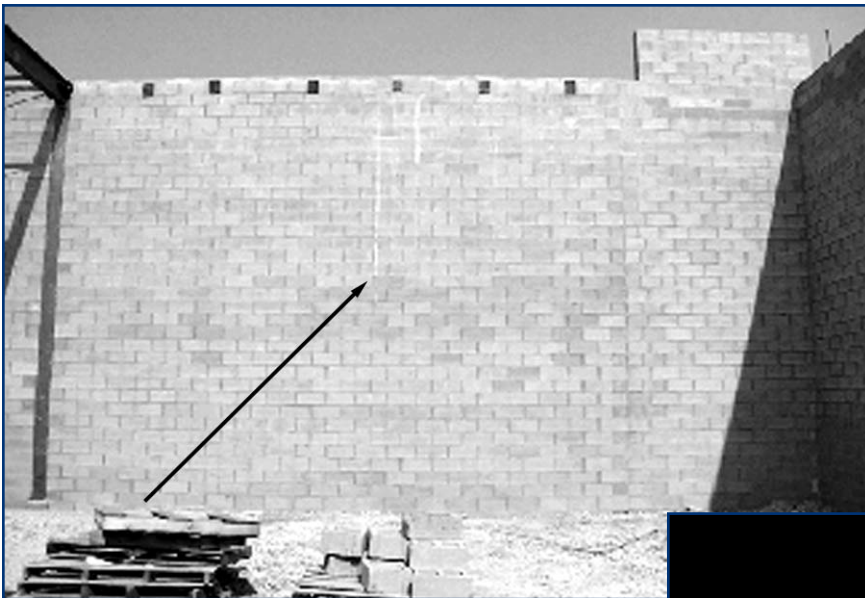
Figures 1 and 2) Photograph and thermograph of CMU wall with excess grout.

It is easy to find buildings that are constructed using CMU (Concrete Masonry Unit) walls. *Figure 1* shows a typical wall. Buildings such as malls, strip shopping centers, retail buildings, schools, and others are built using this method. They are used as inside and outside walls because they are erected quickly, have relative low construction costs, high load-bearing capabilities, fire ratings, and are versatile. With a wide range of densities, colors, decorative outer faces, and treatment options, CMU is a popular method of wall construction.

save the expense of putting a highly skilled supervisor on the job. His past experiences tell him to concentrate on what "shows." If the grouting and reinforcement of the walls are of great concern, the GC will lay out the building for his masons. We often find quite a bit of wasted grout in "over-poured" walls. This is due to a long-perceived notion that too much concrete is always better. However, owners concerned about heating and cooling costs do not want excess grouting in the walls, since it displaces the amount of insulation that can be installed. See *Figures 1 and 2.*

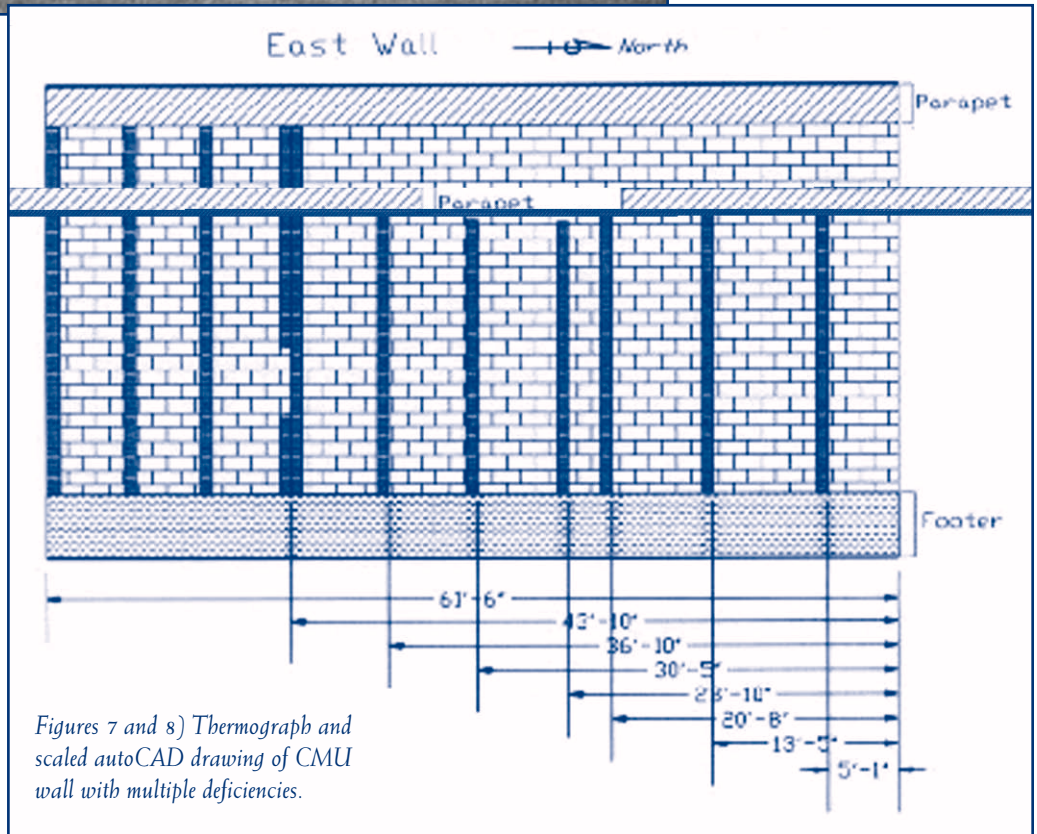
Figures 7 and 8) Thermograph and scaled autoCAD drawing of CMU wall with multiple deficiencies.

Infrared thermography answers the need for an accurate, inexpensive, non-destructive, non-labor intensive method for finding grout in CMU walls. See *Figures 5 and 6*. Wide areas are covered with one shot. Also, small areas can be tested since modern infrared cameras are fairly portable. Scaled AutoCAD drawings of the problem walls can be produced (see *Figures 7 and 8*). Several ways of using active IR to find the grout and the reinforcing metal bars are currently being tested. There are tools that can magnetically find the metal by scanning them across the wall. This is not infrared. We have found that the quality of the grouting is indicative of the accuracy of the placement of reinforcing bars and the quality of the construction in general. If the grout is not properly installed, it does not matter whether the rebar is in the wall or not, since the two work together. If the grout is properly installed, the reinforcing can be spot-checked.

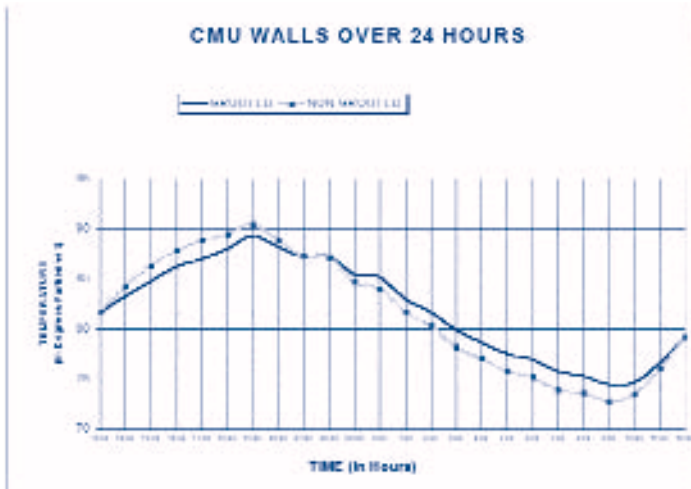
Figure 11) Time vs. temperature.

Grouted and non-grouted areas are easily seen. A time vs. temperature graph (*Figure 11*) of a typical wall over a 24-hour period shows how grouted and non-grouted areas heat and cool over the course of a summer day and night. Unfortunately, all walls cannot always be surveyed under ideal conditions. For instance, during the winter months, because of the orientation and low angle of the sun to the building, some outside walls do not receive direct sunlight at any time during the day. This does not mean that these walls cannot be surveyed. The change of temperature over the day is the main factor. Inside walls never receive any direct sunlight. Awnings or canopies may cover other walls. Timing is the key. However, as stated earlier, just
