TRACKING DOWN THE MOISTURE —

HOW INFRARED INVESTIG

BY DOUGLAS C. TAIT

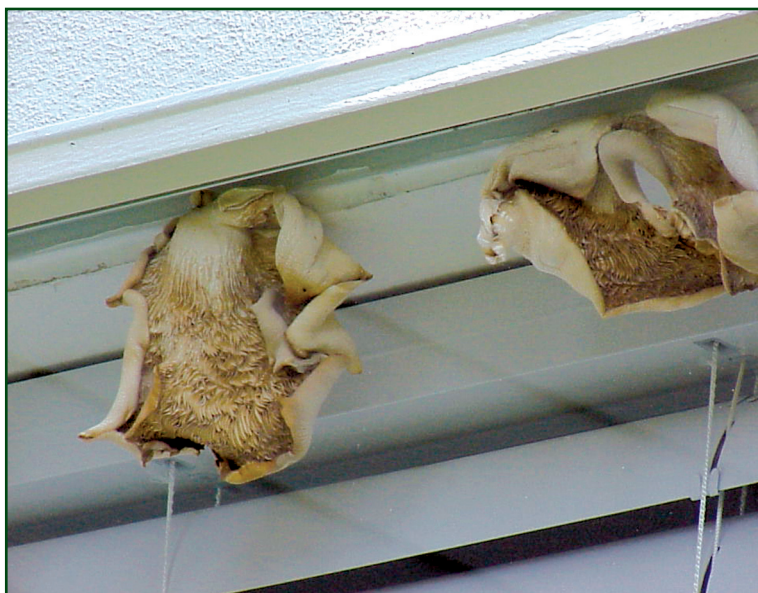
Photo 1: Previously undetected moisture is revealed through mushroom growth in a homeowner’s window.

Photo 1 is an example of undetected moisture entering a building structure. This shows mushrooms – not in a salad, but in a homeowner's window.

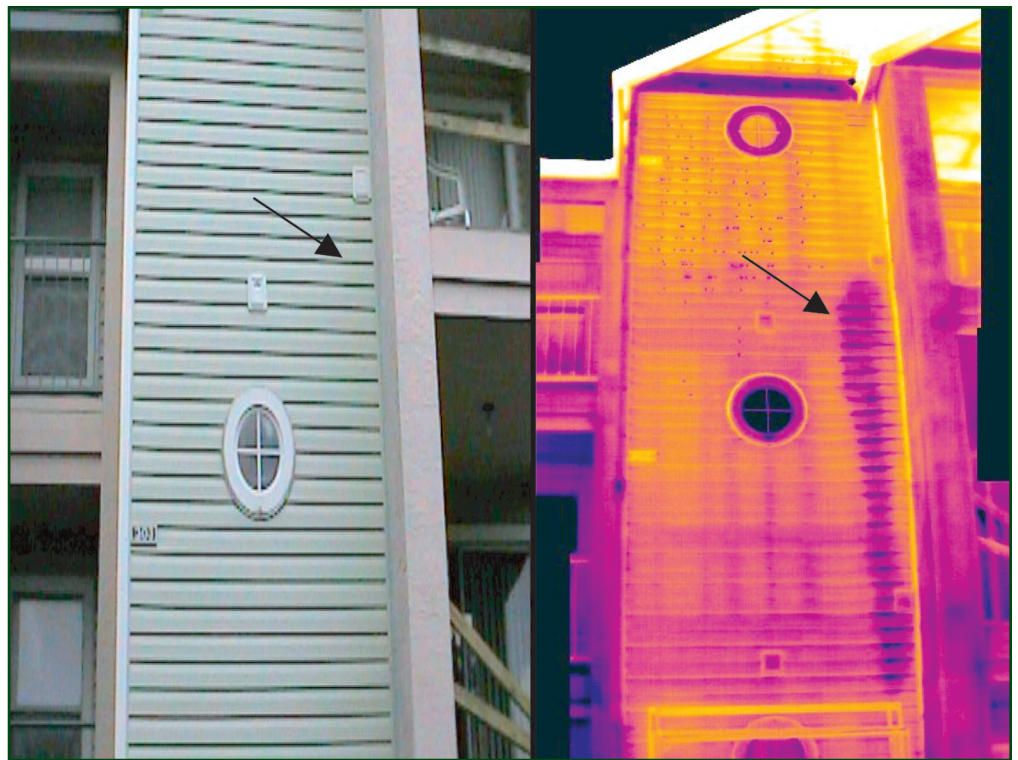
Photo 2 (left) shows apparently well-constructed exterior wall. Photo 3 (right), using an infrared camera, shows moisture infiltration not detected by the naked eye.

Photos 2 and *3* are examples of an infrared inspection after the apartment resident complained about mold and mildew appearing on the interior walls. The photo on the left shows an exterior wall that appears to be well constructed. The same photo on the right, using the infrared camera, shows the moisture infiltration, which could not be detected by the naked eye. Without removing the exterior siding, it was determined that the dryer vent installation was allowing the moisture to enter this building.
