THE ENVIRONMENTAL BENEFITS OF A TEXAS GARDEN ROOF

By Karl A. Schaack, PE, RRC

Design Development & Demonstration

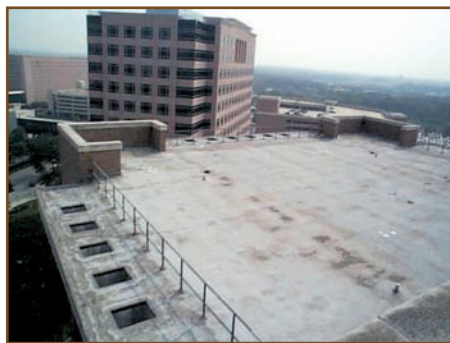
Overview of roof area prior to replacement.

One of the buildings planned for roof replacement was the School of Public Health. The subject building is a 12-story structure composed of structural concrete framing. The existing roof system consisted

of a spray-applied polyurethane foam (2 to 4 inches thick) applied over a gravel-surfaced, built-up roof membrane. A thermosetting asphaltic fill (3 to 6 inches thick) was installed over the structural concrete deck. The subject roof was comprised of a main level and two mechanical penthouses encompassing a plan area of approximately 21,000 square feet. The main level was oriented in an east/west direction and consisted of two similar

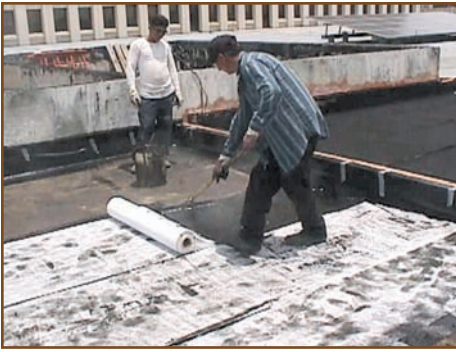
Test Plot - Quad 1.

The system provided by American Hydrotech, called “Monolithic Membrane 6125-FR,” consisted of a hot-applied rubberized asphalt reinforced with a polyester fabric. The rubberized asphalt was melted in a kettle and applied in a heated liquid form directly on top of the deck in an initial application of approximately 90-mil thickness. Polyester reinforcing fabric was embedded in the asphalt. A second layer of hot rubberized asphalt was then applied on top of the fabric at approximately 125 mils, with a resulting total membrane thickness of 215 mils. A prefabricated sheet of modified bitumen was embedded into the top layer of hot asphalt to serve as a protection mat. A 40-mil, high-density polyethylene sheet was then installed over the protection mat to serve as a root barrier. Polypropylene fiber moisture retention mat was installed on top of the root barrier. Prefabricated drain board was installed on top of the moisture retention mat. A geotextile, non-woven polypropylene filter fabric was then installed over the drain board. “Engineered soil,” consisting of expanded lightweight aggregate, sand, and compost, was placed over the filter fabric.

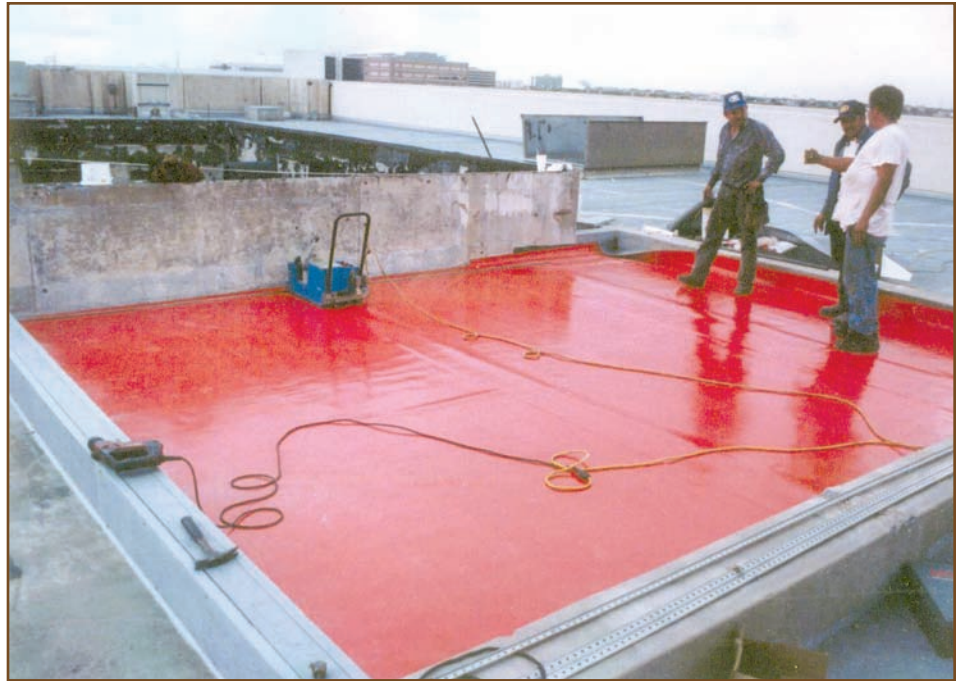
Test Plot - Quad 2.

The system provided by Sarnafil is called “G 476” and consisted of a prefabricated, fiberglass reinforced PVC thermo-plastic single-ply membrane that is 80 mils

thick. The membrane was loose-laid over the concrete deck and secured along the perimeters with a metal termination bar anchored into the concrete deck. Adjacent sheets were overlapped, and the overlapped portions were thermally fused via hot-air welding. The chemical composition of the membrane inhibits root growth, thus eliminating the need for additional root barrier mediums. Pre-fabricated drain board, consisting of a dimpled polymeric core with a filter fabric laminated to the core, was placed over the membrane. General landscaping soil was installed over the drainage board.

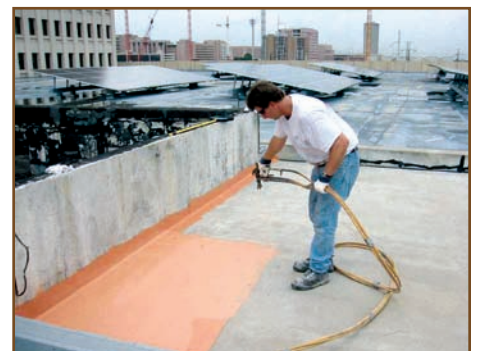
Test Plot - Quad 3.

The system provided by Grace is called “Procor Deck System 3R,” which consists of a cold-vulcanized, fluid-applied synthetic rubber membrane with a polyester reinforcing fabric. The fluid-applied waterproofing membrane consists of two parts that were site-mixed and cold-applied, using conventional spray equipment, directly on top of the concrete deck in an initial application of approximately 60-mil thickness. Reinforcing fabric was embedded in the initial application of the material, and then a second layer of liquid-applied material was spray-applied at approximately 60 mils, with a resulting membrane thickness of 120 mils. Prefabricated drainage board, consisting of a dimpled polymeric core with a filter fabric laminated to the core, was then placed on

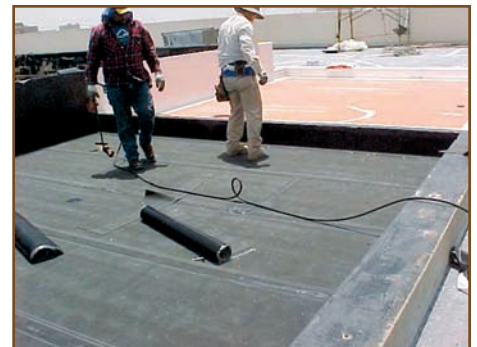
Test Plot - Quad 4.

The system provided by Siplast is called “Teranap System,” which is a two-ply SBS modified bitumen membrane. The mem-

brane is composed of a smooth-surfaced, modified bitumen, fiberglass-reinforced base ply, 110 mils thick, which was fully-adhered to the concrete deck by torch-application methods; and a smooth-surfaced, modified bitumen, polyester-reinforced top ply, 160 mils thick, which was fully-adhered to the base ply via torch-application methods, with a resulting membrane thickness of 270 mils. The top surface of the top ply consists of a polymeric film that inhibits root growth. Prefabricated drain board was then placed on top of the membrane sheet. The drain board is manufactured with dimpled polymeric core with cross flow holes and nonwoven fabrics laminated to both sides of the core and the perforations in the core allow drainage. The fabric laminated to the top surface of the core has a "root barrier" embodied into the fabric that stops the initial root growth. "Engineered soil," consisting of an expanded lightweight aggregate (shale), coarse sand, pine bark humus, and compost was then placed on top of the drain board.

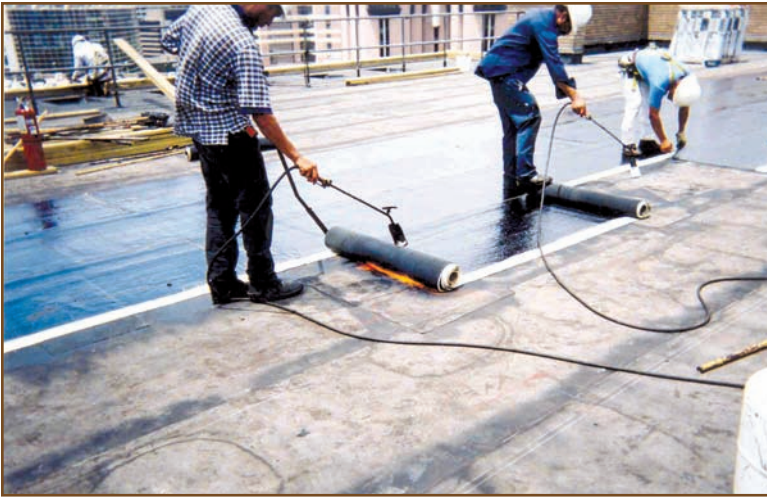
Installation of membrane.

The existing materials on the eastern portion of the main level were removed, and the new membrane and flashings were installed across the entire roof prior to the installation of any of the garden accessory components. The installation process was completed in the latter part of July 2003. A flood test was performed on the membrane after completion of the installation. The water for the flood-test was maintained over the membrane for 48 hours with no evidence of infiltration into the building interior. After successful completion of the flood test, the prefabricated drain panel was installed over the entire area. Adjacent panels were interlocked by nesting the perforations, and the filter fabric was overlapped by four inches.

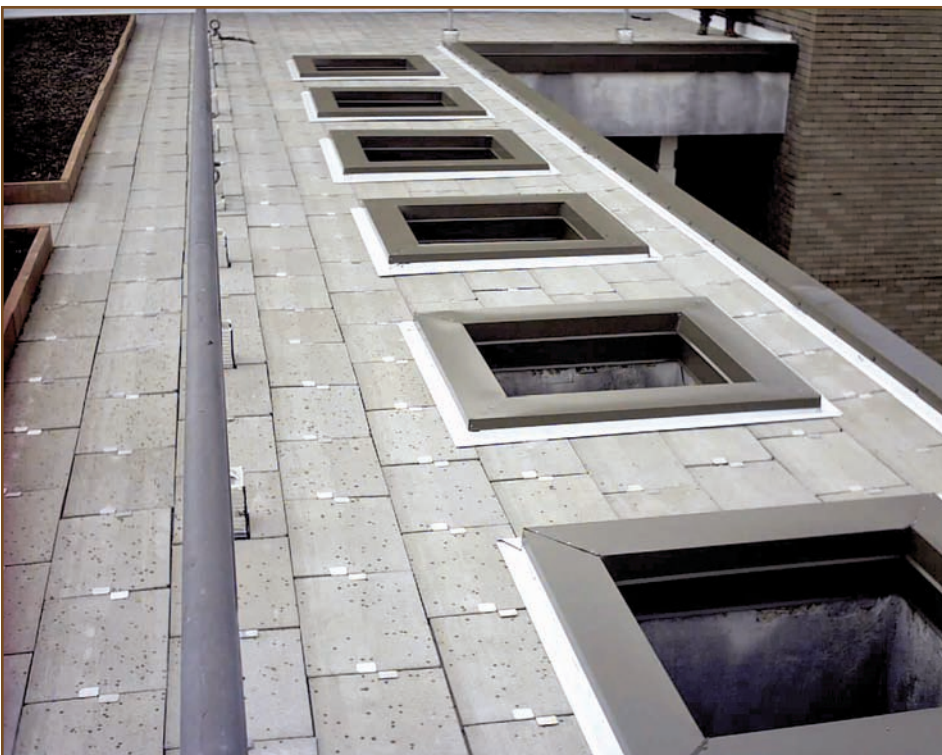
Typical perimeter paver condition.

The paver system consisted of interlocking concrete pavers, "Ballast Paver" by Westile. A sheet metal tab was placed between adjacent pavers to interlock the adjoining abutting sides (longitudinal side) of the pavers. The pavers were installed along the perimeter of the roof, extending inward from the edge to a distance of approximately six feet. This boundary provided several functions, including the following: provided a walking surface around the planned planting areas; provided protection along the perimeters against wind erosion/scour of the soil and fire; and pro-

The sheet metal fabrications located at the low-profile roof edge and the counter-flashing assemblies along the parapet walls were extended over the top surface of the adjacent pavers to provide additional wind-uplift resistance. Concrete pavers were installed over a filter fabric that was installed over two inches of extruded polystyrene insulation board placed over the prefabricated drain panel. The board had ribs or channels on the top surface and drainage channels along the edges on the bottom surface of the board, "Ribbed," Roof-

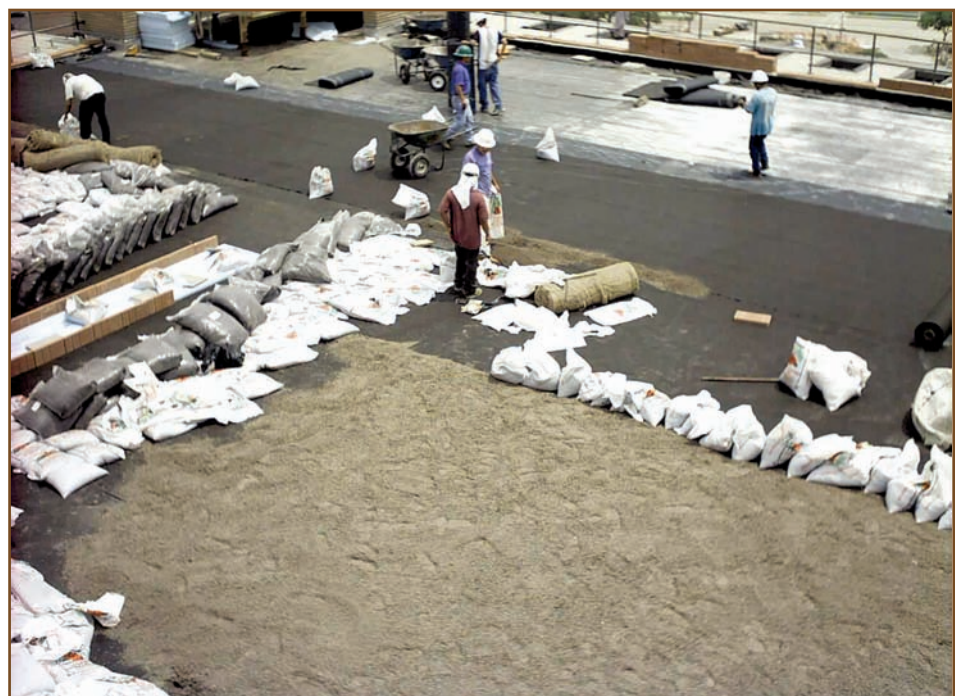
Placement of soil.

The roofing contractor found and utilized a local resource for the engineered soil. The “engineered” growing medium (soil) was pre-mixed and bagged by the LETCO Group L.P. of Houston, Texas. The soil was packaged in 4,000 40-pound bags delivered on 68 pallets to the site and raised to the roof via a hoist by the contractor. The constituents of the soil provided by LETCO were as follows: 1) an expanded shale, “Tru-Gro” supplied by TXI in Streetman, Texas; 2) coarse sand complying with specifications of the United States Golf Association; 3) compost based on horse manure blended with aged pine bark

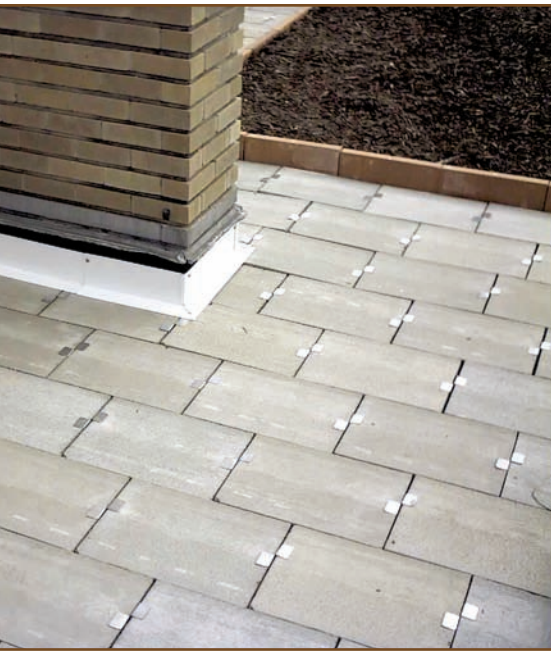
Typical wall flashing.

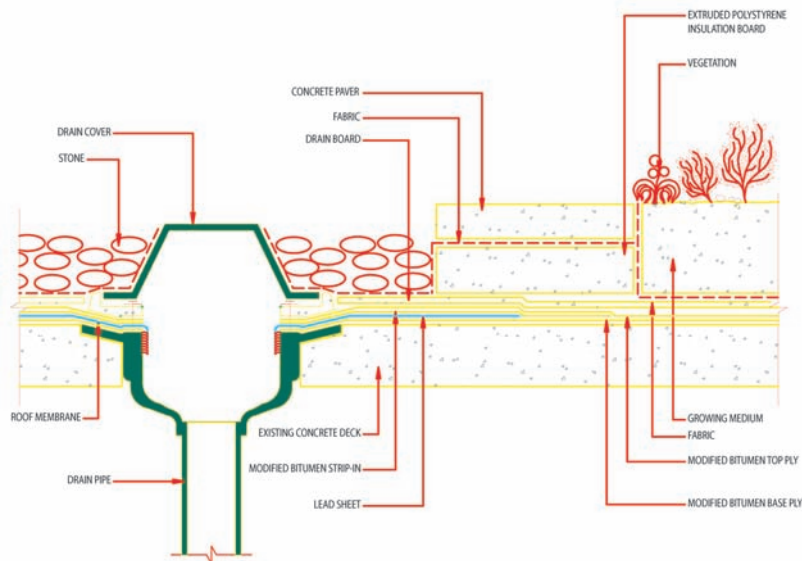
Drain detail drawing.

mate by Dow Chemical. An 8-inch x 16-inch x 2-inch terra-cotta colored paver was placed on end between the interlocking concrete pavers and the planned growing areas to serve as both a border and a small "retaining wall" to contain the soil within the quadrants. A primary roof drain and overflow drain were positioned in each quadrant. The drain panel was extended to the drain assemblies and white marble stone ballast was placed over the drainage panel around the drains for a distance of approximately one foot with one course of concrete pavers and the border paver positioned between the stone and soil.

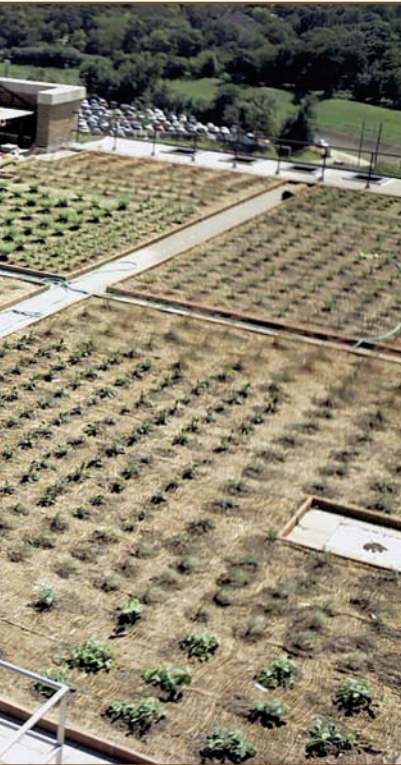
Completed roof in 2003.
