BUILDING ENVELOPE TECHNOLOGY SYMPOSIUM

THIN MARBLE FAÇADES: HISTORY, EVALUATION, AND MAINTENANCE

WALTER P. MOORE AND ASSOCIATES, INC.

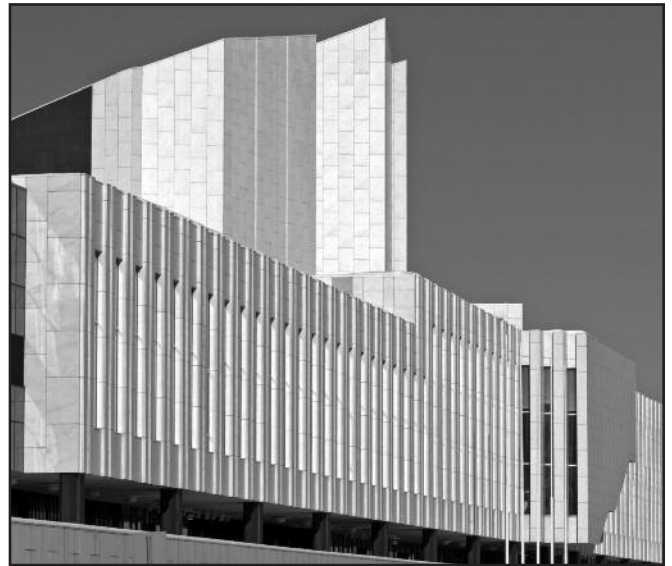
Several infamous case studies of systemic failure of marble thin-stone veneers have been heavily published, with the most noteworthy being Alvar Aalto's Finlandia Hall in Helsinki, Finland¹ (Figure 1). Completed in 1971, the modernist concert hall was clad in thin panels of Carrara marble, an icy-white Italian stone that was poorly suited to the harsh climate of Finland. Within only a few years, noticeable deformation of the cladding panels had begun. By the late 1980s, safety and aesthetic issues necessitated a major renovation of the marble veneer. Because Finlandia Hall is a cultural icon and protected by law by the Finnish National Board of Antiquities, restoration of the exterior was a heavily regulated and highly political process. Although the material properties of the Carrara marble were determined to be a leading factor in the deterioration of the cladding system, the restoration was ultimately limited to the reuse of Carrara for the new façades.

In an effort to reduce the potential for future deformation and deterioration of the marble, the new façade was designed to provide flexible connections for the stone panels, which in theory would reduce the internal stresses in the stone created by the supporting hardware. Additionally, the replacement marble was required to have superior flexural strength, although the

original thickness of the marble of less than 1½ in would be maintained in the replacement units. The restoration was completed in 1999, and, within just two years, deformation of new panels was observed. The continued deterioration of the original and replacement panels at Finlandia Hall exemplifies the typical distress conditions and the difficulties encountered when repairing thin-stone veneers.

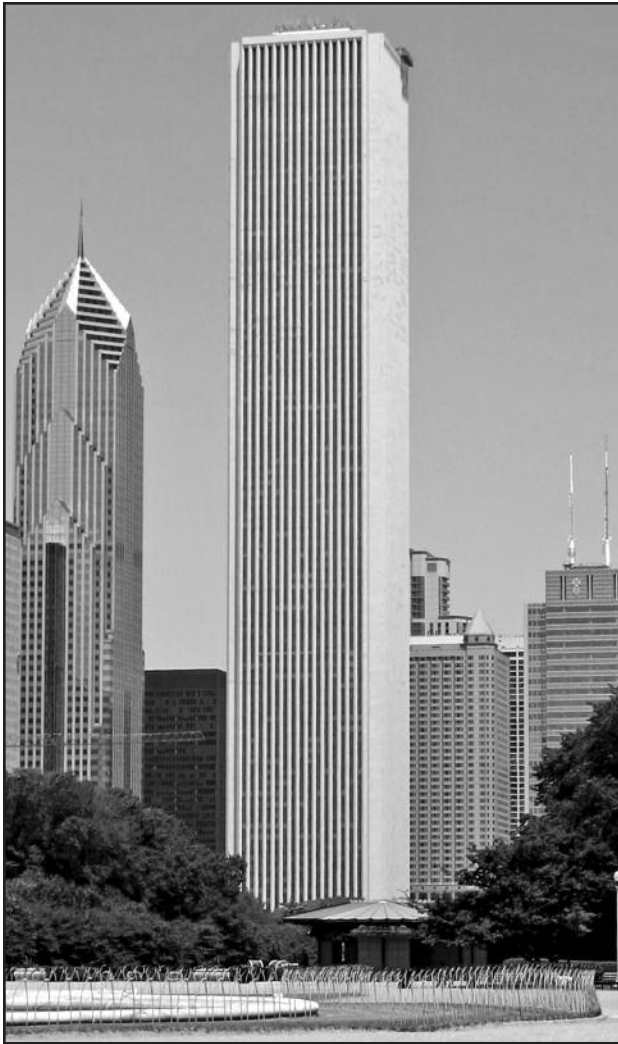
Another important case study is that of the 80-story AON Center (formerly the Amoco Building) in Chicago² (Figure 2). Six marble types were originally evaluated for use on the façade, and after careful consideration, Carrara Alpha Gray marble was selected. The effects of weathering were known and flexural strength testing was performed before and after thermal cycling in an attempt to simulate anticipated conditions.

Completed in 1972, the building was clad with 44,000 panels that were typically 1¼-in thick, and by 1979, evaluation of the façade had found cracks in the panels. A majority of the cracked panels were located on the elevations that received the most sun exposure, and it was concluded that thermal cycling had caused the cracking. The most shocking conclusions were reached after laboratory testing was conducted on

panels removed from the building and on additional virgin panels. It was found that the flexural strength assumed from the original testing was much lower than that of panels actually installed on the building. Testing concluded that within 10 years of testing, the marble panels would lose a total of 70% of their original flexural strength. All panels were eventually removed from the building, and, by September 1991, 44,000 marble panels had been replaced with Mount Airy granite.

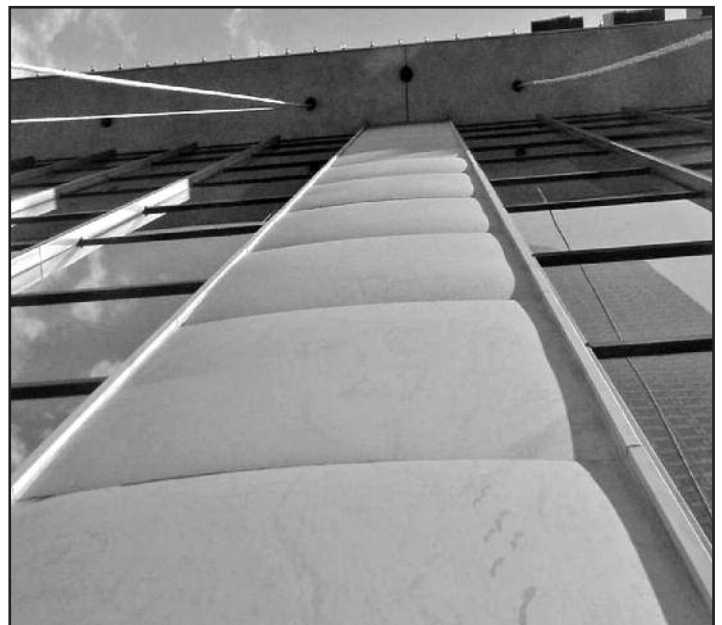
ing that it expands more in one direction than another. With several cycles of thermal expansion and contraction, as much as one-fifth of the initial expansion can be expected to be irreversible, causing intergranular fracturing, weakening the marble’s flexural strength, and increasing the overall porosity. Because of the uneven exposure of a marble panel on a building’s exterior, thermal hysteresis will eventually cause the panel to deform into a cupped or bowed shape (*Figure 6*) and may reduce the flexural strength of the stone by as much as 70%.

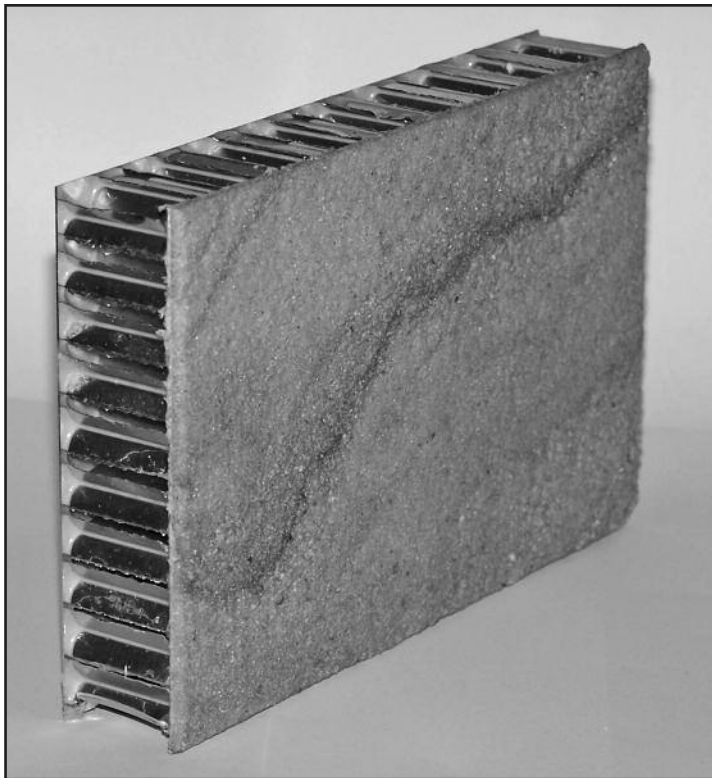
- In the "late 1980s, stone-faced composite panels with 5-mm-thick stone panels adhered to 4-cm honeycombed aluminum, fiberglass, or sheet steel core began to be used."⁷ *Figure 7* (image from Flexistone) shows a sample of honeycomb-backed sandstone similar to that used for marble. These mechanical systems have been used successfully with marble panels.
- Prebowing of panels has also been a technique used in a building in Karjaa (west of Helsinki). This was done by sandblasting the backside of the panel until a 4-mm bowing of the panel was present. The backup of this prebowed system was concrete. As the concrete dried and shrank, the panel straightened out with it.
- The General Motors (GM) building in New York City has to date not experienced any signs of thermal hysteresis. This building was constructed in 1968 using Georgia White marble attached to precast concrete panels.
