ABSTRACT

Roof systems are one of the most commonly damaged elements of the building envelope during natural disasters such as tornados and hurricanes. Determining if damage has occurred to a roof and the extent of the damage related to a storm event can be a difficult and controversial issue among building owners, professionals, and insurance companies. This paper will discuss how to utilize wind uplift field-testing procedures as a tool to assess and determine if an adhered roof system has failed from a storm event. The presentation will also review some of the tasks and procedures to follow when performing a detailed damage assessment. These tasks include collecting weather data, performing code research, documenting visual observations, and performing additional testing such as nondestructive testing (electrical capacitance meter, infrared imaging, etc.) and destructive test openings. Information gained from these tasks will assist in determining the existing conditions and the extent of damage from the storm event.

Evaluating Storm Damage to Flat-Roof Assemblies

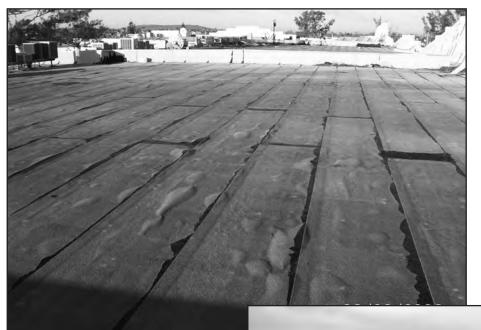
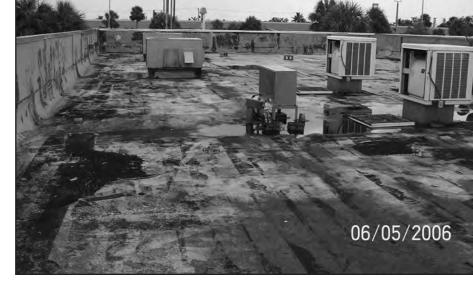
Figures 3 and 4 – Examples of natural weathering observed on a flat-roof system.

Natural weathering of granule-surfaced modified-bitumen and built-up roof membranes includes uniform loss of granules, exposed reinforcing fabric, cracked and brittle membranes, blisters, ridges, and splits (*Figures 3* and 4). Natural weathering can also be from entrapped water

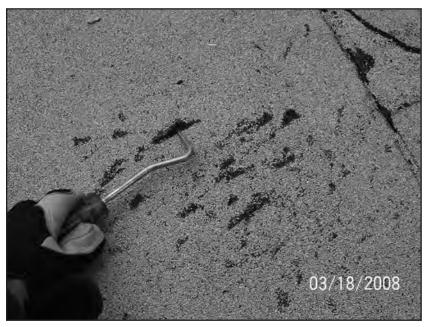
Figure 5 – Example of storm damage to granule-surfaced modified-bitumen membrane from glass debris.

scoured and missing areas of granules or gravel surfacing, uplifted and detached roof membrane, broken and damaged roof insulation, and missing areas of the roof assembly (*Figure 5* and 6). Storm damage to fully adhered thermoplastic and thermoset membranes can include punctures, cuts and tears, uplifted and

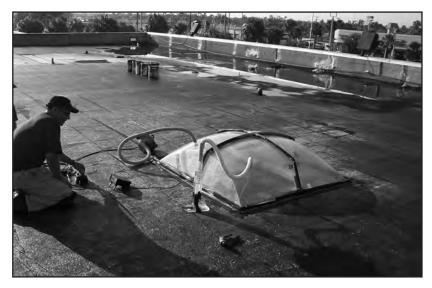
Figure 8 - View of uplift test in progress.

The uplift test is performed by creating a controlled negative pressure on top of the roof surface by means of a fitted plastic chamber with a pressure-measuring device and vacuum equipment (Figure 8). A 5-ft x 5-ft square plastic chamber is placed over a deflection bar with a dial indicator attached. The perimeter of the chamber is then temporarily sealed to the roof surface. The dial indicator is positioned so that the tip of the dial indicator is in contact with the roof membrane near the center of the test area. A pressure-measuring device (manometer) and the vacuum equipment are attached to the holes provided in the chamber. The vacuum equipment is activated and adjusted to regulate the negative pressure in the chamber to specified levels. According to the test procedures, a negative pressure of 15 lbs per sq ft (psf) is created in
