INFRARED THERMOGRAPHY IN TODAY'S ROOFING WORLD

BY KARL SCHAACK, RRC, PE

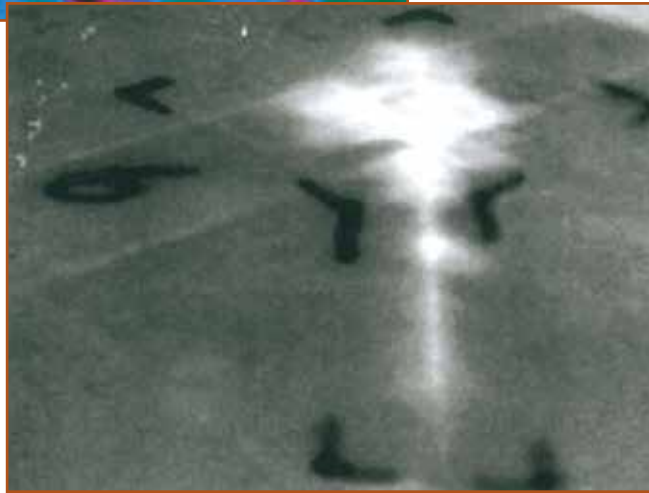
Photograph 4: View of wet insulation occurring along joint between ISO boards (gray contrast).

The board joint thermal anomaly can also occur within cellular insulation material such as cellular glass and foamed plastics. This anomaly is observed and typically occurs during the initial wetting as the moisture becomes absorbed along the cut or formed edges of these boards. This type of anomaly, when viewed through an infrared camera, typically appears as irregular-shaped brightened borders around the perimeter edges of the insulation board or joints between adjacent boards (Photos 3 and 4).

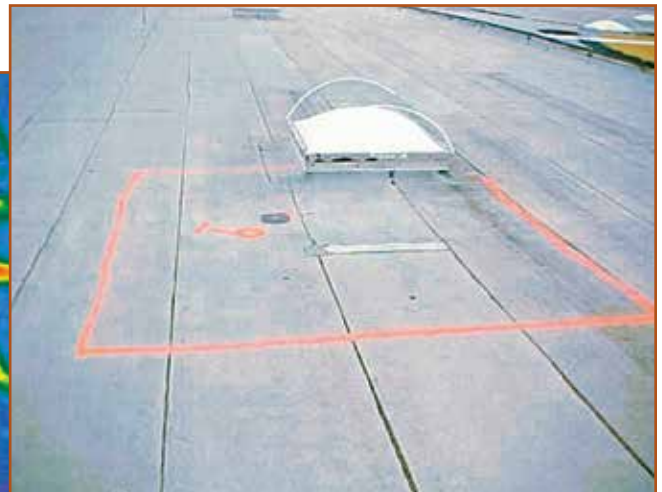
Photograph 6: View of anomaly of wet ISO under modified-bitumen membrane.

In today's roofing market, applications can be composed of a roof membrane—either single-ply or modified-bitumen—installed directly on top of ISO without the use of a cover board (Photographs 5 and 6). Single-ply membranes, as well as bituminous membranes, have also been installed directly over LWIC without incorporating any type of rigid board insulation above the surface of the LWIC. Modified-bitumen and single-ply membranes with white-colored surfacing are currently installed in more widespread applications and over various substrates that provide additional challenges for thermographers. If the roof system is applied directly over cellular insulation or LWIC, and moisture intrusion has occurred, entrapped moisture can be detected with infrared thermography (Photos 7, 8, and 9). On white-colored membranes, the images may not be as discernible compared to other darker-colored membranes. On smooth-surfaced, white, single-ply membranes, thermal anomalies may appear as ghost-like images, depending on the weather conditions during the day and survey time.

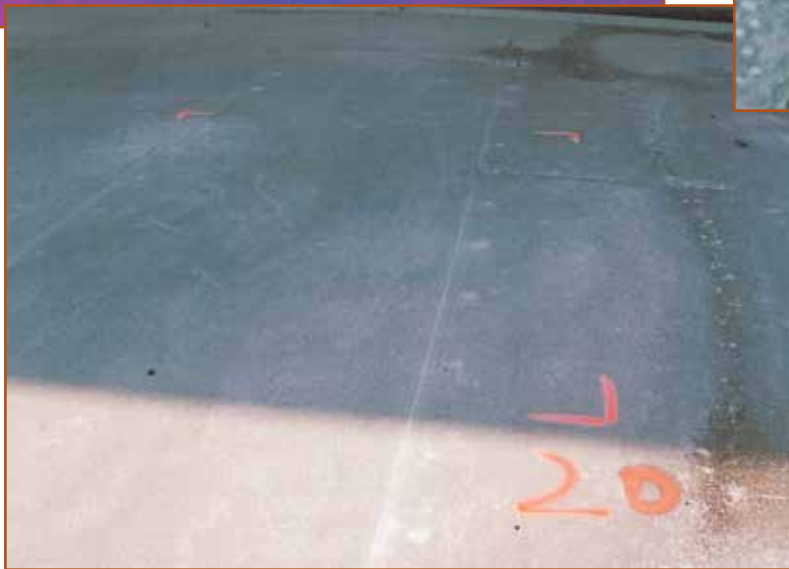
Photo 9 – Small hole in membrane that was source of water entry.

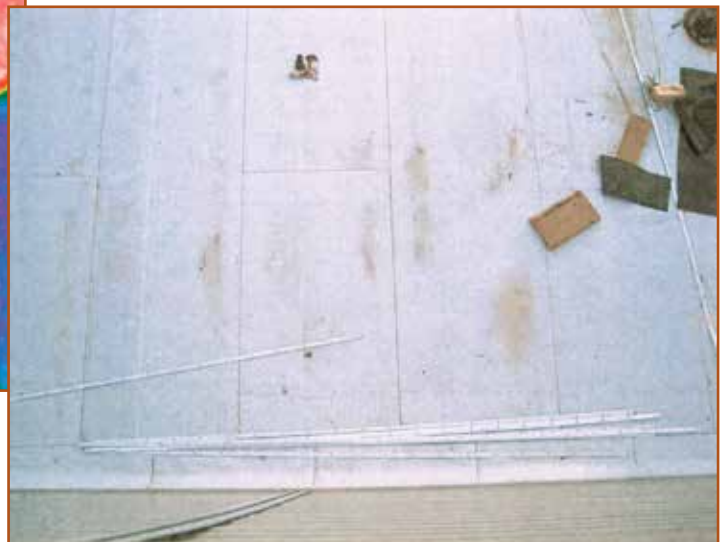
Photo 11 – View of soiled areas of white-surfaced modified-bitumen cap sheet.

With the reflectivity and physical characteristics of white roofs, the surface temperature of the roof can remain close to the ambient air temperature on the day of the inspection and not become elevated such as typically occurs with bituminous or dark-colored coverings. Therefore, the thermal loading and thermal differential between wet substrate and outside and interior air temperatures may not be as great during the warmer months. The optimum weather conditions for performing an infrared survey would be a relatively warm, sunny day followed by a rapid cool-down after sundown, resulting in a thermal difference of 20° to 30° or greater. Although most commonly used equipment is capable of detecting temperature differentials of less than 1°, the greater the difference in temperatures from daytime to survey time, the better the opportunity for finding thermal anomalies. White-colored surfacings could also have false thermal anomalies associated with isolated areas where the surface has become darkened or stained, such as is associated with ponding water (Photographs 10 and 11). Stained or darkened areas on white-colored

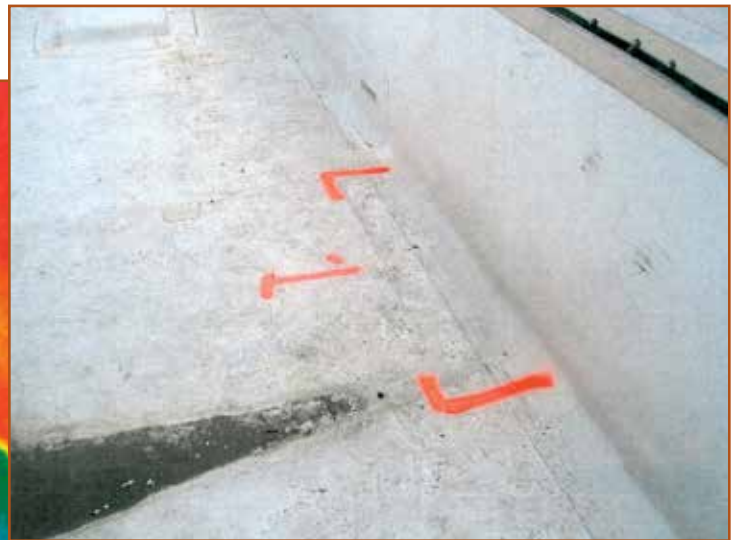
Photograph 16 – View of anomaly location of water in TPO base flashing.

insulation with a facer and taped seams can also accumulate moisture. The water may not be contained within an insulation material or the substrate, but it can be of significant quantity to form a blister or a balloon shape within the flashing material and, therefore, become detectable with infrared technology (Photos 15 and 16).

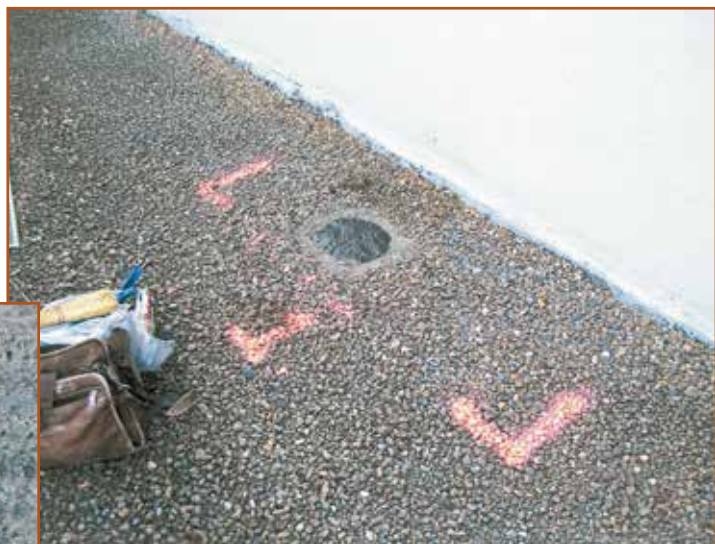
Photo 21 – View of anomaly of wet perlite under BUR.

Gravel-surfaced built-up roof coverings typically can offer the most challenging conditions for gathering accurate results from thermal imaging (Photos 20, 21, and 22). The irregular surfacing from the differing accumulations of bituminous materials or gravel typically creates numerous variations in the thermal appearance of the roof and will most likely involve significantly more time for the thermographer to differentiate between false and actual anomalies associated with wet substrate materials. Asphalt bleed-out at side and end laps or other overlapped sections of sheets, together with embedded metal flashings, provide obstacles such as “false” readings during the survey for detecting thermal anomalies in a roof with a granule-surfaced cap sheet (Photo 23). It is prudent to take additional time when viewing these areas, as they are considered to be more vulnerable to moisture intrusion or are most likely sources of moisture penetration if a breach is present.

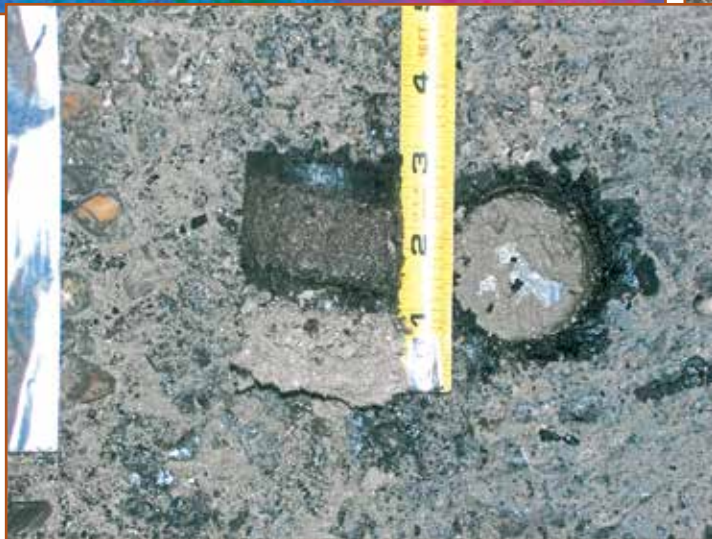
Photo 22 – Core showing wet upper layer of perlite in BUR.
