ACCESSING THE ARCH

The 630-foot-tall stainless steel Gateway Arch in St. Louis, Missouri, was designed in 1947 by architect Eero Saarinen to commemorate the city's role in westward expansion. Since its official dedication in 1968, this National Historic Landmark has captivated over one-hundred million visitors. As the tallest man-made monument in America and the largest catenary structure ever built, the Gateway Arch stands as a gleaming model of architectural and engineering innovation. After observing increasing discoloration, streaking, and surface irregularity of the stainless steel exterior, as well as interior corrosion, the National Park Service sought an expert assessment of the structure to determine the source of the apparent corrosion and staining of the stainless steel; establish repair recommendations based on the structure's historical context; and develop a plan for long-term, sustainable protection.

Location: St. Louis, Missouri
Client: National Park Service

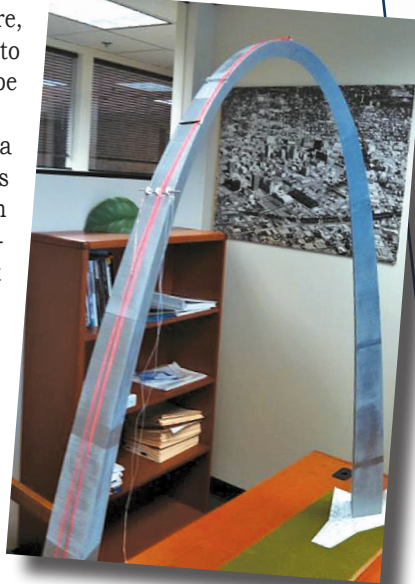
Figures 3A (above) and 3B (right) – 3-D printed scale model of structure showing the custom IRA system.

As the design progressed, a three-dimensional scale model was printed to replicate the Gateway Arch and to assure the system would provide access to the areas of interest during the site investigation (Figures 3A and 3B).

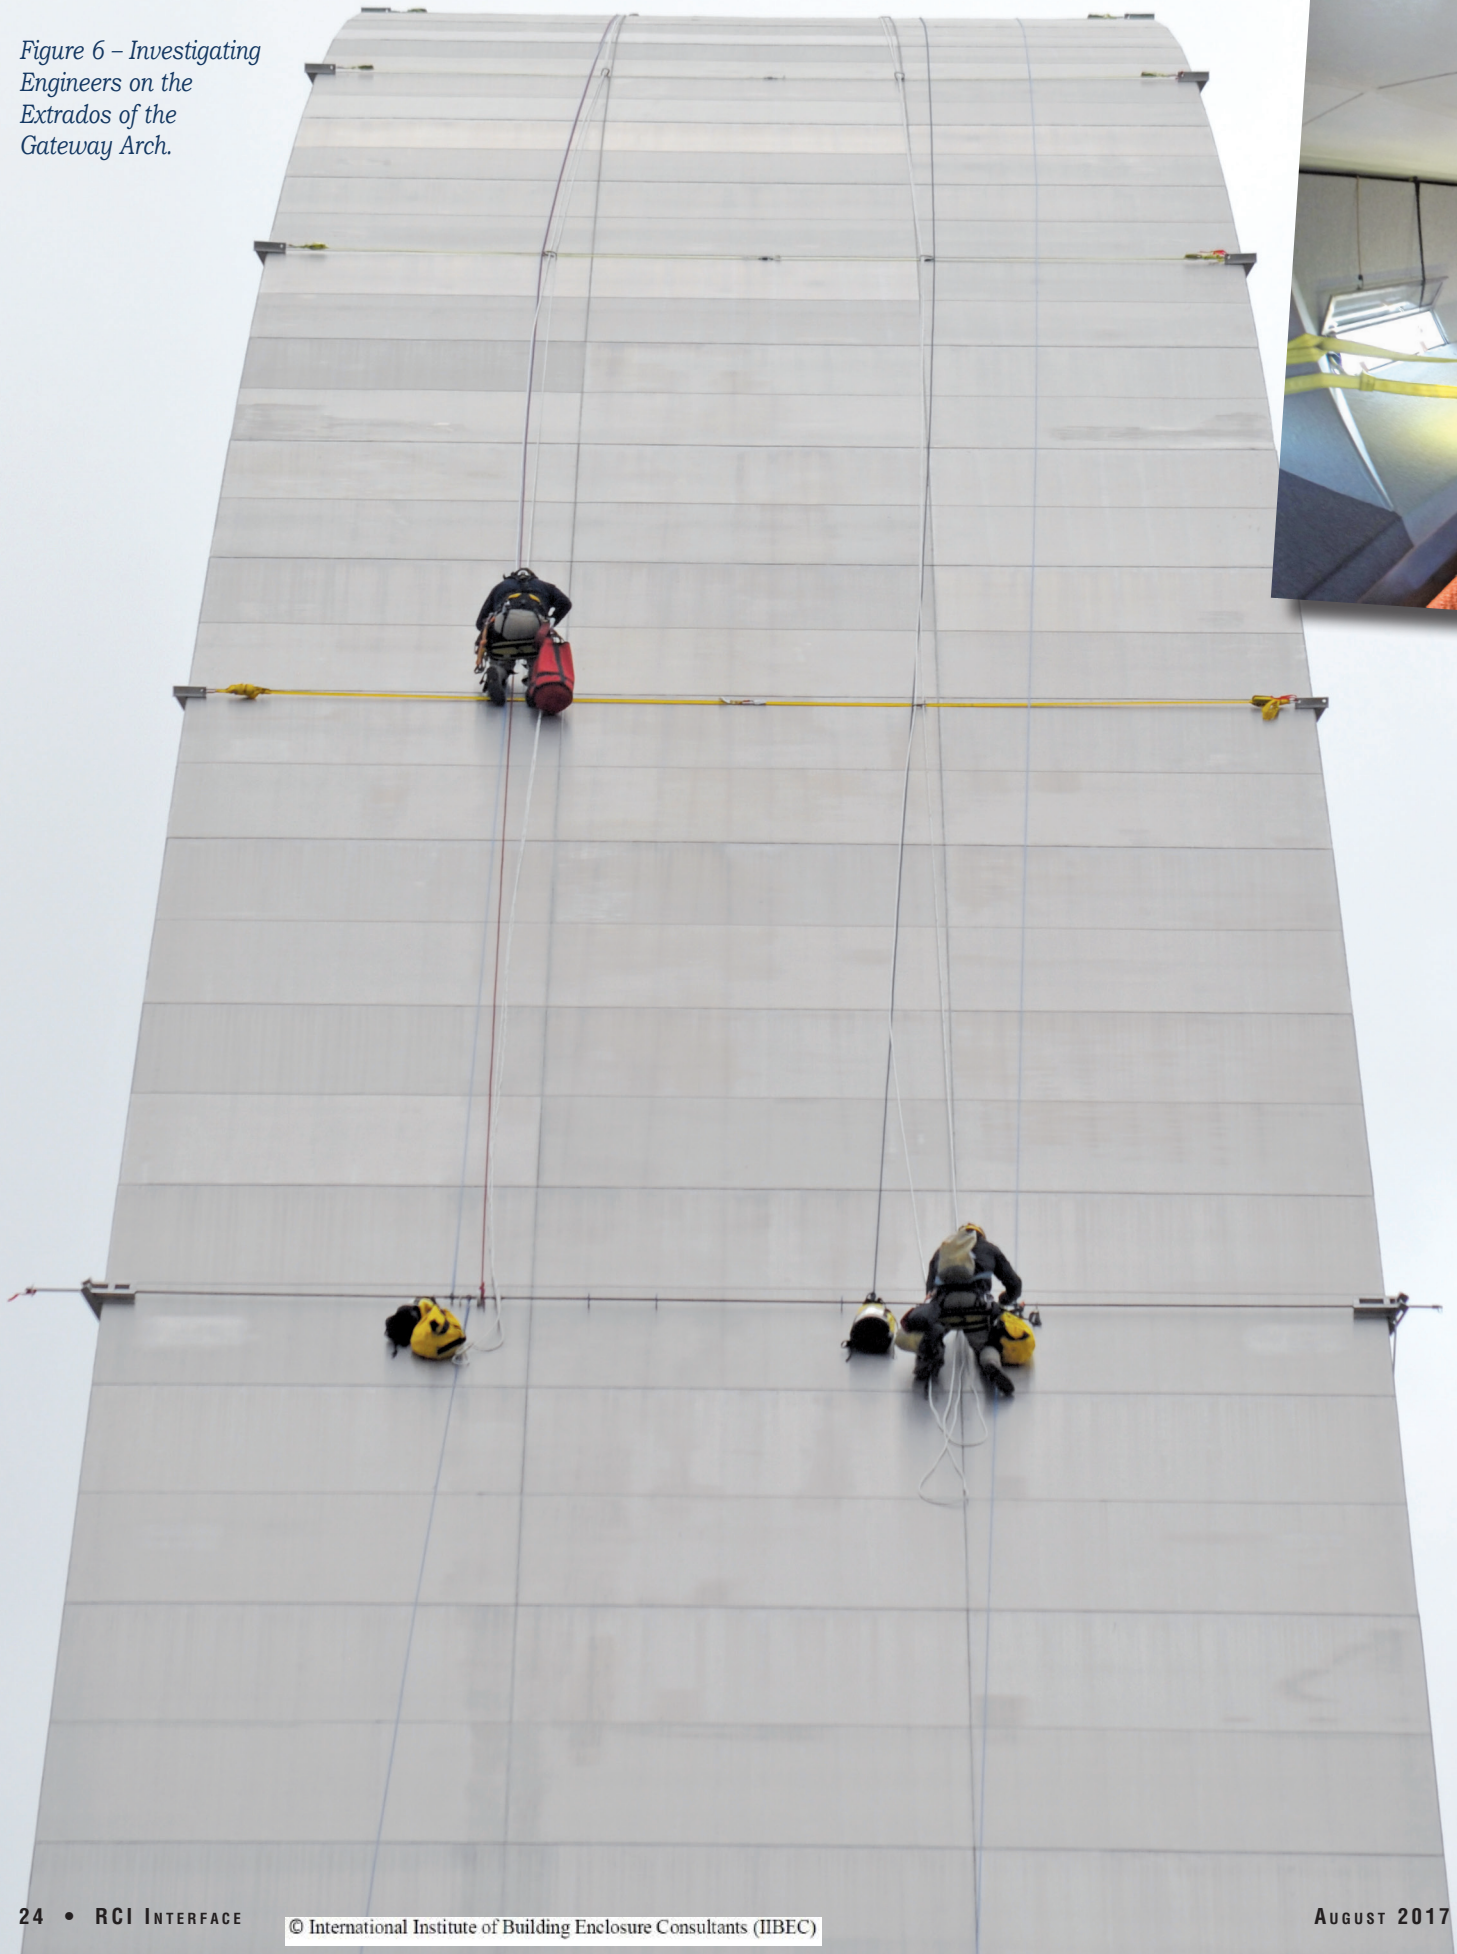
Figure 6 – Investigating Engineers on the Extrados of the Gateway Arch.

Accessing the exterior of this structure was truly a monumental task (Figure 6). While the goals of the investigation were
