HISTORIC IDAHO CAPITOL BUILDING EXPANSION

By Robert D. Card,
RBEC, RRC, RWC, REWC, REWO

project profile

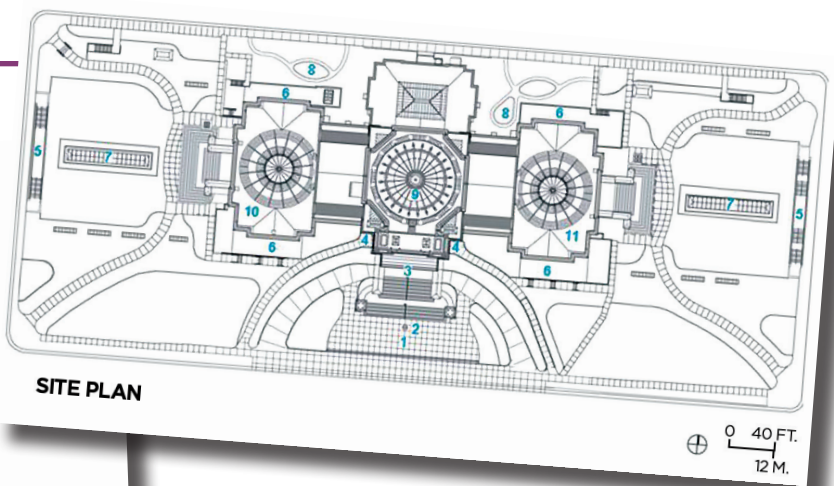
Figure 1 – Site plan and section through addition.
Courtesy of CSHQA.

- 1 Public Hallway
- 2 Inner Dome
- 3 Central Rotunda
- 4 House Chamber
- 5 House Lounge
- 6 Transition to East Wing
- 7 East Wing Public Hallway

SECTION A-A

SITE PLAN

It was determined that additional space could be provided without impacting the visual aspect of the existing building by utilizing the areas below the expansive flanking lawns. The lawns adjacent to the main building would be excavated (~100,000 cubic feet [2,832 m³] of earth), and waterproof concrete shells constructed and carefully connected to the existing building below grade (Figure 1).
