BUILDING ENVELOPE TECHNOLOGY SYMPOSIUM

MID-RISE WOOD FRAME CONSTRUCTION: A CALL FOR BEST PRACTICES

DEREK A. HODGIN, RBEC, RRO, PE, CCCA

CONSTRUCTION SCIENCE & ENGINEERING, INC.

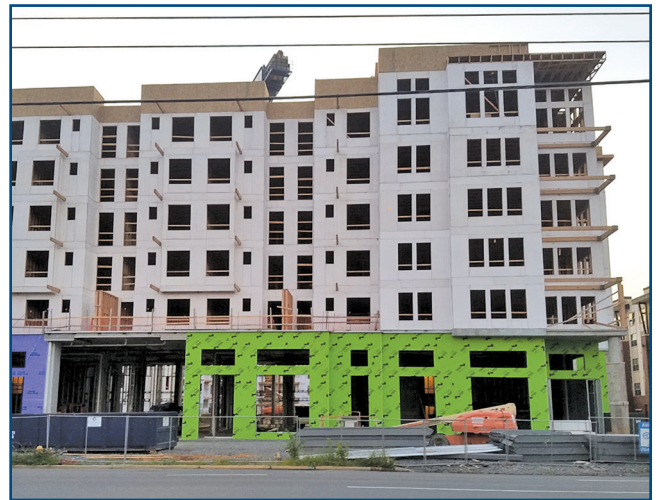
Figure 1 – Typical mid-rise wood frame building under construction.

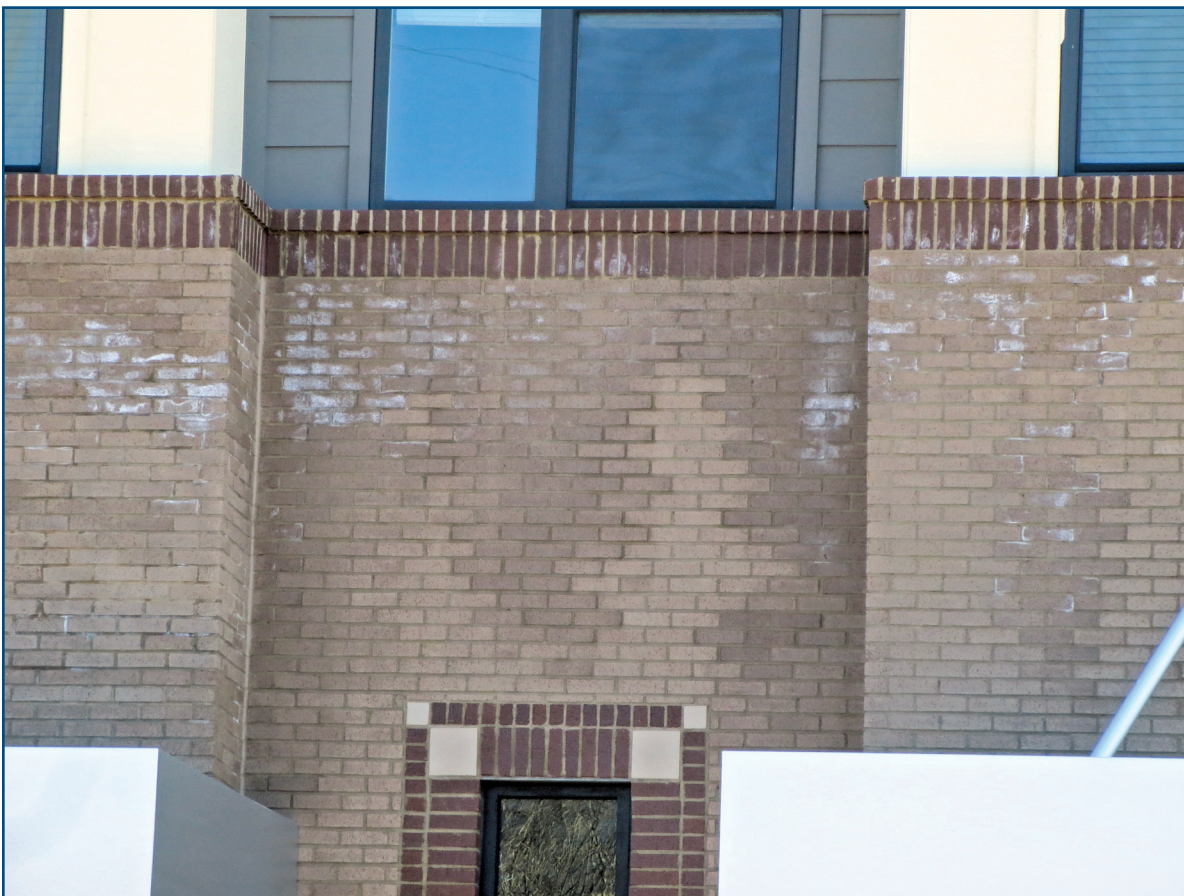
Figure 2 – Wall modulation with efflorescence.

In order for these larger buildings to have architectural appeal, many local ordinances require exterior walls to include setbacks or reveals, also referred to as modulation. By moving the walls in and out, numerous inside and outside corners are created. To detail properly, the corners require attention. Specifically, the drainage plane—typically consisting of components such as a weather-resistive barrier (WRB), self-adhered flashing (SAF), liquid-applied waterproofing, and metal flashing—needs to be constructed in a manner that provides continuity.⁴ An open gap, joint, or unsealed or reverse lap can, and often does, lead to significant water-related damage (*Figure 2*).

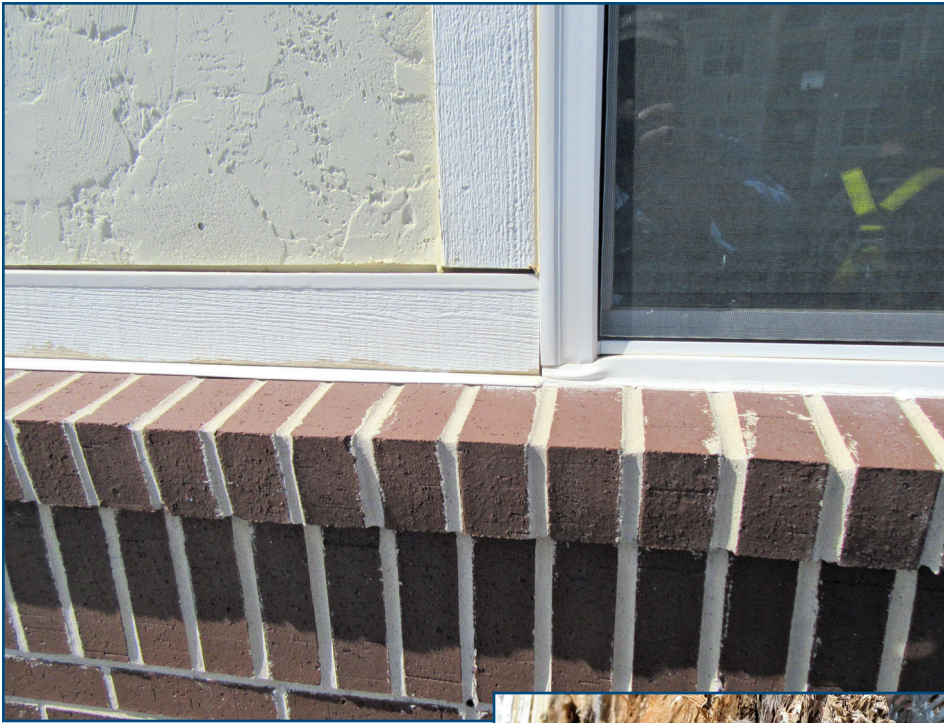
Figure 3 – Window damage caused by differential building movement.

Many ordinances require a mixture of exterior cladding types (i.e., brick veneer, stucco, cement board siding, metal panels, glass storefront, etc.) to create an attractive and interesting appearance. Some of the desired claddings can be particularly challenging when combined with wood framing (e.g., brick veneer), particularly if used on a four- to five-story building. Brick veneer grows due to wetting, while wood framing typically shrinks and/or compresses. Even if proper flashing details are provided to direct water away from the building at the time of construction, the differential movement between the brick veneer and wood framing could serve to damage the brick or adjacent wall components (e.g., windows) and/or reverse the slope of the flashing and direct water toward the building (*Figure 3*). Visit

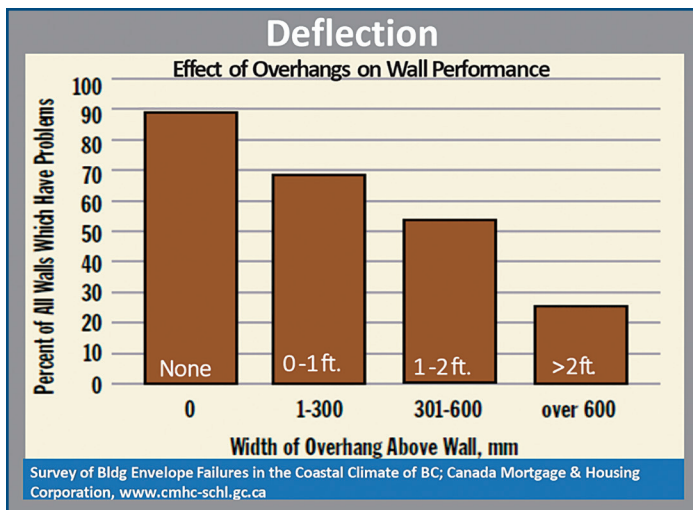
Figure 5 – Correlation between roof overhang width and wall performance problems.

The benefits of a roof overhang are significant. A roof overhang can dramatically reduce an exterior wall’s exposure to rain. As depicted in *Figure 5*, the percentage of walls that had reported problems in the coastal climate of British Columbia, Canada, decreased dramatically based on the width of the roof overhang above the wall.^[4] While this condition is not unique to mid-rise wood frame buildings, there seems to be an architectural trend toward reducing or eliminating roof overhangs on mid-rise buildings. The absence of adequate roof overhangs serves to exacerbate the water intrusion problems that can be associated with these types of buildings.

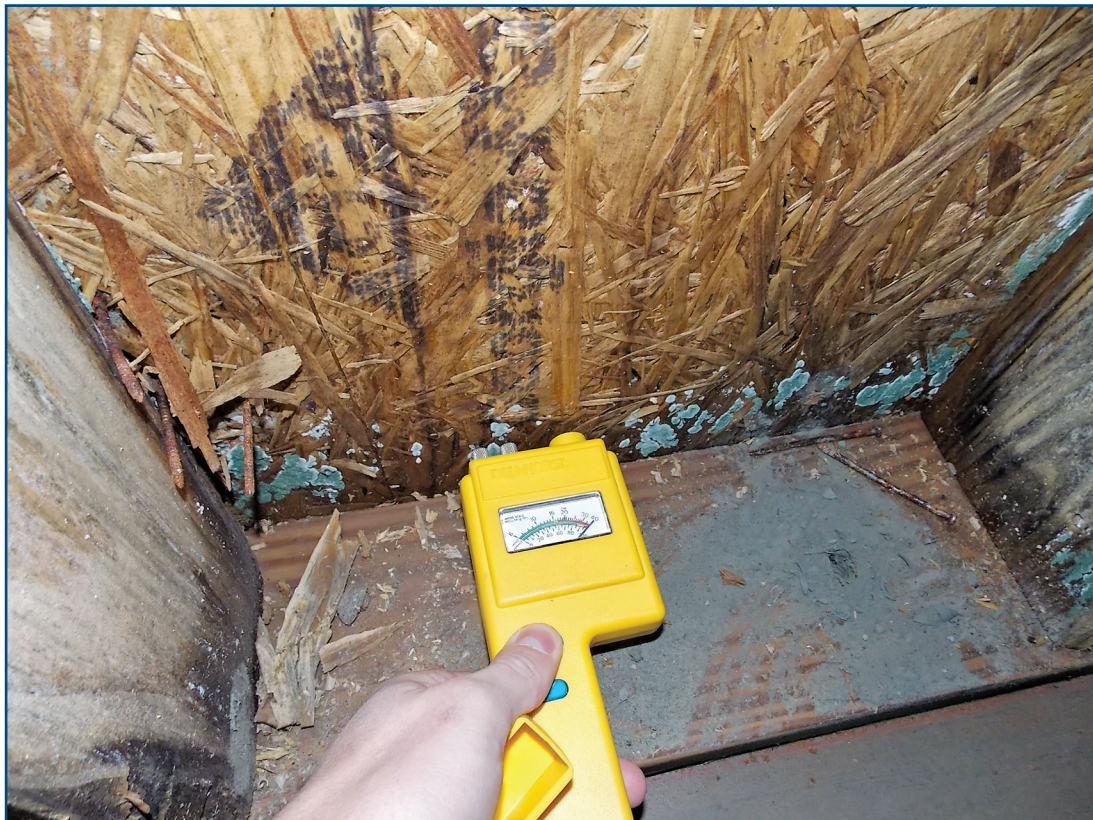
Figure 6 – Water intrusion/damage of a mid-rise wood frame building under construction.

frame buildings, the consequences of poor sequencing can be more dramatic and costly. For instance, several cases investigated by (or known to) the author have experienced water intrusion during construction to the extent that significant repairs were required to address mold and structural compromise before the buildings were completed (*Figure 6*).

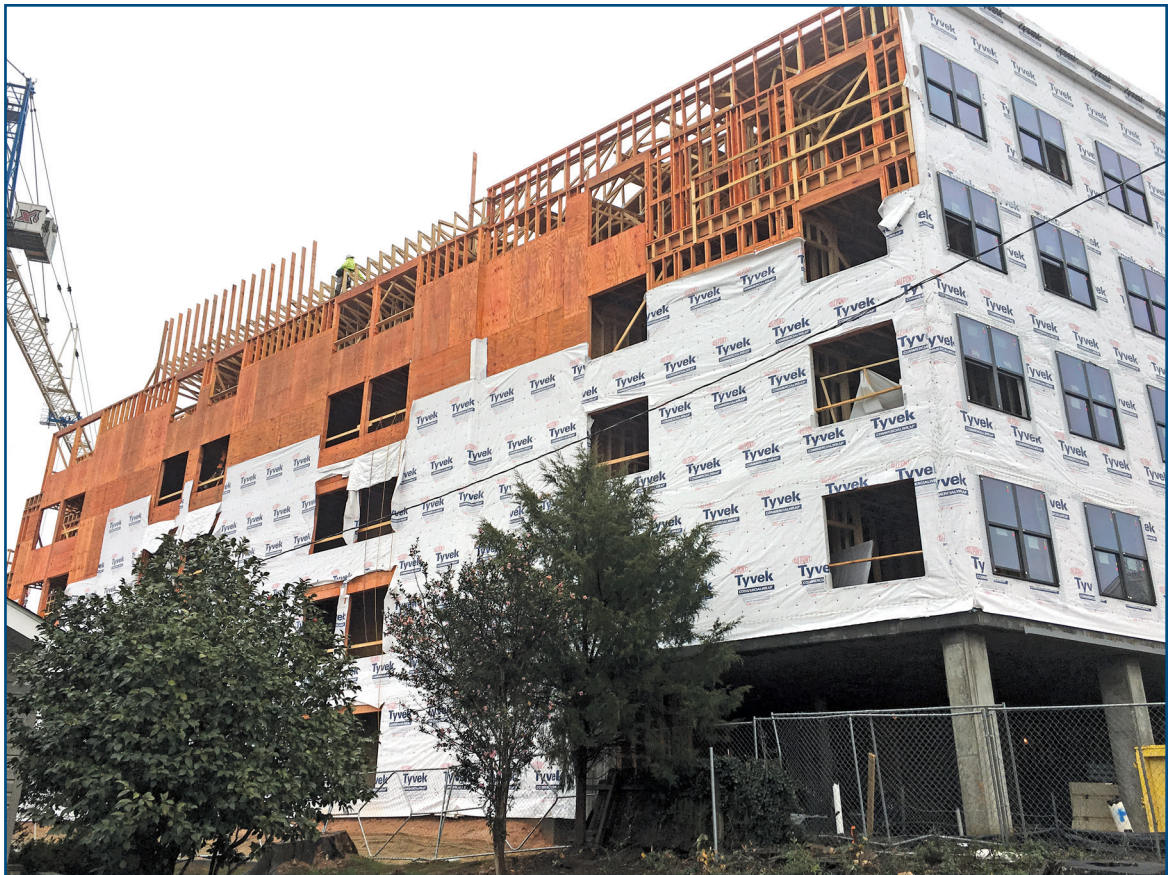
Figure 7 – A haphazard sequencing of multiple trades on the exterior wall of a building under construction.
