ROOF PONDING FUNDAMENTALS

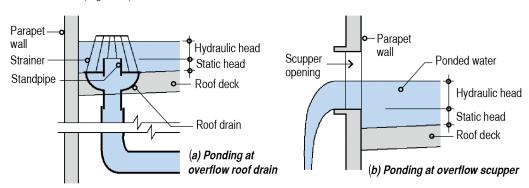
Figure 2 – Hydraulic head and static head explained with respect to secondary (overflow) roof drain and overflow scupper.

A term closely related to hydraulic head is static head. Static head refers to the elevation of the inlet level of the drainage element above the roof surface. Static head exists only with secondary (overflow) drainage elements, together with hydraulic head (*Figure 2*). Static head is constant and

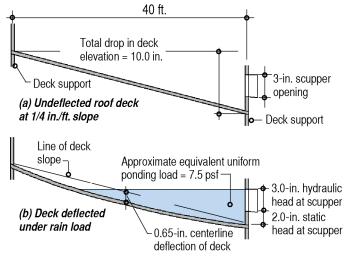
Figure 5 – Ponding on the hypothetical roof at ¼-in.-per-ft. slope. The first sketch represents the original, unponded roof, and the second sketch illustrates the extent of ponding and the resultant deflection of the same roof.

The amount of ponding on the roof with ¼-in.-per-ft. slope is approximately 7.5 psf when the hydraulic head at the scupper reaches 3.0 in., explaining its relatively high degree of safety against ponding overload (Figure 5).

Note that the discussion of roof slope, illustrated in *Figures 3* through 5, tacitly assumed the roof configuration mentioned in this provision. The discussion concluded that if the roof slope is equal to (or greater than) ½ in. per ft., the ponding load on the roof will be too small to cause ponding overload (hence, ponding instability).

The first part of this provision reiterates the commonly understood drainage design principle for low-slope roofs in that the roof ponding load is to be determined assuming that the primary drainage system is fully blocked and the secondary system is functioning. Note that the illustrations of ponding in *Figures 3* through 5 are based on this requirement.

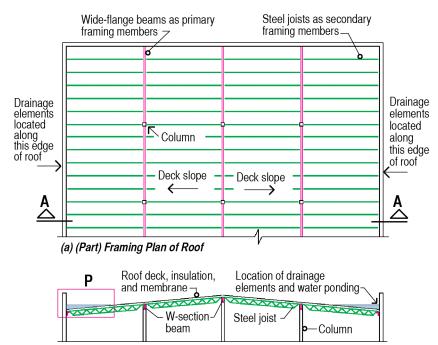
Figure 7 – Detail section P refers to Figure 6. The joists near the roof's drainage edge are subjected to gradually decreasing ponding loads, limited to a small part of their spans.

Figure 6 and Figure 7 illustrate the roof framing plan and section of a roof referred to in this provision—where the secondary framing members (roof joists, shown in green color) are perpendicular to the roof's edge, which houses the drainage elements. Note that in this situation, the joists are subjected to gradually decreasing ponding loads, which are limited to a small part of their spans. Note also that the lesser the slope, the greater the spread of ponding. This provision, therefore, requires that a roof whose framing plan is as shown in Figure 6, and which has a slope less than ½ in. per ft., be investigated for ponding instability.

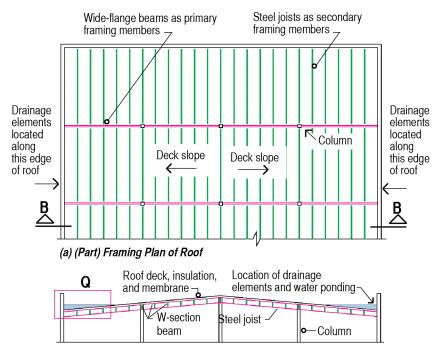
Figure 9 – Detail section Q (refers to Figure 8). Note that the secondary members (joists) near the roof's drainage edge are subjected to relatively large ponding loads over their entire spans.

Figure 8 and Figure 9 illustrate the roof framing configuration of this provision, which shows that the ponding on secondary framing members (steel joists, shown in green color) that are in the vicinity of the roof's edge (housing the drainage elements) are subjected to (relatively large) ponding loads over their entire spans, requiring investigation of ponding instability in them if the roof slope is less than 1 in. per ft.
