First Line of Defense - Plaza Waterproofing Replacement

Casey Williams, PE

Simpson Gumpertz & Heger, Inc.

First Line of Defense – Plaza Waterproofing Replacement

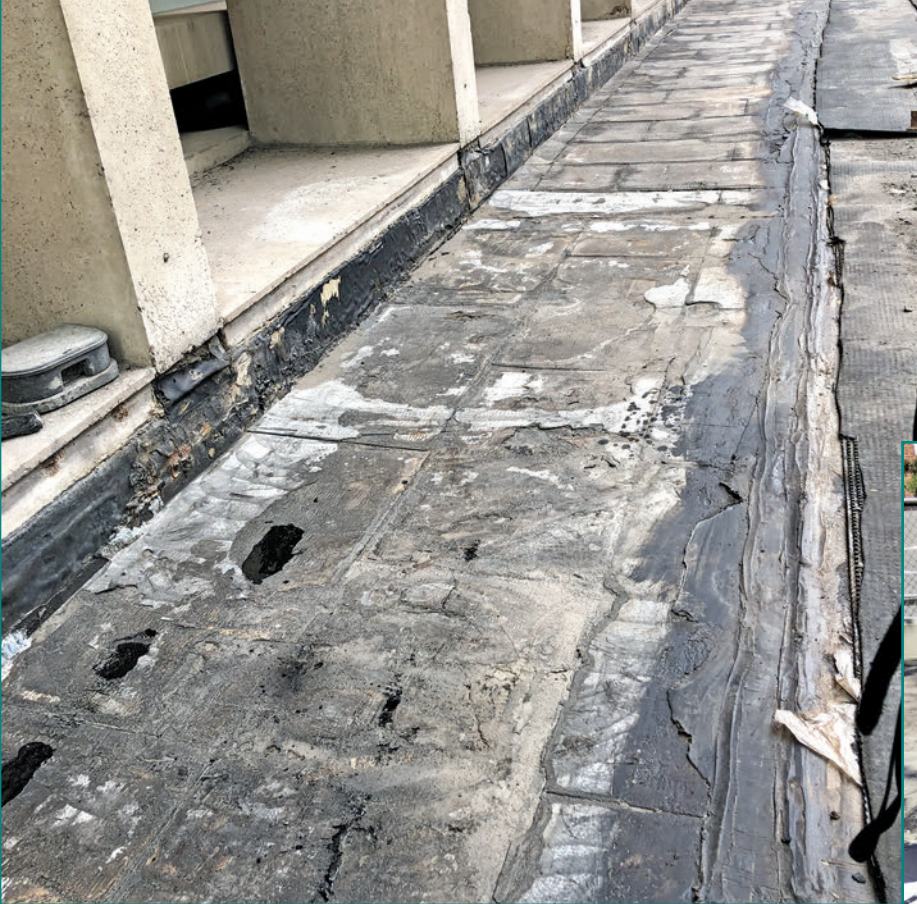
Figure 1 - Aged self-adhered sheet membrane exposed in plaza waterproofing system.

Self-adhered membranes (such as bituminous sheets with polyethylene facers, *Figure 1*) have been widely used for plaza waterproofing and, although less widely used today, are still available. These membranes have numerous seams due to available membrane roll sizes. Membrane seams are weak points since ponded water can lead to premature failure of self-adhered membrane seams and degradation of membrane materials. To improve self-adhered sheet membrane performance, careful surface preparation is necessary to ensure long-term adhesion, and this can be time consuming and costly. Some manufacturers recommend a robust adhesive or fluid-applied membrane layer below the self-adhered membrane to prepare the substrate and improve membrane adhesion, while some manufacturers require mastic

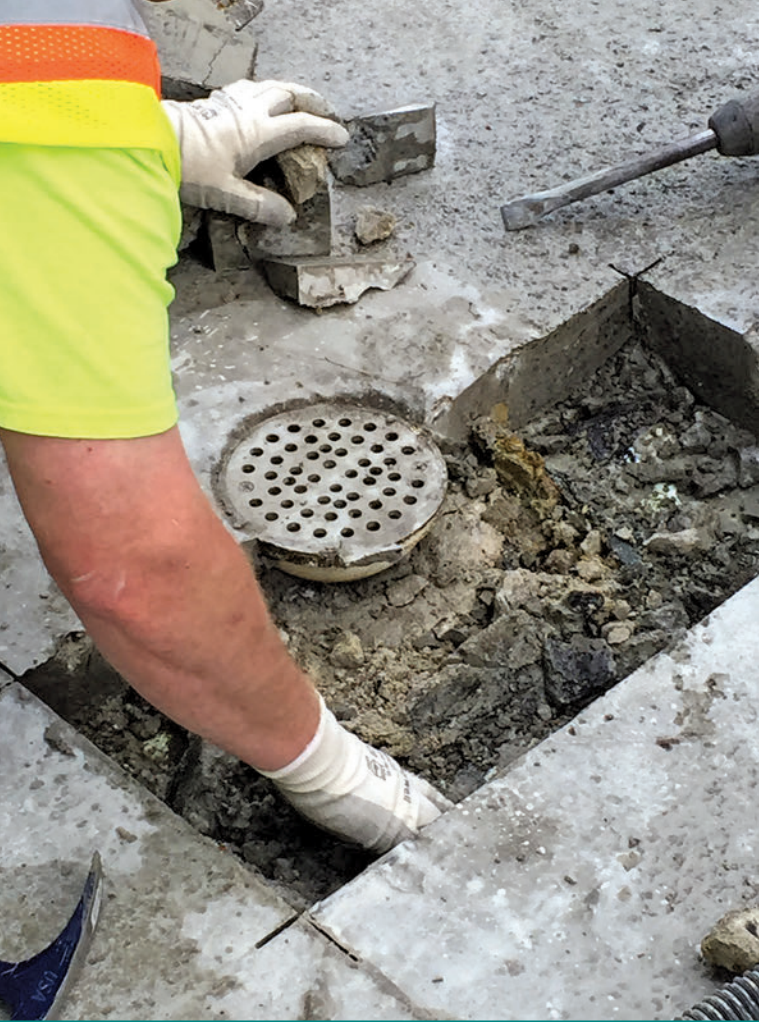
Figure 3 – Exploratory opening at plaza drain.

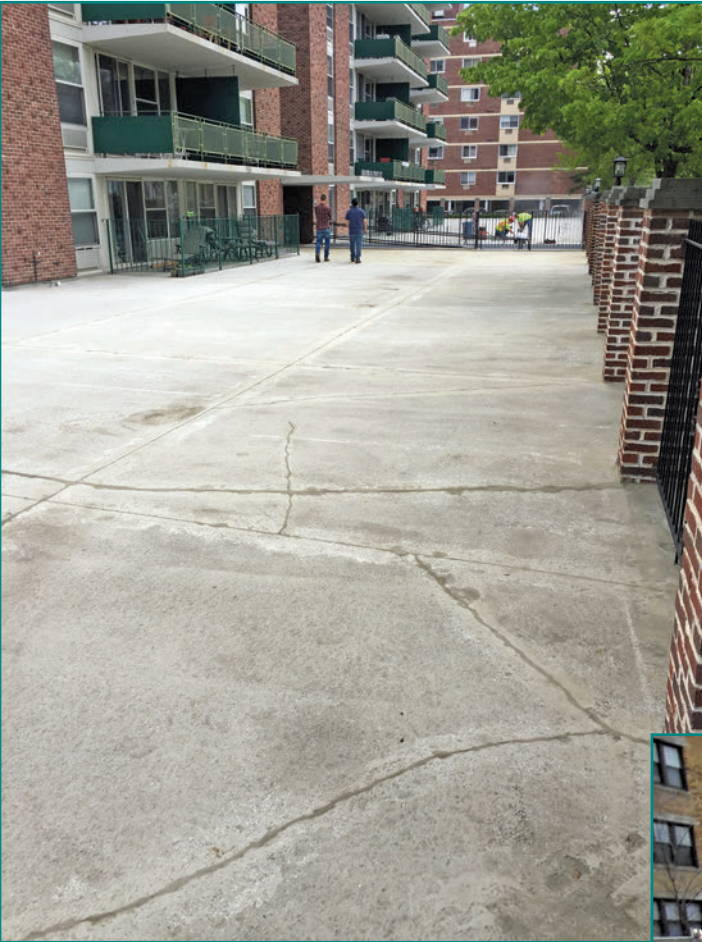
Figure 4 – Case Study 1 plaza with cracked and unsightly concrete paving surface.

This existing plaza with concrete paving surface surrounds an apartment building located over an unconditioned parking garage (Figure 4). The plaza wraps around the building with stairs leading to lower slabs-on-grade, and a ramp leading from the sidewalk level to the building’s primary entry. As part of a full-building renovation project, the owner wished to improve the plaza aesthetics and usability for residents, as well as addressing ongoing leakage into the parking garage—which was both unsightly and restricting parking—so that vehicles were not damaged by water leakage.

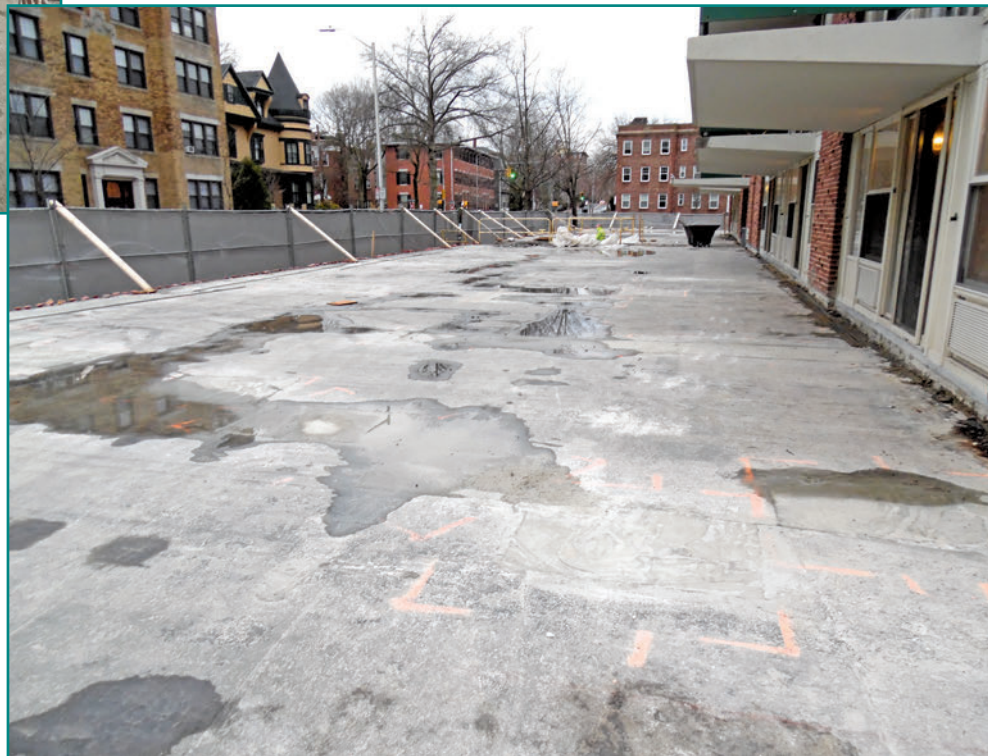
Figure 5 – Concrete structural slab lacks slope to drain and water ponds on the surface.

- **Drainage** – Based on a level survey and exploratory openings during our investigation, we determined the existing structural slab and waterproofing level had no appreciable slope to drain, which was later confirmed during construction (Figure 5). Knowing that our new system would rely on drainage at the waterproofing layer because of open joints at the pavers and plaza landscaping, we recommended providing a sloped concrete topping on the existing structural slab to improve the slope to drain and adding drain locations to limit the sloped topping height buildup. Additionally, we recommended replacing drains with bi-level drains and providing a drainage layer directly at the waterproofing surface. The client decided against the sloped topping, based on their assessment of relative costs and construction schedule impacts vs. risk of possible premature membrane deterioration if it is saturated. This decision greatly impacted the waterproofing membrane selection, which must be durable, redundant, and ideally adhere to the substrate to be successful in this application.

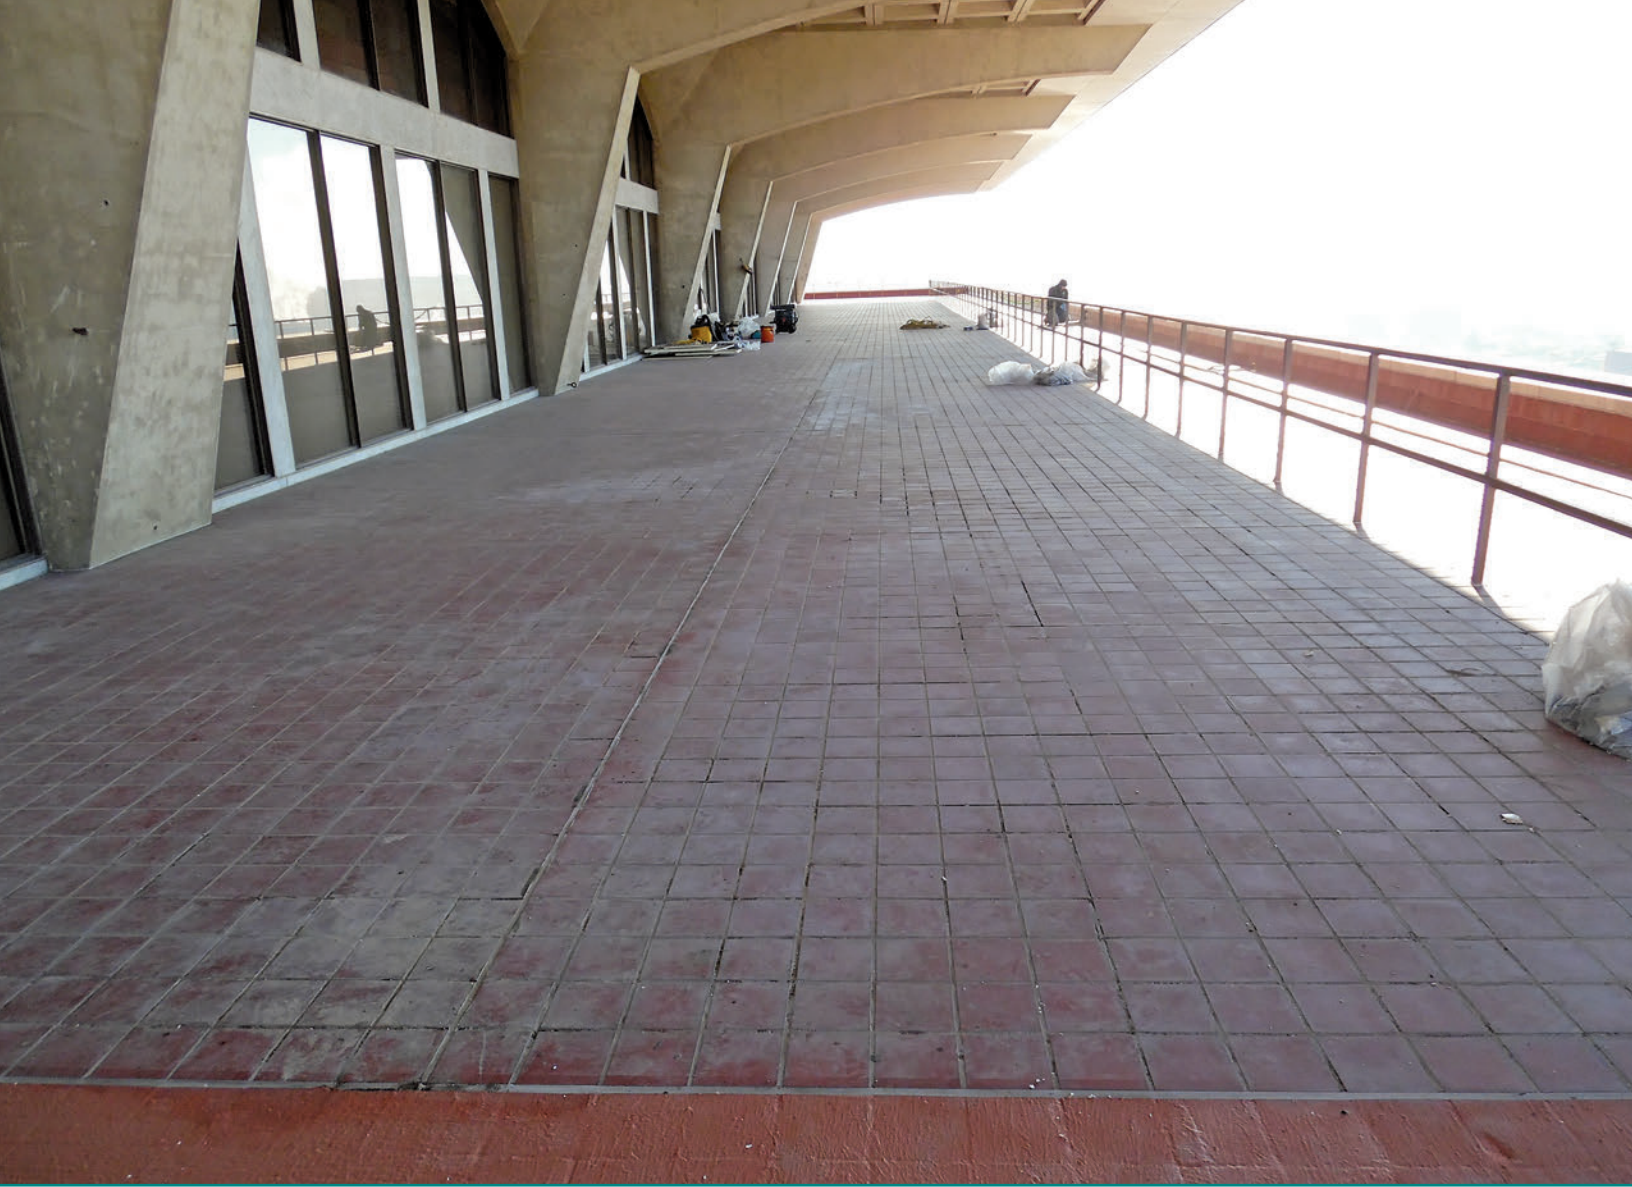
Figure 6 – Case Study 2 ninth-floor terrace with quarry tile pavers.

This ninth-floor terrace provides unique outdoor space for an office building with sensitive occupied space below, although the space is currently unused due to interior leakage (*Figure 6*). The existing walking surface is spalled, cracked, and heaved, ponds water, and has vegetative growth at paver joints. The terrace is aged and has failed. The existing plaza system consists of quarry tiles on a reinforced mortar setting bed over a polyethylene sheet bond break, a reinforced concrete protection slab, neoprene waterproofing, insulation, sloped concrete topping ($\frac{1}{8}$ in. per ft.), and the structural concrete slab. A remedial coating was applied to the tile surface in some areas as an attempt to limit ongoing water infiltration, though this was unsuccessful and the coating was blistered.

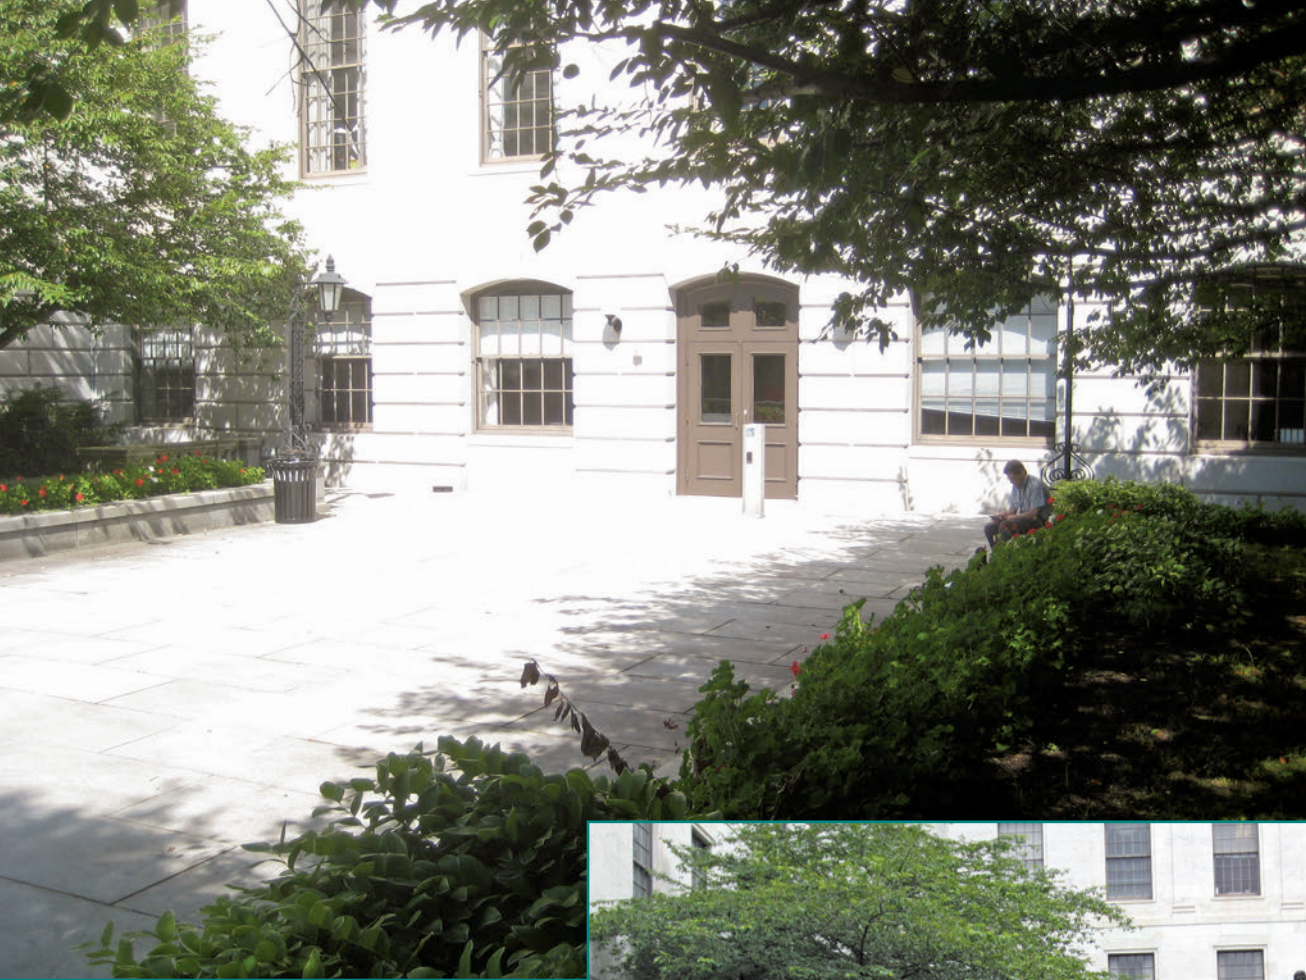
Figure 7 – Case Study 3 raised granite plaza with large planters.

large planters on either side (Figure 7). A multi-flight granite staircase descends from the plaza to a lawn area with secondary building access to occupied spaces below the plaza. Granite balustrades line the plaza edge and staircase. The client reported leakage into the spaces below the plaza and was concerned that some of the leaks might be related to failed planter waterproofing and heavy spring rains.

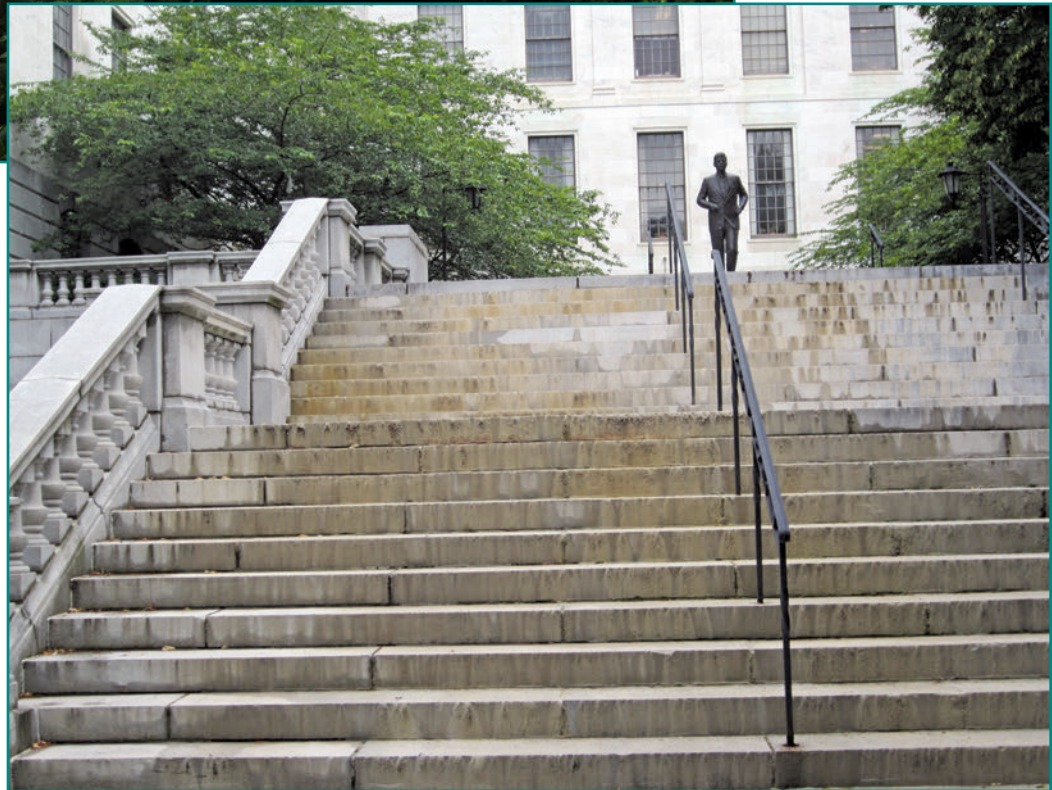
Figure 8 – Staining and efflorescence at stairs.

Additionally, the plaza trench drain was a maintenance problem and was seemingly perpetually clogged, and the stairs, which are a focal point facing the street, were heavily stained (Figure 8).
