SHEET INDEX					
NO.	TITLE	ISSUED			
		2023/03/03: REVIEW SET	2023/04/14: CONSTRUCTION DOCUMENTS

# RESTORATION OF THE NORTH CAROLINA STATE CAPITOL BUILDING

1 EAST EDENTON STREET  
RALEIGH, NORTH CAROLINA 27601

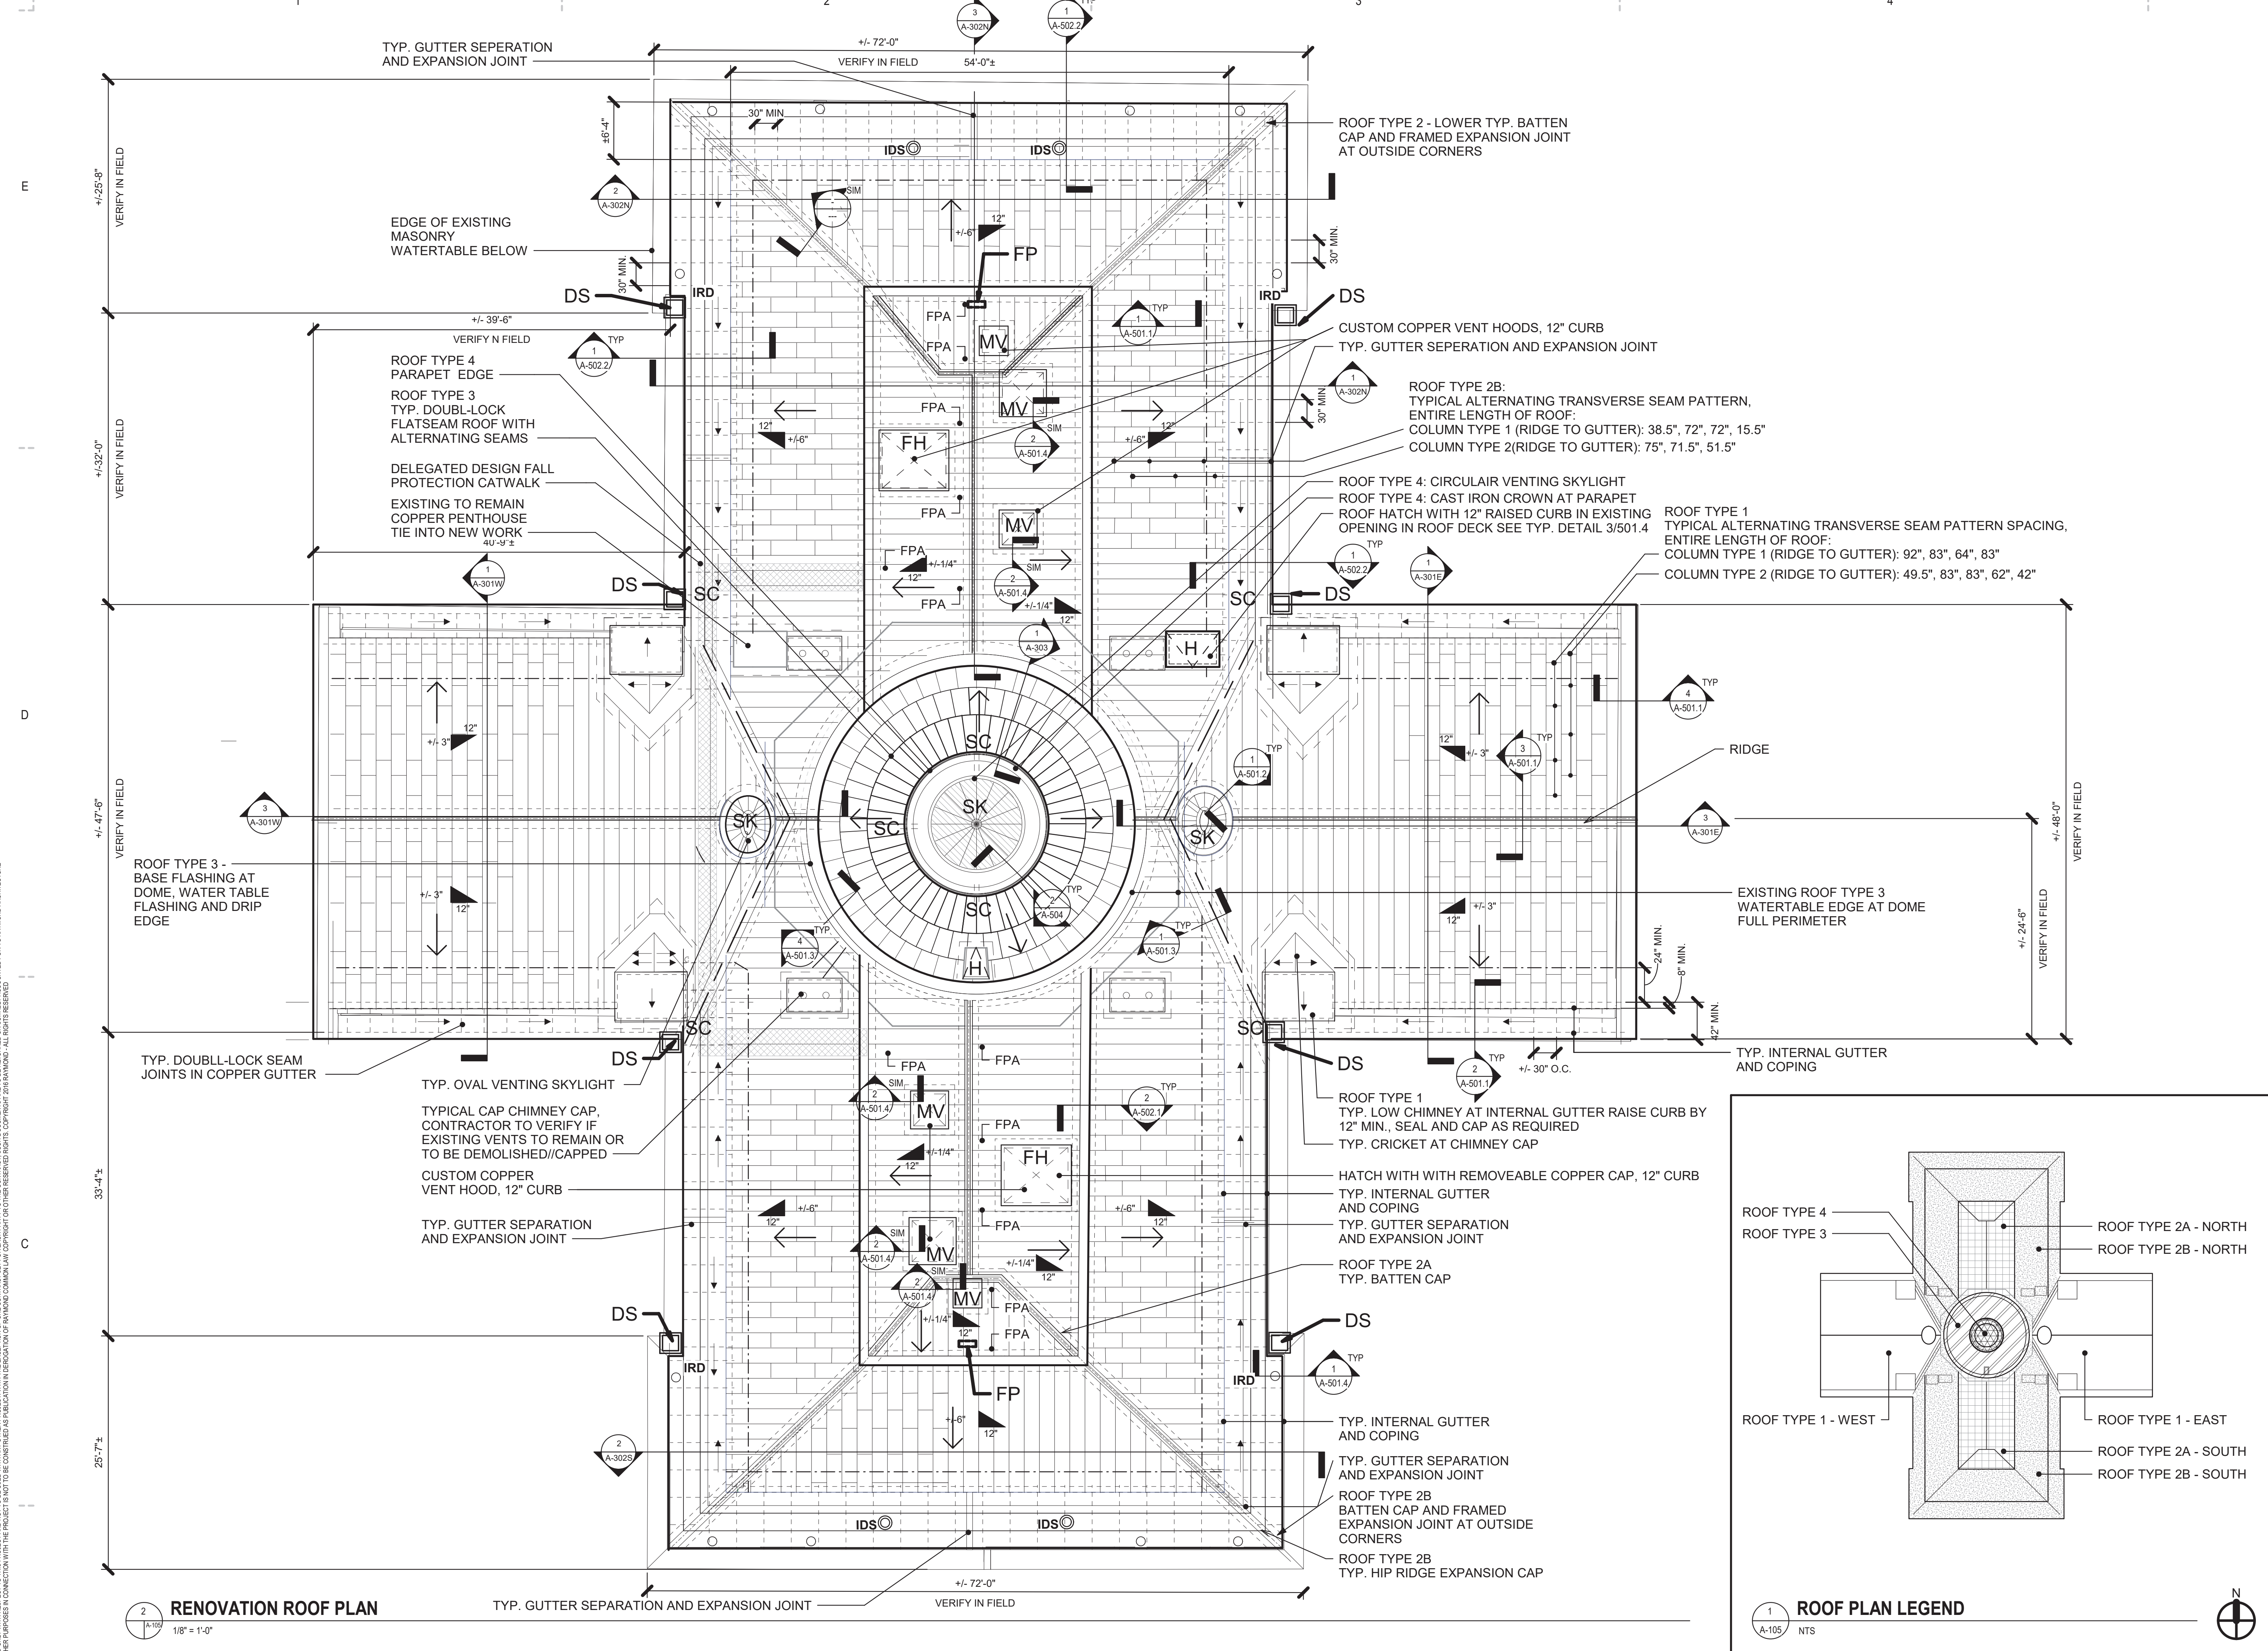
**RG-1** THE PROGRESS ROOF PLAN IS IN DEVELOPMENT, REFER TO ROOF INVESTIGATION SCOPE OUTLINE FOR ENTIRE SCOPE OF WORK.

**RG-3** EXISTING ROOF ELEMENTS TO REMAIN AND BE PROTECTED AND TIED INTO NEW WORK AS REQUIRED UNLESS OTHERWISE NOTED. RAISE EXISTING CURBS WITH 8" NEW BLOCKING, REPAIR EXISTING CONDITION AS REQUIRED MODIFY AND MAY BE NEEDED.

**RG-6** ALL COPPER ROOF CLADDING, FLASHING IS TO BE REPLACED IN ITS ENTIRETY UNLESS OTHERWISE NOTED.

**RG-7** COPPER STANDING SEAMS ARE SHOWN AS THEY ARE IN THEIR EXISTING CONDITIONS. ASSUME ALL NEW STANDING SEAMS ARE TO BE UNIFORMLY SPACED 20" MAXIMUM BETWEEN SEAMS.

**C-2** STANDING SEAMS ARE TO BE DOUBLE-LOCK 1" TALL WITH CONTINUOUS BUTYL SEALANT WITHIN THE SEAM. SPACING IS TO BE 20" MIN. BETWEEN STANDING SEAMS UNLESS OTHERWISE NOTED.

**C-3** COPPER CLEATS ARE TO BE 2" WIDE AND INSTALLED AT A SPACING 12" MIN., UNLESS OTHERWISE NOTED.
