“COOL” ROOFS CAUSE CONDENSATION

— Fact or Fiction? —

By Phil Dregger, RRC, FRCI, PE

This article is reprinted, with permission, from the January/February 2012 issue of Western Roofing.

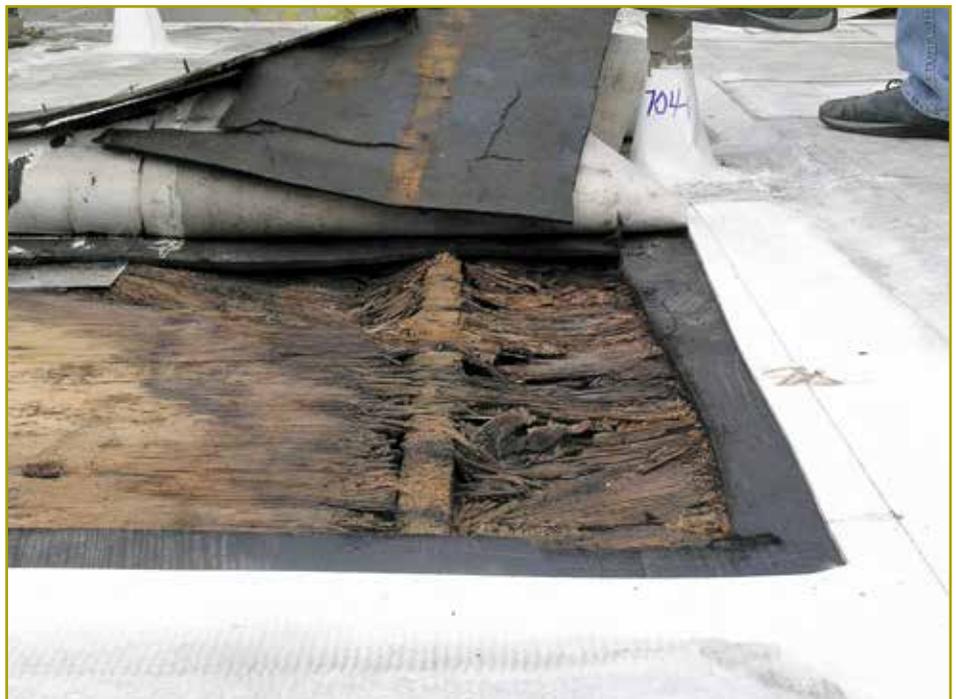
Figure 1 – Severely deteriorated plywood a few years after replacing an old cap-sheet BUR with a white single-ply roof.

Figure 1 shows severely deteriorated plywood discovered a few years after replacing an old cap-sheet built-up roof (BUR) with a white single-ply roof in the San Francisco Bay Area. Workers sent to inves-

tigate reports of the roof dripping found no obvious openings for roof leaks but found many so-called “soft spots.” Before the white single-ply roof was installed, the old BUR had been in place for many years without similar reports of dripping or soft spots. Changing from a noncool roof to a highly reflective cool roof is believed to have at least contributed to these problems.

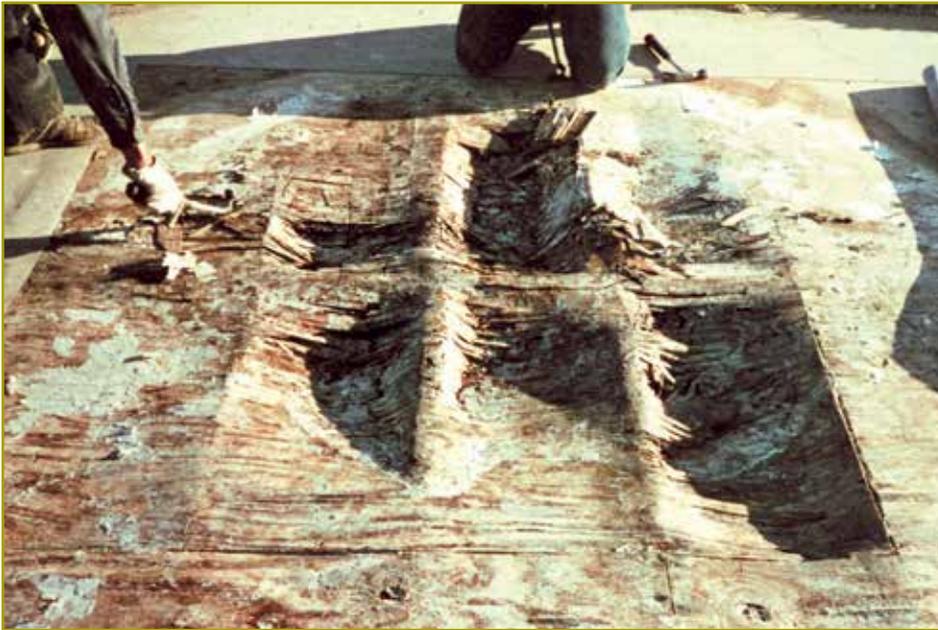
Figure 2 – Severe deterioration caused by water vapor migrating up through the ceiling of a laundry room.

Figure 2 shows severe deterioration caused by water vapor migrating up through the ceiling of a laundry room (with insulated rafter spaces) and condensing on the cold underside of the roof membrane and plywood roof deck. Eventually, the plywood got wet enough, warm enough, and for long enough to support the growth of wood decay fungi.

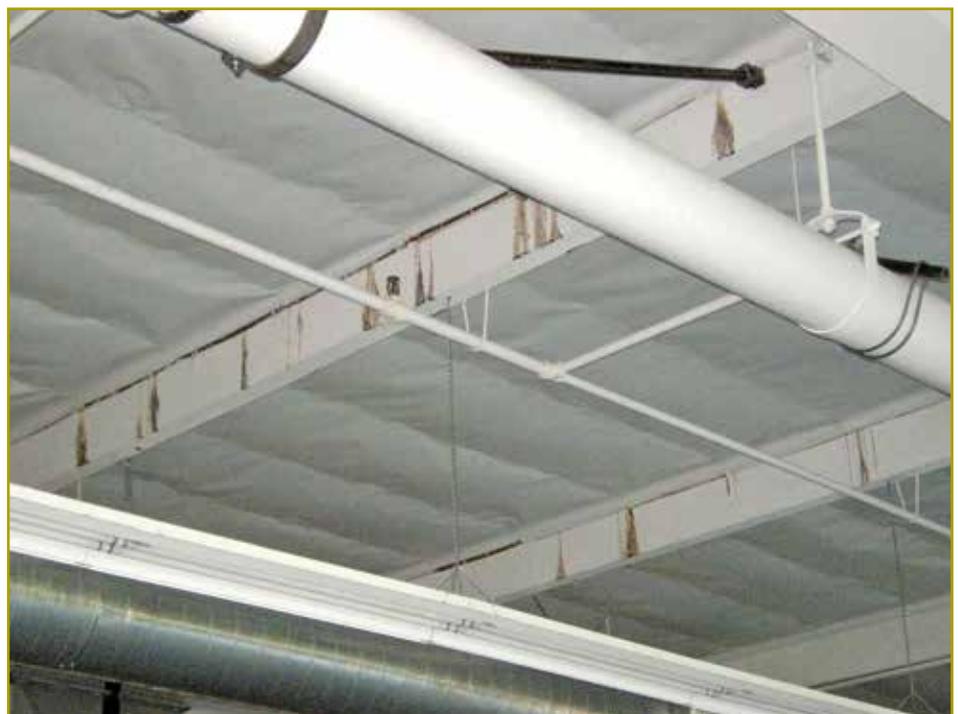
Figure 3 – Stains on the sides of beams in an office/warehouse building in California.

Severe conditions can develop—even in mild climates. Figure 3 shows stains on the sides of beams in an office/warehouse building in California. The owner reported that the BUR was quite old, but it had been

recently overlaid with a highly reflective, reinforced elastomeric coating system. And although he remembers previously getting occasional reports of drips in the spring, the owner was sure he never got the kinds of reports he was getting now of widespread water dripping and even of water-soaked insulation falling to the floor (Figure 4). He mentioned, however, he still was not getting any reports of leaks during rains.

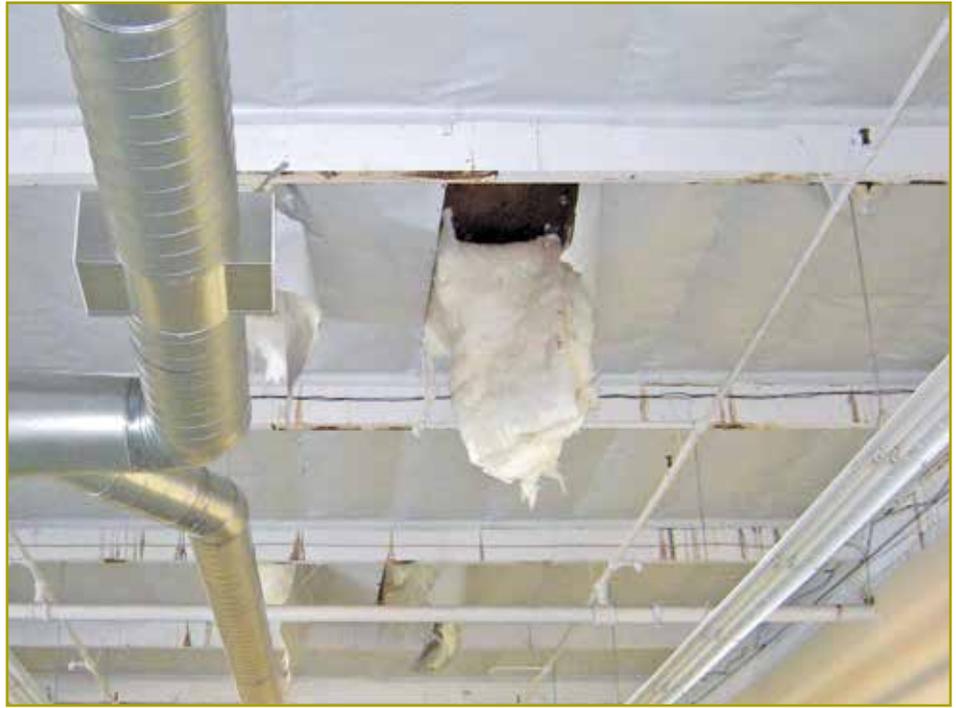
Figure 4 – Water-soaked insulation.

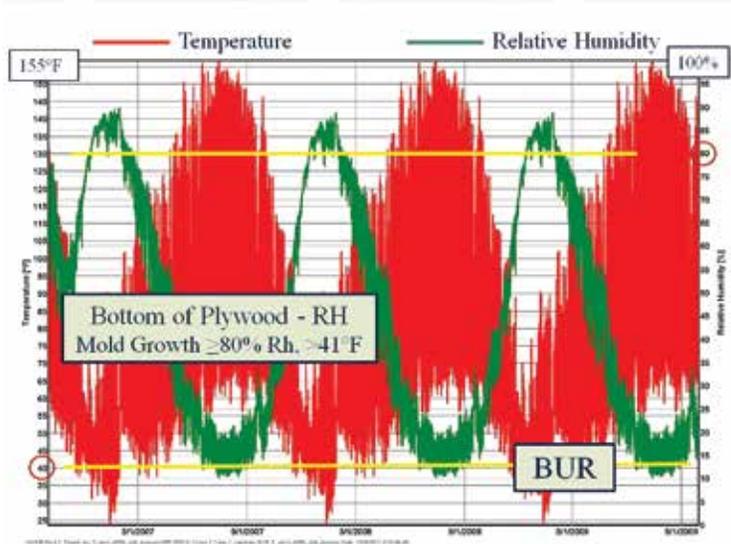
Figure 5 - WUFI-predicted fluctuations in temperature and RH near the bottom surface of the plywood roof deck with the original BUR. The yellow lines represent 80% RH and 41°F temperature.

Figure 5 indicates WUFI-predicted fluc-

tuations in temperature and relative humidity (a measure of the water present) near the bottom surface of the plywood roof

deck with the original built-up roof. *Figure 6* indicates WUFI-predicted fluctuations in temperature and relative humidity (RH) after installation of the highly reflective overlay. Superimposed on both figures are yellow lines representing 80% relative RH and 41°F.

The WUFI graphs indicate that, after installation of the reflective overlay, the plywood did not get as hot (e.g., maximums near 115°F rather than 155°F), accumulated more water (higher RH), and held it longer than it had previously.

ANSI/ASHRAE Standard 160-2009, *Criteria for Moisture-Control Design Analysis in Buildings*, recommends specific performance criteria to “minimize the undesirable effects of moisture in a building or building envelope.” Among other things, the standard recommends roof and wall systems be designed to limit how high the RH of materials like wood gets and for how long. One criterion is that the “30-day running average surface RH <80% when the 30-day running average surface temperature is between 41°F and 104°F.” Again, the yellow lines in *Figures 5* and *6* represent 80% RH and 41°F temperature.

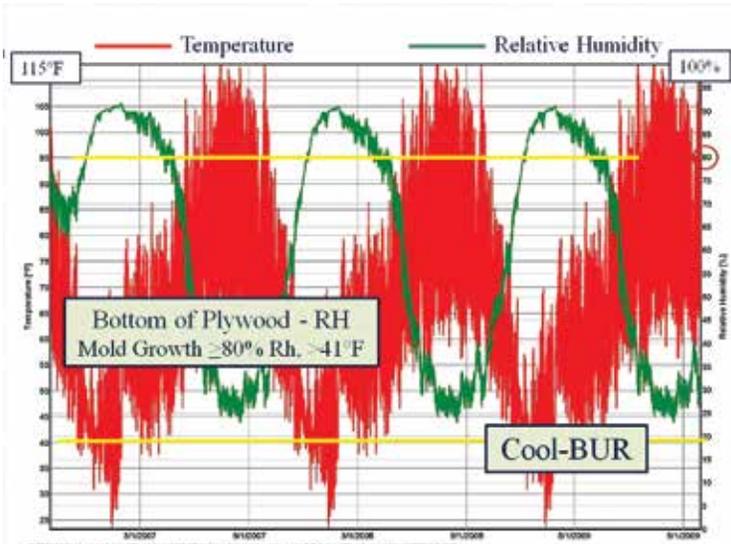
Figure 6 - WUFI-predicted fluctuations in temperature and RH after installation of a highly reflective overlay. The yellow lines represent 80% RH and 41°F temperature.

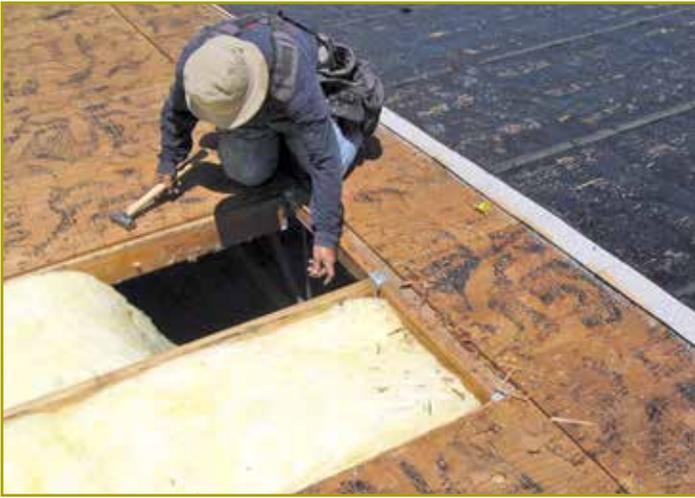
Figure 7 – Roof construction along truss purlins.

Figures 7 and *8* show roof construction along truss purlins where modest gaps in the foil-faced batt insulation allowed interior air to enter, condense, and accumulate on the wood deck during cold weather. In the spring, with higher temperatures and plenty of water to work with, very high vapor pressures were created at wood deck level, forcing water vapor downward where it condensed on nearby metal surfaces and dripped out.

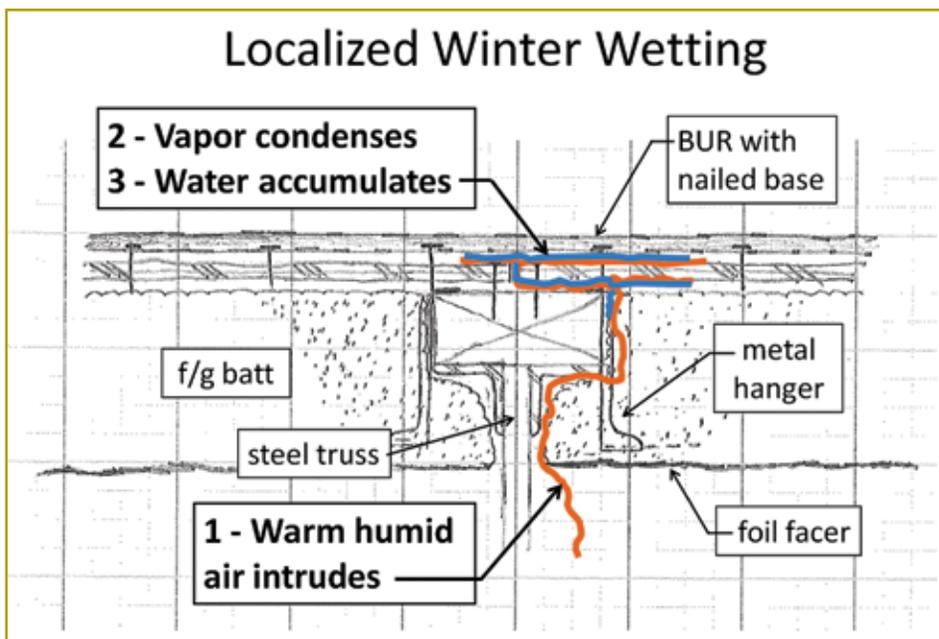
Figure 8 – Localized winter wetting.
