THE CASE FOR AERIAL INFRARED

BY
**GREGORY R.
STOCKTON**

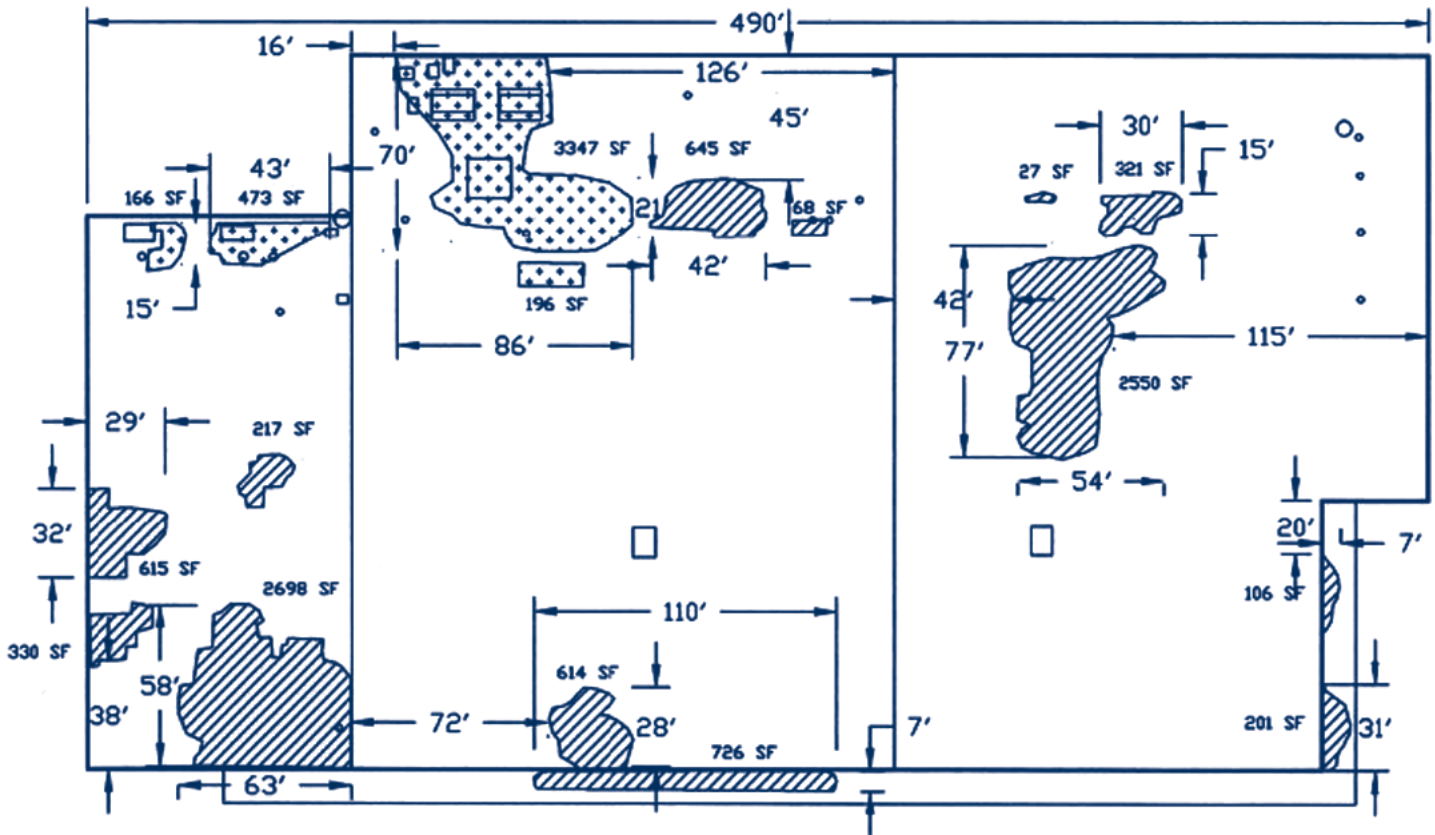
ROOF AREA = 125,118 SF

PROBABLE = 9118 SF (7.3 %)

POSSIBLE = 4183 SF (3.3 %)

Aerial infrared thermograph showing a roof with extensive rooftop equipment. It would take 20 infrared images to completely document all the areas of suspect roof moisture on this one roof section.

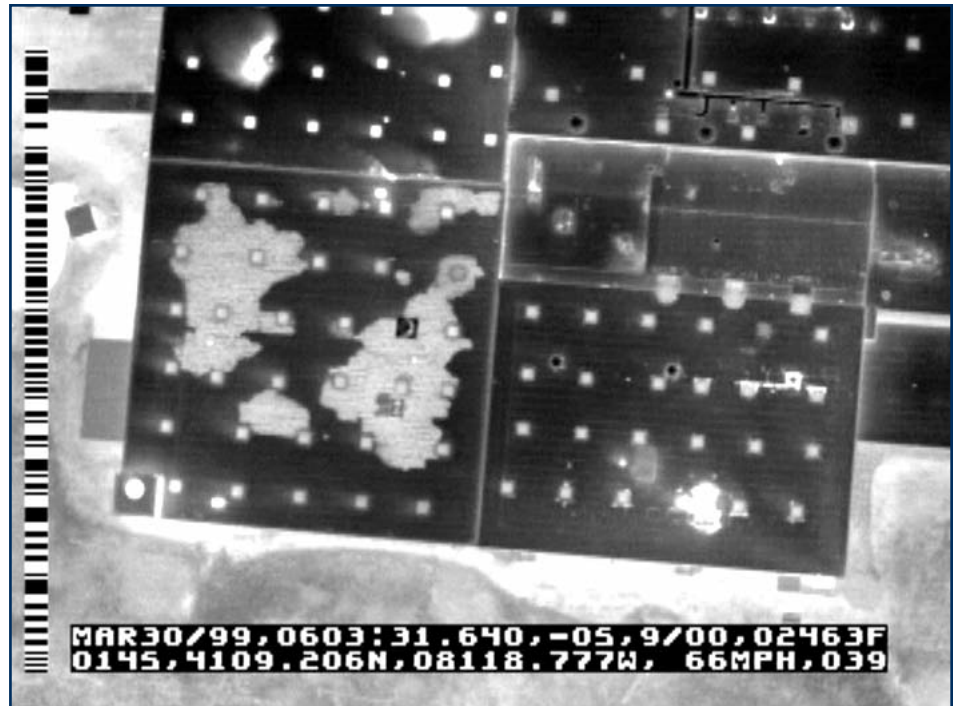
An aerial infrared thermograph showing clear outlines of subsurface moisture contamination from 2,000 ft. AGL (Above Ground Level).

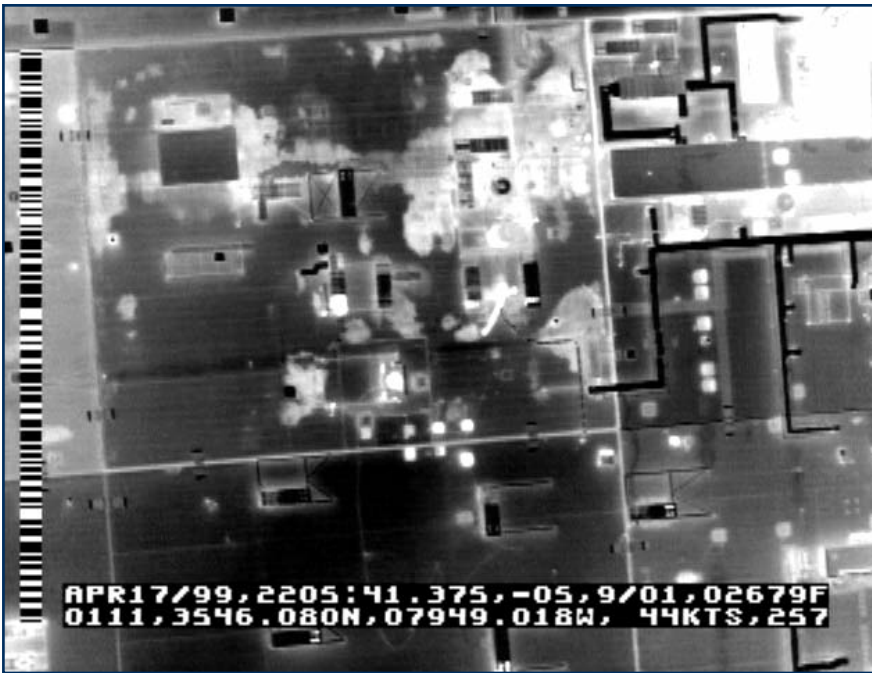
Example of a scaled AutoCAD drawing of roof moisture.

- Plan view allows for infrared images, visual images, and AutoCAD drawings to be reconciled closely. As a result, the report is clear, concise, and easy to understand.
- Plan view imaging allows accurate marking of areas of suspect roof moisture contamination. AutoCAD drawings can be made by drawing "over" the captured visual and infrared images on the screen. Hatch marked areas indicate probable and possible wet areas. The infrared, visual,

and AutoCAD components can then be separated. If dimensional information is available, this creates a quantitative, scale quality AutoCAD drawing of the suspect roof moisture contamination on the roof. If dimensional information is not available, the drawings become scaleable and easily updated at any time in the future, once quantitative data are obtained.
