# THE INS AND OUTS OF LABORATORY TESTING OF ROOFING MATERIALS

BY RENÉ M. DUPUIS, PH.D., P.E.

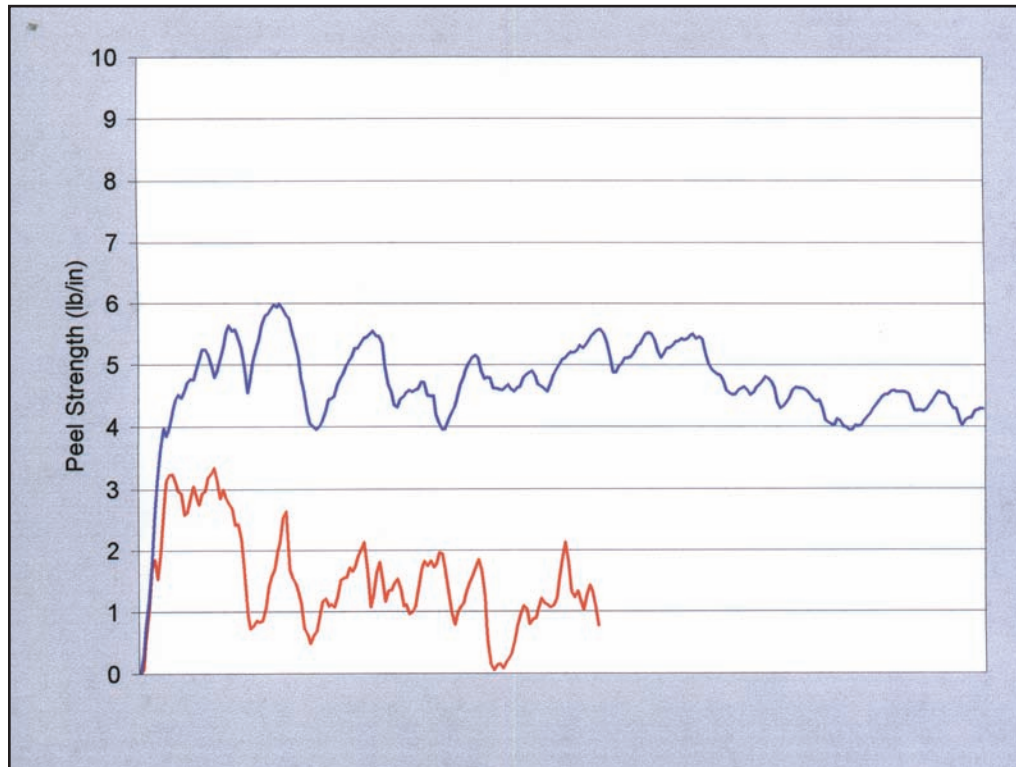
Figure 1

per minute in a constant rate of elongation tensile test machine. *Figure 1* shows a poor lap in red on the lower part of the graph. It barely reached 3 lb/inch of peel resistance; the average strength is about 1.5 lb/inch. Notice how the peel force goes down to almost zero at one point, then regains strengths as the lap is pulled apart.

The upper blue line of *Figure 1* shows the actual peel resistance of a good EPDM lap splice. Note how the maximum peel resistance goes over 6 lb/inch; the average peel is about 4.5 lb/inch—three times that of the poor lap seam shown in red. Does the consultant accept this job based on these results or should more tests be run? EPDM manufacturers have their own acceptance criteria (which are not publicized).

EPDM lap seams are tested in the 180° peel mode at 2 inches
