AN OVERVIEW OF WOOD ROOFING

BY LYLE D. HOGAN, PE, RRC

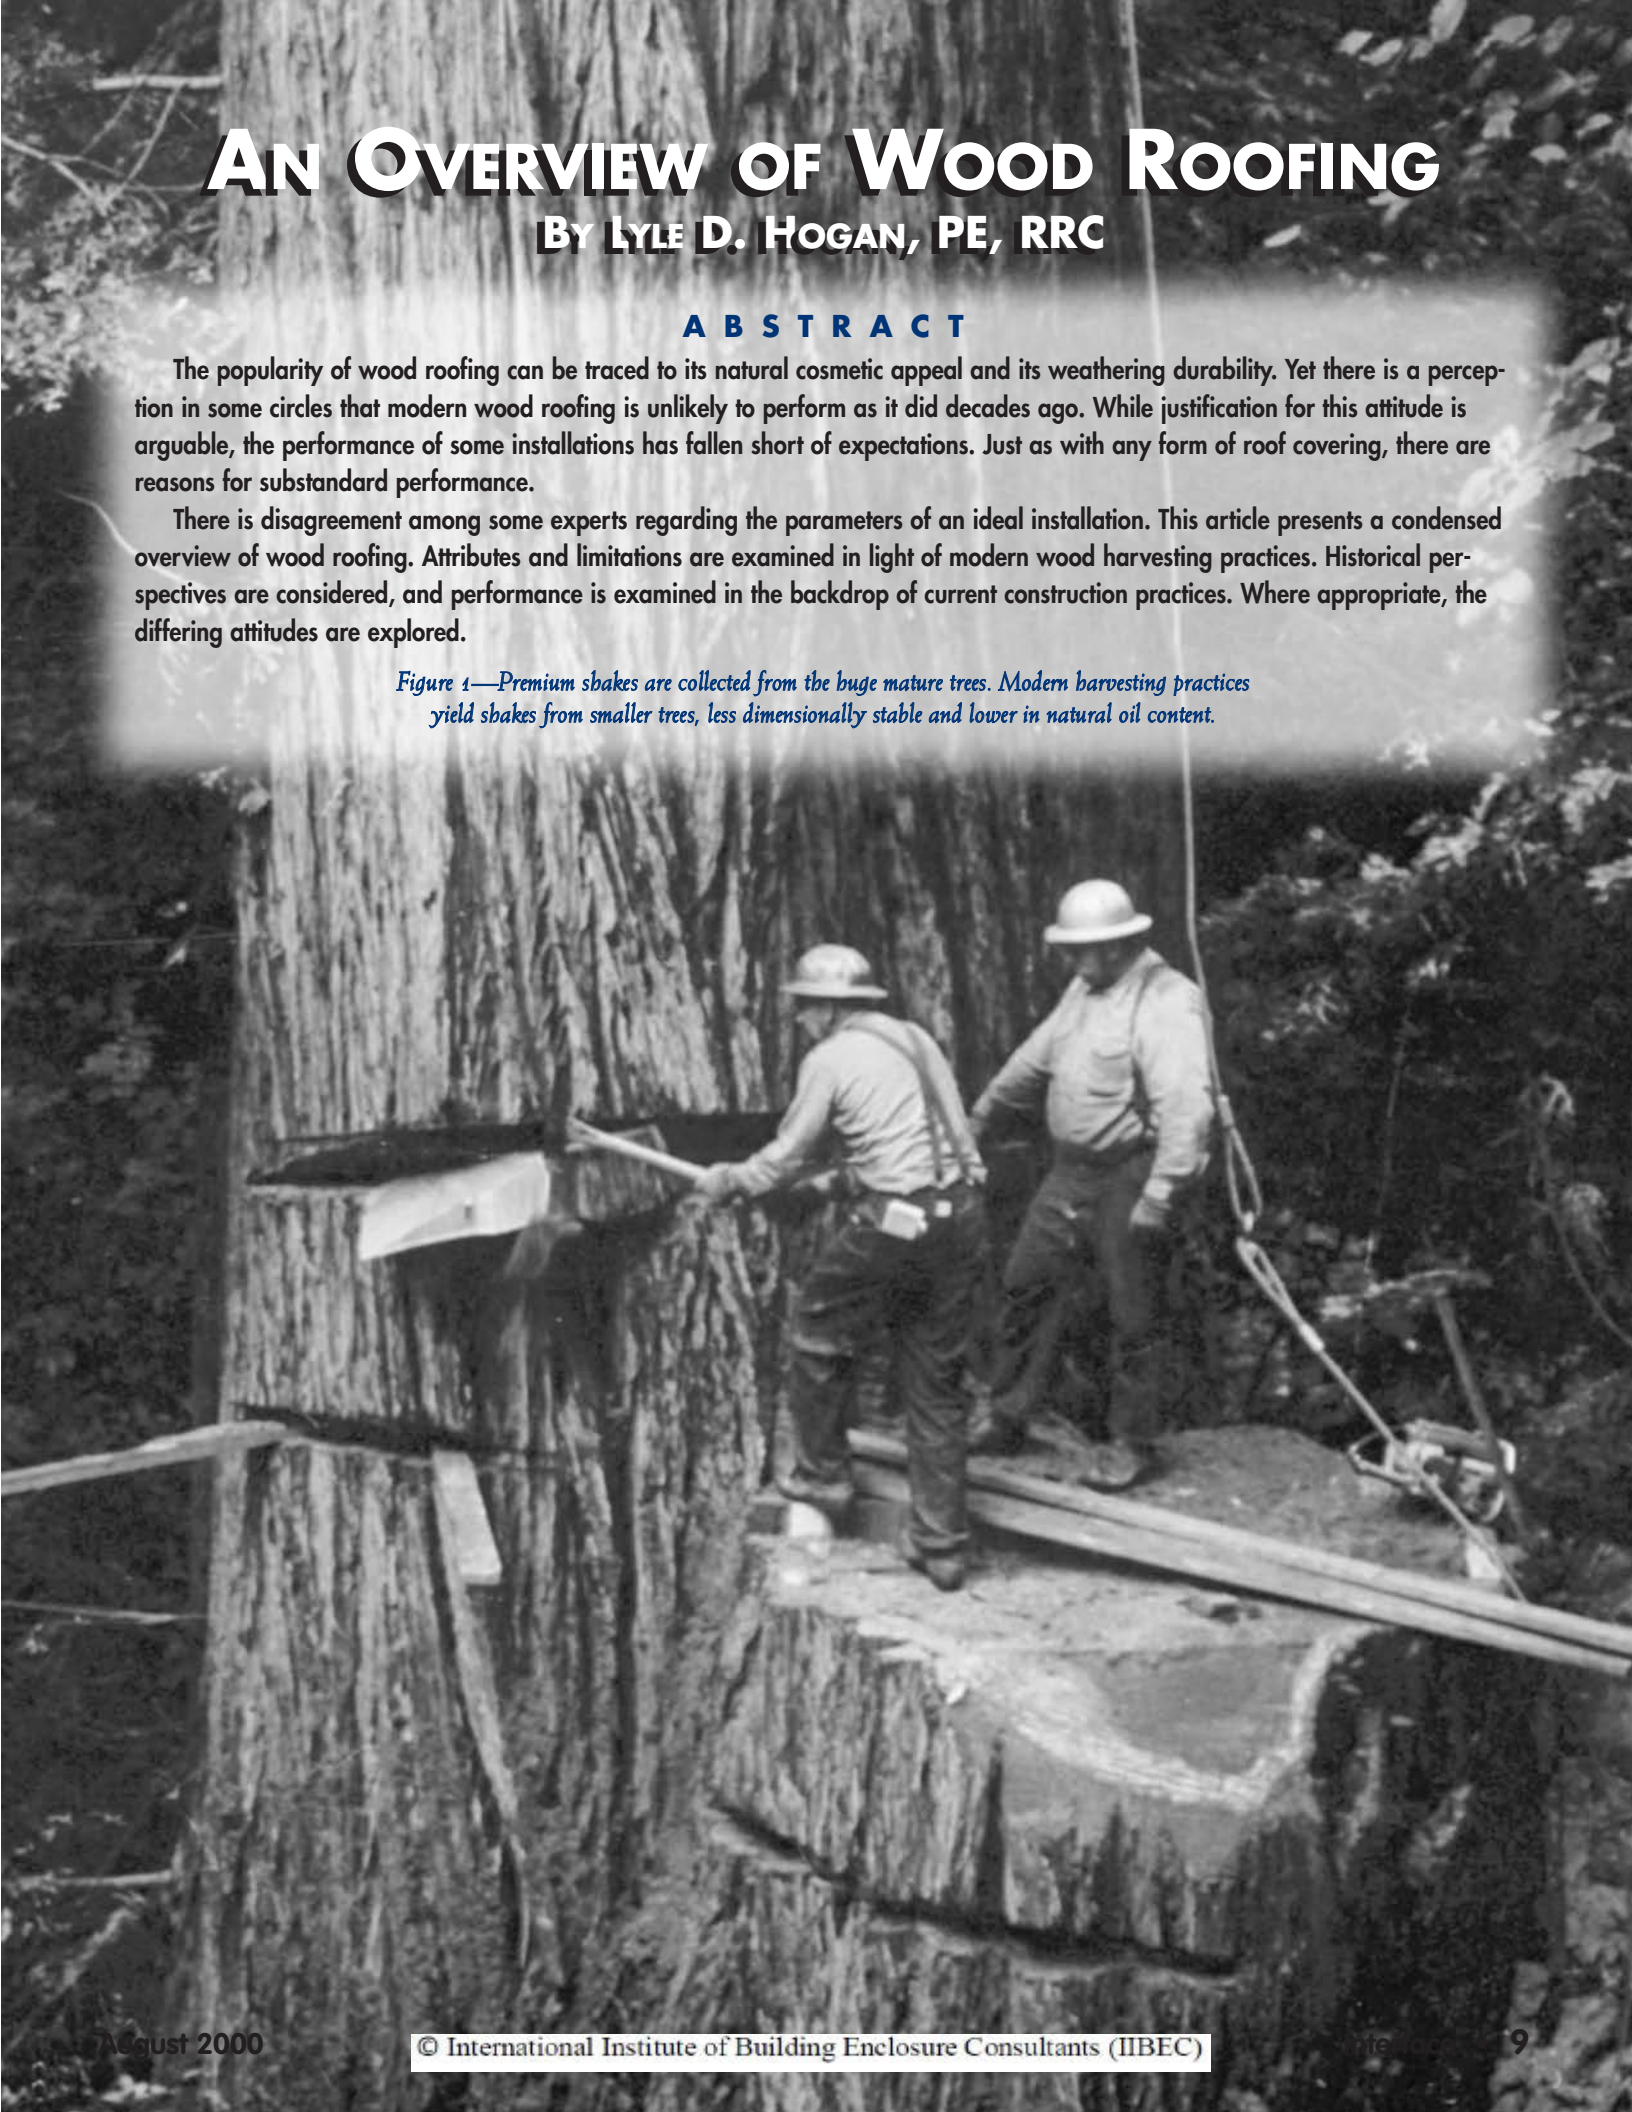
Figure 1—Premium shakes are collected from the huge mature trees. Modern harvesting practices yield shakes from smaller trees, less dimensionally stable and lower in natural oil content.

Trees were formerly brought from the forest one at a time, snaked out by draft horses, tractors, or other means. It was then common that only one log would be placed on the trailer. These were huge logs (only one would fit; see Figure 1), rich in the natural oils responsible for the good weathering properties with which cedar products are credited. This is sometimes termed "old growth" although such description means different things to different folks. West coast redwoods are considered old growth at 500 to 800 years old. Southeastern seaboard live oaks and longleaf pines apparently earn this title in only 400 years (Bugwood, 1998).

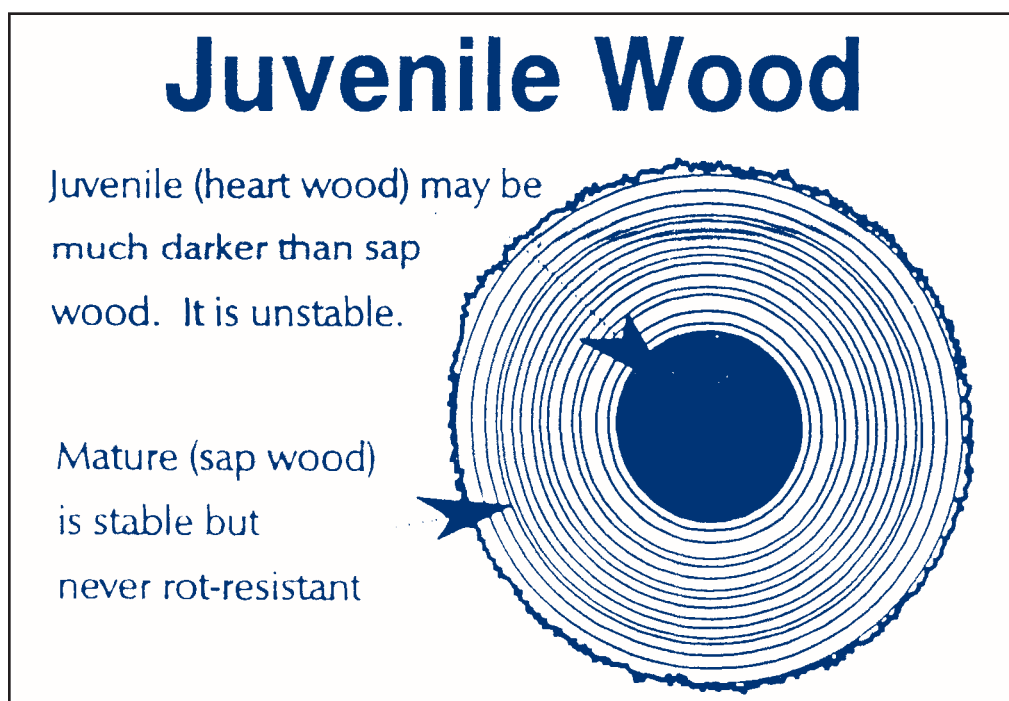
Figure 2—New growth heartwood may contain only half of the preserving extractives found in the old growth trees (reprinted from ASHI).

Later harvesting practices placed a dozen or more logs on a given truck. These were juvenile growth trees, less dimensionally stable and lower in natural oil content. Juvenile heartwood (Figure 2) may contain only half the preserving extractives found in the old growth trees (ASHI). For comparative purposes, modern white cedar roofs may experience performance problems in less than four years in some climates.

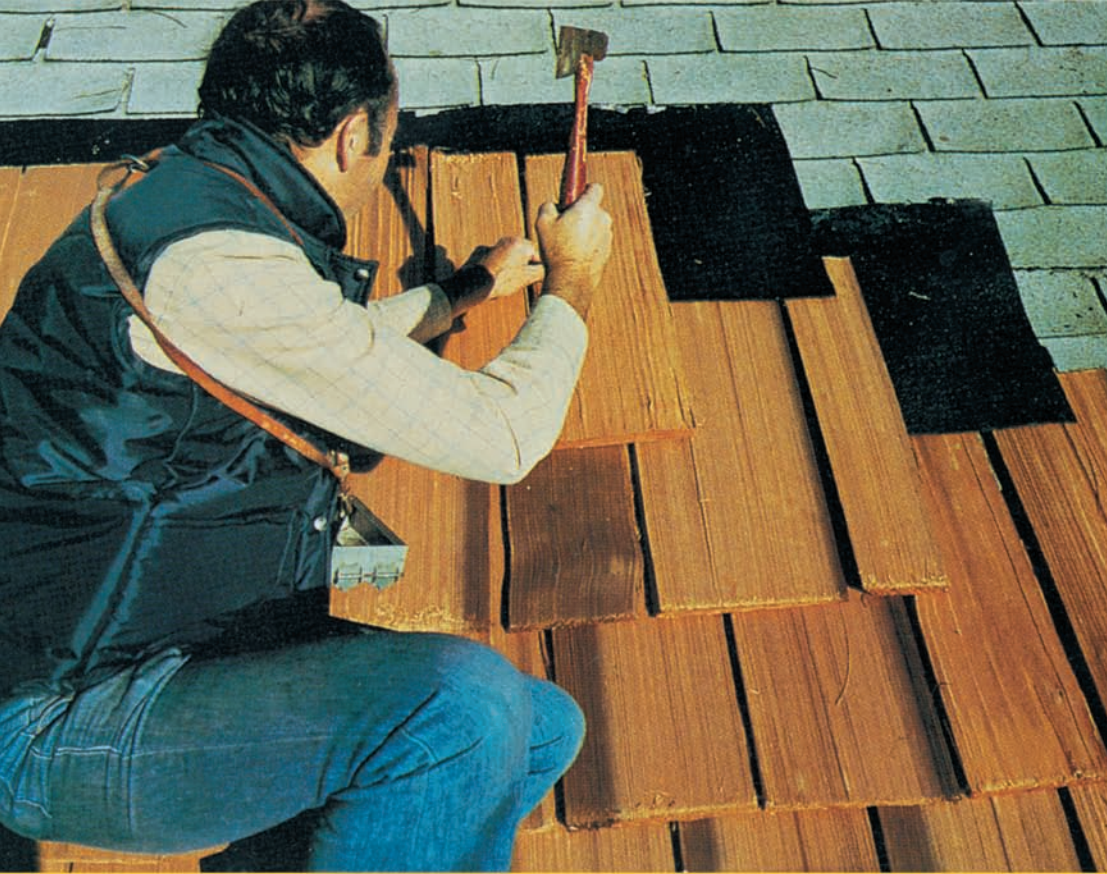
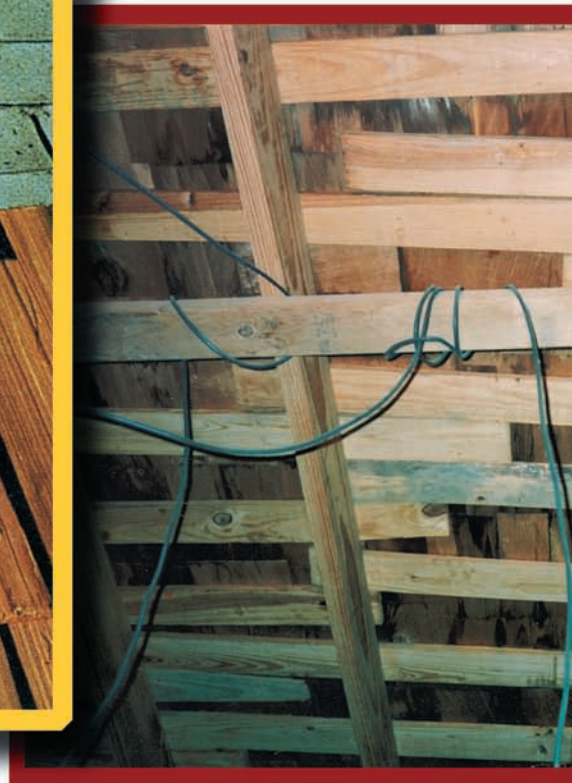
Above: Figure 3 —Over-roofing with shakes may inhibit the underside air circulation so vital for wood roofing products. However, over-roofing can be accomplished in a functional configuration.

Over-roofing with shakes may create a similar ventilation malady. As shown in *Figure 3*, the old shingle roof left in place may inhibit the underside air circulation that is so vital for wood roofing performance. But even over-roofing can be accomplished in a functional configuration. The Cedar Shake and Shingle Bureau (now in Sumas, Washington) offers guidance with a publication entitled *Roofing, Shake-Over-Shake* to assist in construction of this nature.

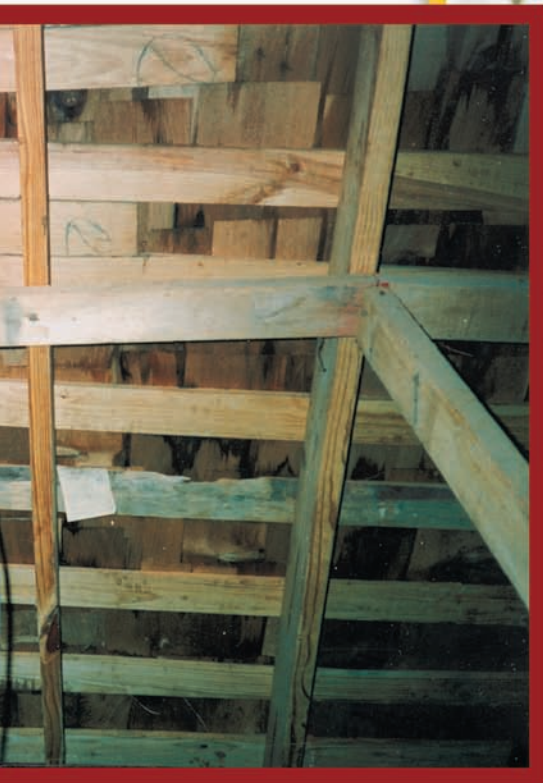
Left: Figure 4—Spaced support sheathing is a preferred arrangement for wood roofing products (although this carpentry is marginal). Observing daylight from below a wood roof covering on spaced strapping does not always signal substandard construction.

Observing daylight from below a wood roof on spaced strapping (skip sheathing) does not always signal substandard construction (*Figure 4*). Indeed, a little rain may periodically blow through, and minor water staining may occasionally be evident. However, chronic leakage will not necessarily result from this condition.

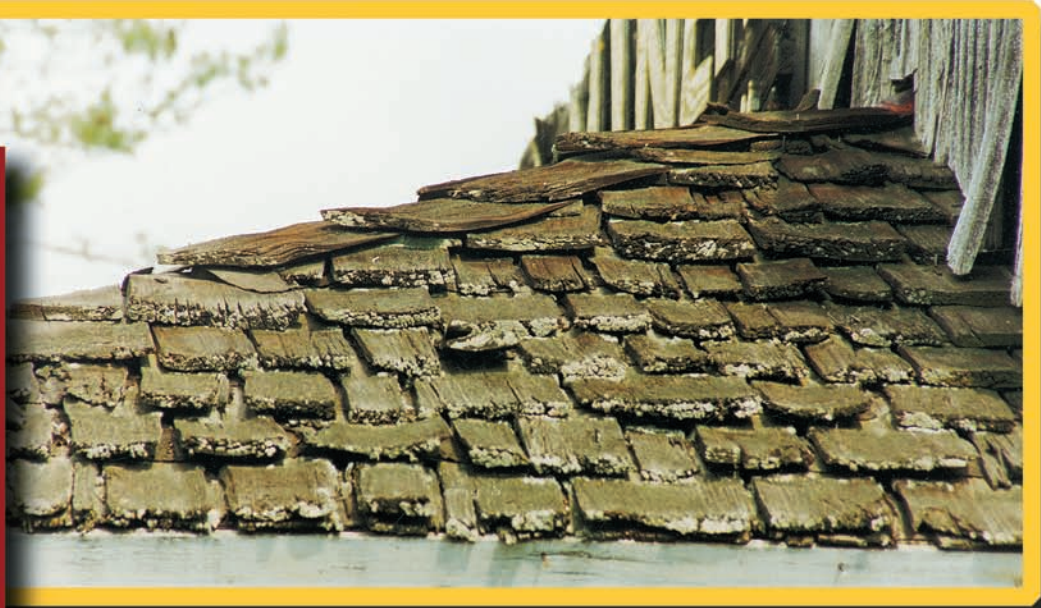
Above: Figure 5 —Cedar shakes and shingles are a natural, organic product and may harbor moisture. Colonies of moss, lichens, fungi, mildew, bacterial spores, algae, or insects drastically shorten the service life expectancy of wood roofs.

Cedar shakes and shingles are a natural, organic product and consequently retain moisture. Prolonged exposure to moisture is prone to foster biological colonies (i.e. moss, lichens, fungi, mildew, bacterial spores, algae, or insects). These colonies can drastically shorten the service life expectancy of wood

roofs (*Figure 5*). Equally important, biological development displeases some consumers because of the diminished sidewalk appeal. Among the wood species used, redwood and red cedar contain a natural fungicide in the cells. This serves quite well in all but the unusually warm and moist environments.

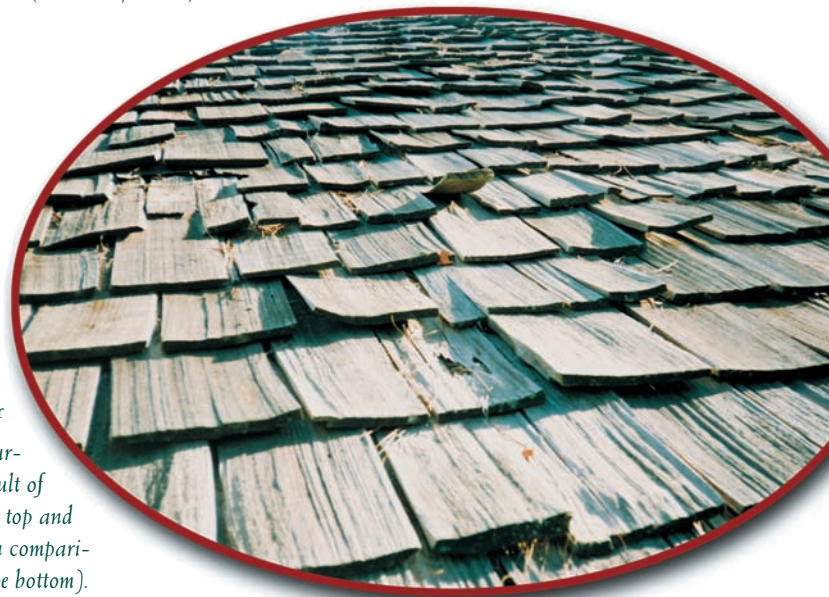
Figure 6—Curling and cupping are common sources of displeasure. The curvature is the result of uneven drying (the top and edges dry rapidly in comparison to the bottom).

Curling and cupping are other sources of displeasure (*Figure 6*). The behavior is an inter-relationship of grain and drying rates (the top and edges dry rapidly in comparison to the bottom, a phenomenon more likely to occur with continuous decks). It is increasingly difficult to obtain "exceptional quality" wood, and some tendency toward cupping probably cannot be avoided (Carlson, 1996).

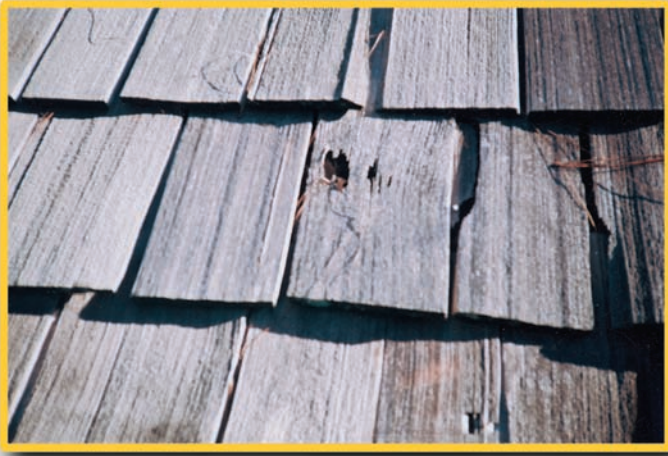
Figure 7—Some installers are unqualified or unwilling to cull unacceptable materials. This shake has a significant knothole and should not have been used.

Many problems encountered by this author are caused by application of substandard materials. Some installers are unqualified or unwilling to cull inferior materials and apply functional wood roofs (Figure 7). This is particularly true in fast-track, developed construction. Interpreting the grain of wood shakes is a worthwhile skill to acquire. Products not made from 100% vertical grained wood generally develop curling and cupping. When quarter-grain, mixed-grain, and flat-grained products become

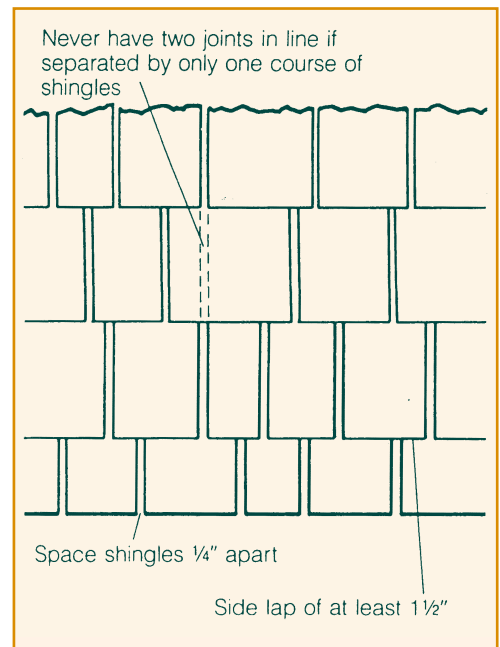
Figure 8—Accepted practice mandates certain offsets among respective courses. Sidelap offset, one course to the next, is to be greater than 1-1/2 inches. Two vertical joints should not align in any three courses. (Reprinted from Modern Roofing Care and Repair.)

Sidelap offset, one course to the next, should be greater than 1-1/2 inches.

Another practice taught is that two vertical joints (Figure 8) should not align in any three courses (Meyers, 1981). According to industry experts, this practice is arguable in terms of its need. Indeed, the importance of such practice in two layers of wood shakes is reasonably different from that of wood shingles applied in three or more layers.

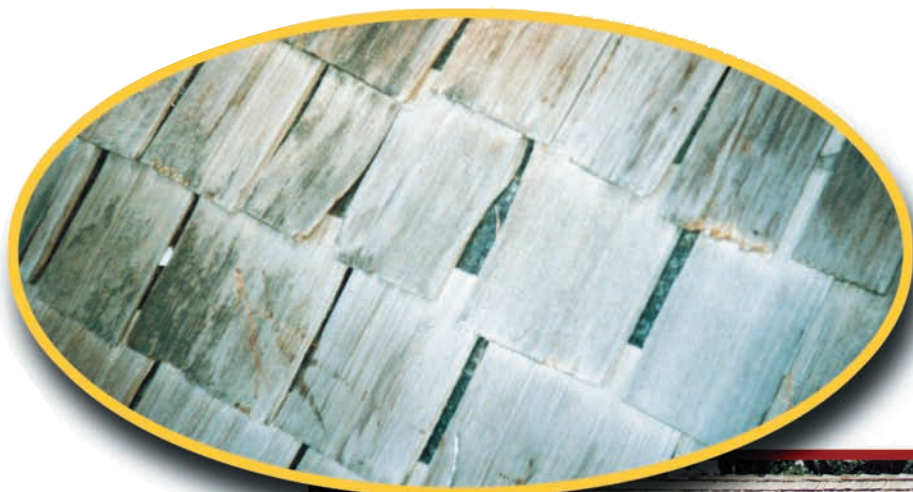
Figure 9—Felt interlayment should never show through in the finished array. "Rot-felting" may attract water upward to higher reaches of the installation. Moreover, the organic felt routinely used will not endure such exposure.

arguable, particularly with wood shingles. The felt is an absorptive material and can harbor moisture against the underside of the wood units. This may lead to performance difficulty as discussed earlier. If used as interlayment for shakes, it should never show through in the finished array (Figure 9). Exposure in this manner is termed "rot-felting," and it may attract water upward to higher parts of the installation. Moreover, the organic felt routinely used will not endure such exposure.

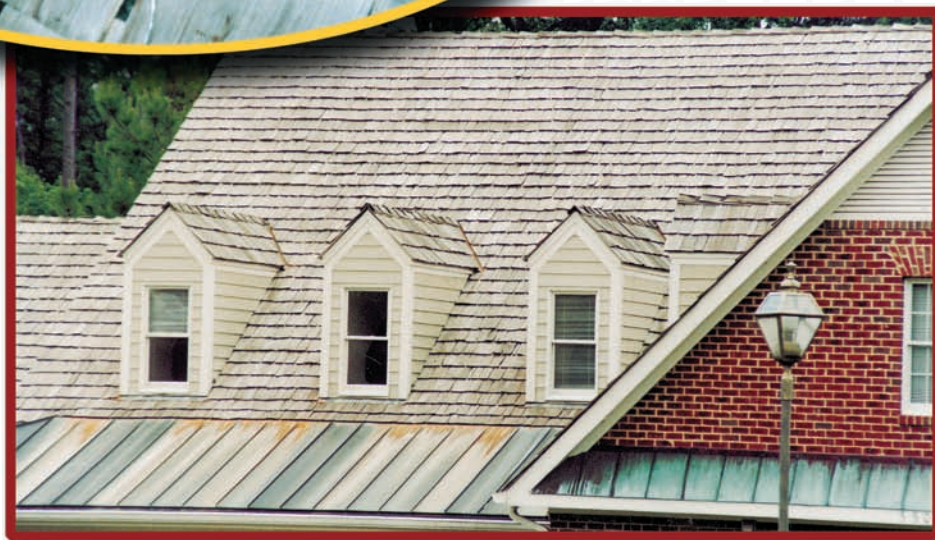
Figure 10—Runoff of certain chemical treatments may influence a copper roof covering. Note variation in patina. The permanency of all chemical treatments should be scrutinized.

Other methods are used to treat installed shakes with chemicals to extend the service life expectancy. These are many and varied and bring about a similar variation in service life improvement. The permanency of any treatment should be scrutinized. Some vendors confidently market preservatives that tout a 30-year warranty against moss and fungal growth. As with most roofing warranties, the language and terms should be carefully reviewed. Figure 10 depicts a recent chemical treatment, draining over a copper roof covering below.
