# Early Leak Detection Capabilities —

## More Timely Than Ever

BY JAMES P. SHEAHAN, RRC, FRCI

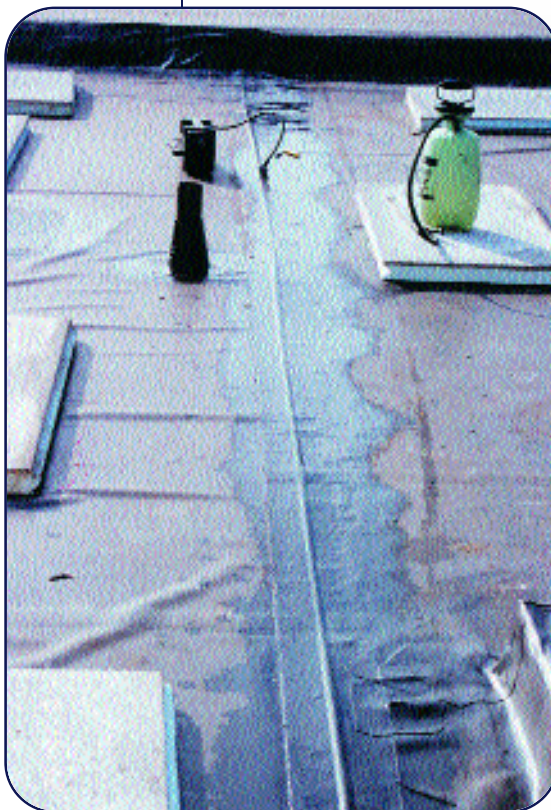
Left: Exhibit 4: View of pressurized seam using portable compressor. Water/soap solution used to locate leaks if present. Uniform profile of pressurized seam denotes correct adhesion area.

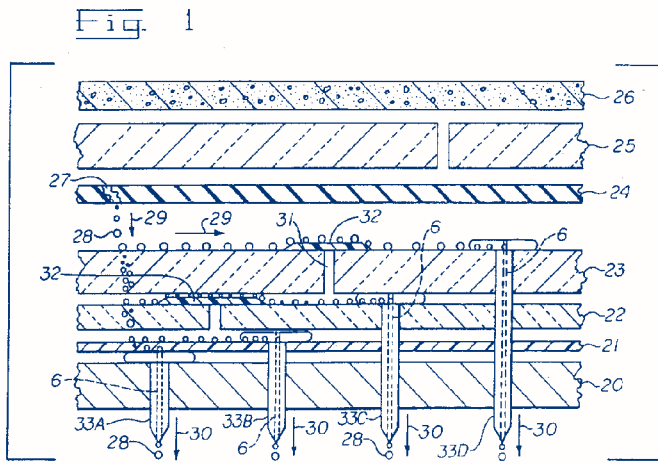
Exhibit 12

This patent describes a leak-localizing methodology using a combination of penetrating devices and barriers. This is based on a multi-barrier system, particularly having a barrier as the lowest component of a roofing assembly such as an air barrier or vapor barrier over a metal deck. Water that enters the system flows through the components to be held at the lower barrier level. Openings in the securement fasteners allow water to pass through and enter the room below, denoting the point of leakage.

Sheahan, J., "Leak Localizing Using a Combination of Penetrating Devices and Barriers," *U.S. Patent 5,212,927*, May 25, 1993.
