WEATHERING OF ARCHITECTURAL METALS -THE ULTIMATE DICHOTOMY

By David L. Hunt

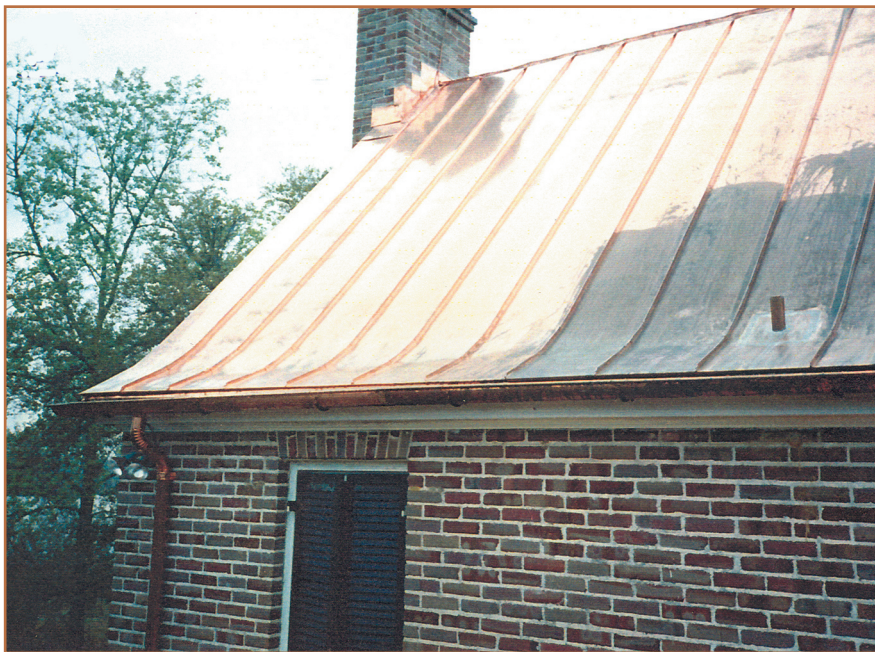
Photo 1: This Maryland residence shows normal but unusual weathering.

The Maryland residence shown in *Photograph 1* is an excellent example of normal but very unusual weathering. By knowing and understanding the factors that can influence early coloration and how long it takes for a mature patina to develop, a roof consultant should have been able to explain what was happening and to persuade the owner and architect to give Mother Nature more time. However, the “experts” who inspected the roof were unable to offer an explanation as to why the roof appeared as it did.

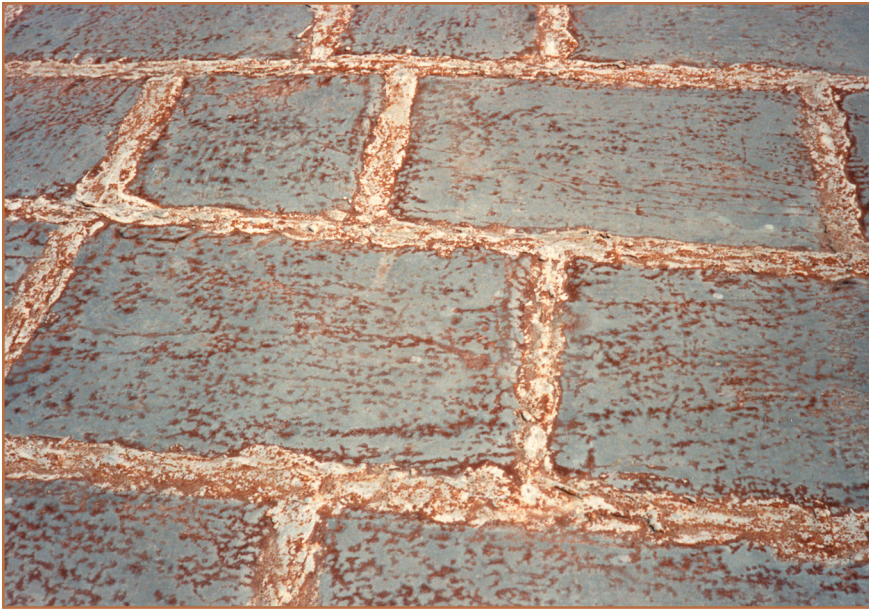
Photo 3: The owner of this roof off the coast of Maine complained that the lead was coming off his lead-coated copper. In actuality, “red lead” patina was forming.

As environmental awareness grew in the latter part of the century, the level of atmospheric sulphur (and other pollutants) was reduced. Early in 1992, Revere was contacted by a New England architect regarding an LCC roof on a residence on an island off the coast of Maine. The owner of the home was complaining that "the lead is coming off the lead-coated copper" (See Photograph 3).

Inspection and tests showed that the lead was not coming off but that a "red lead" patina (Pb_3O_4) was forming. Figures 1 and 2 are pourbaix diagrams developed by an MIT metallurgist retained by the homeowner to provide an explanation as to why the

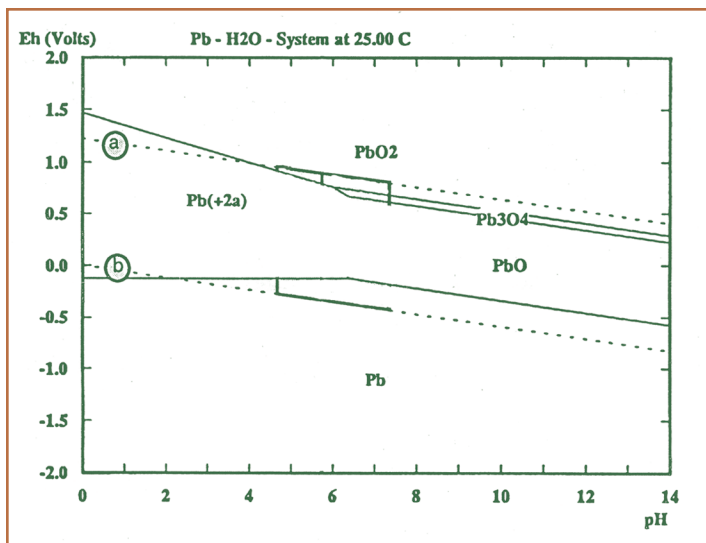
Figure 1

LCC was turning red.

The diagrams show the "products of corrosion" for lead + water and lead + water + sulphur. These are for pure conditions – no other elements. Obviously, this is not the state in nature, but they do show that red lead can develop naturally.

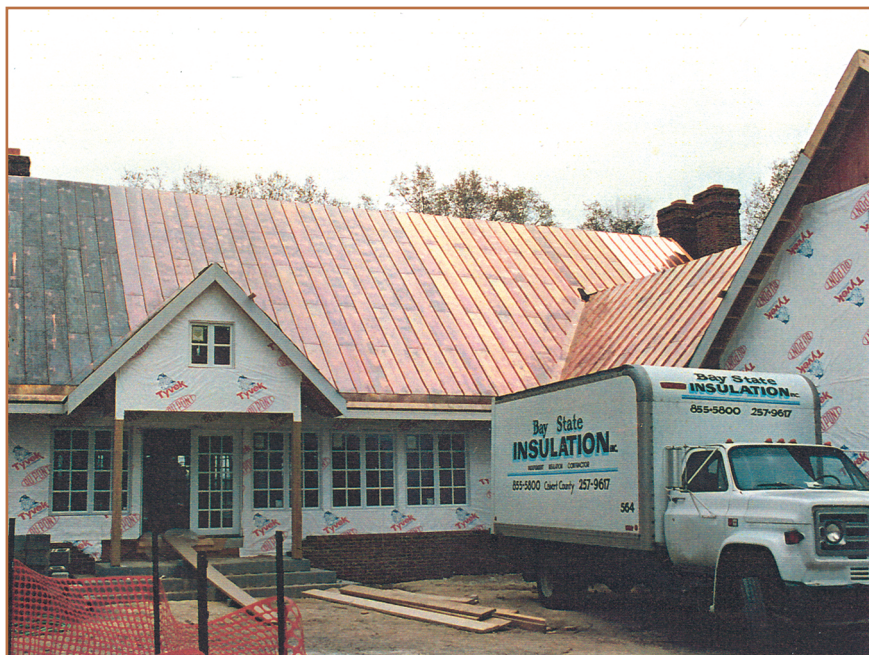
Photo 4: Red lead on a locked and soldered flat-seam, lead-coated copper roof.

Subsequently, red lead was seen on a locked and soldered flat-seam LCC roof of a residence near Myrtle Beach, South Carolina. As shown in Photograph 4, the red is not only on the LCC, but also on the solder.
