Field Performance of Spray Polyurethane Foam Flashings

By René M. Dupuis

In September of 2003, The National Roofing Foundation completed its second field study of Spray Polyurethane Foam (SPF) roofing systems. The study, which began in 2001, examined 188 SPF roofs of various sizes and shapes. The roofs ranged in age from new to 31 years, with an average age of 11.75 years.

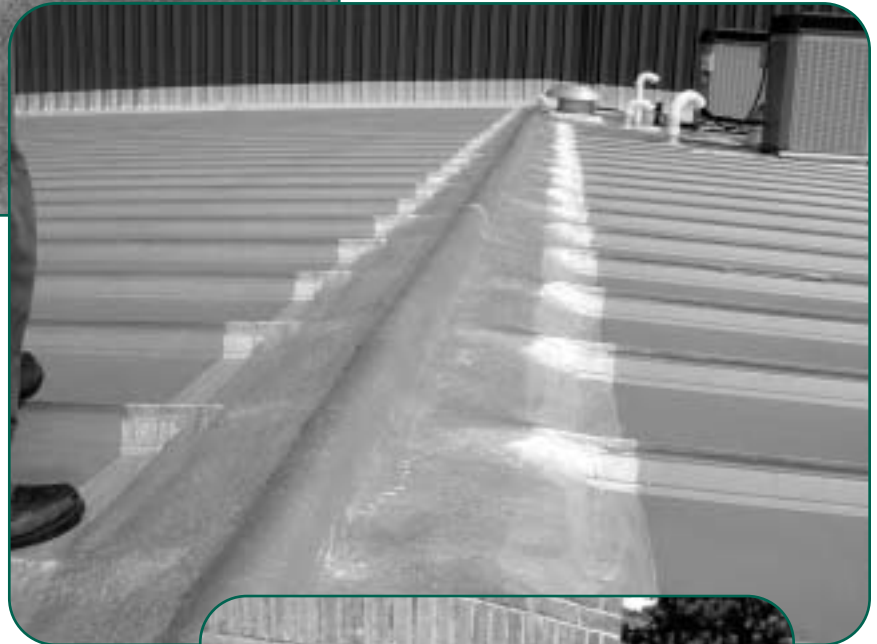
Below: Figure 2 - Metal roof expansion joint.

Figure 2 shows how SPF flashing can be used with a flexible bellows to handle differential and cumulative movement in a large metal roof. Note that the elastomeric bellows has been anchored in SPF and coated. This deck runs along a second-story wall that uses SPF as a transition between roof and wall.

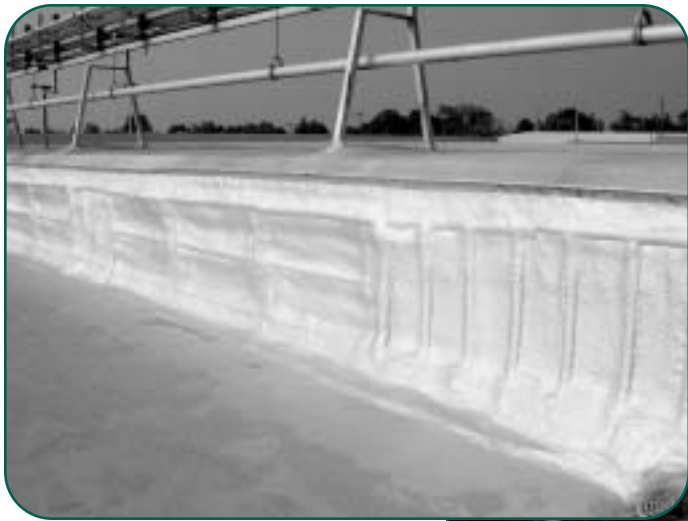
Above: Figure 4 - SPF roof to high roof transition.

A roof-to-roof transition is shown in Figure 4 that details how SPF was used to solve a difficult tie-in for two different roof systems. The existing metal flashing was covered with spray foam and coated. The SPF transition detail also covers a short wall that has metal panels and window units. The SPF tie-in was installed in 1991.

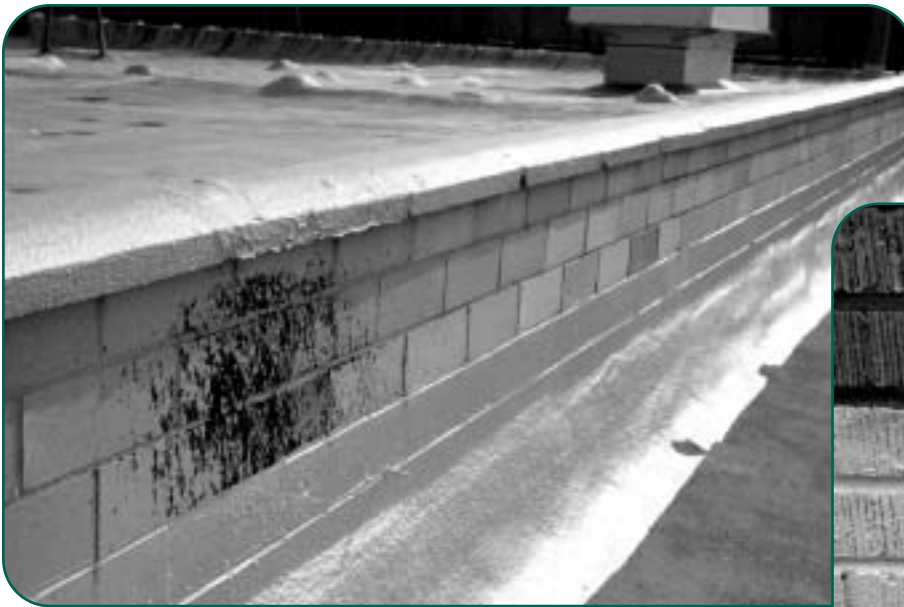
A complete roof and wall transition with SPF is shown in Figure 6. No metal flashing has been used on this 1997 installation. All of the pre-existing metal flashing is now encased in SPF. No new metal was used.

Left: Figure 6 - SPF roof and wall transition.

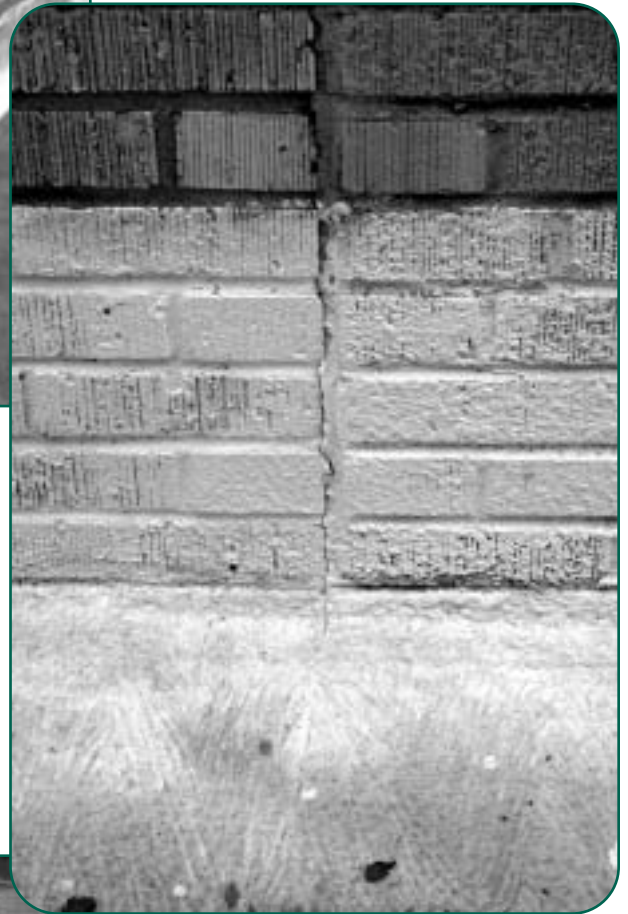
The large lower main roof of this distribution center is broken up by a three-story brick wall. As seen in Figure 7, the expansion joint in the brick wall is active. The SPF re-roof covers all pre-existing metal flashing. The SPF flashing now reaches above the original metal counter flashing. There are no cracks or spalling of the SPF. The coating is functioning as a counterflashing over the SPF at the top of the pre-existing metal.

Below: Figure 7 - SPF wall flashing.

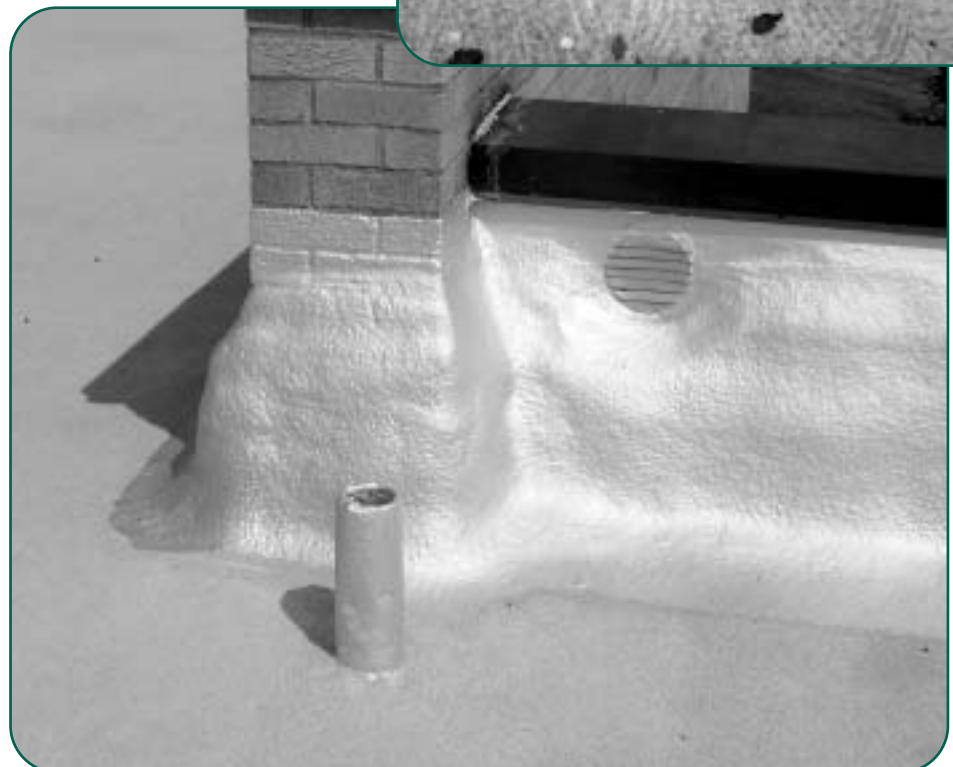
In some instances, walls may be completely covered by the SPF system with no adverse performance. Figure 8 shows a low masonry parapet wall and metal cap system with SPF and coating in a 1998 installation. Wall construction – especially how moisture is handled from the outside brick veneer – must be thoroughly understood before covering with SPF.

Figure 8 - SPF low wall flashing application.

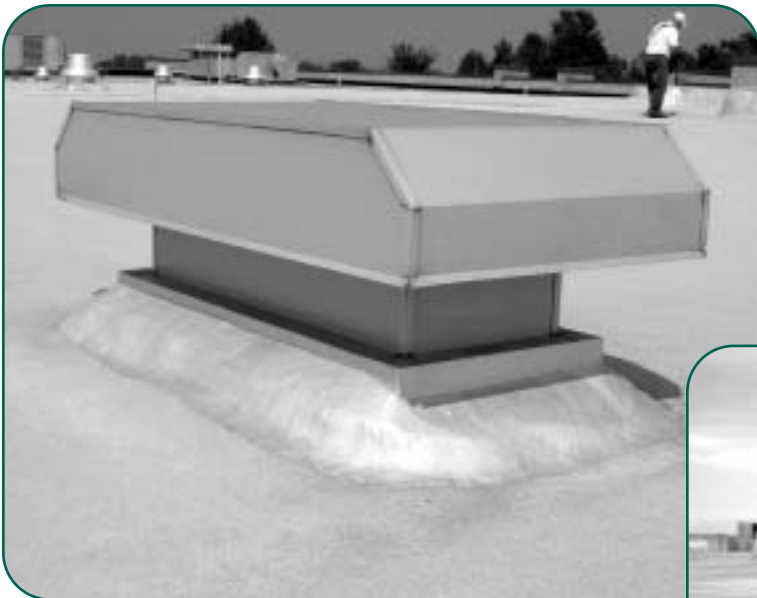
Both low and high equipment support curbs were observed as shown in Figures 9 and 10. The high curb appears to have been extended up with a slightly smaller curb from the original base (Figure 9) and flashed with SPF and coating. Low curbs (Figure 10) were observed to have been treated the same way with no functional difference, using SPF and coating. No metal counterflashing was used, nor does it appear to be needed.

Figure 9 - Equipment support – high curb.

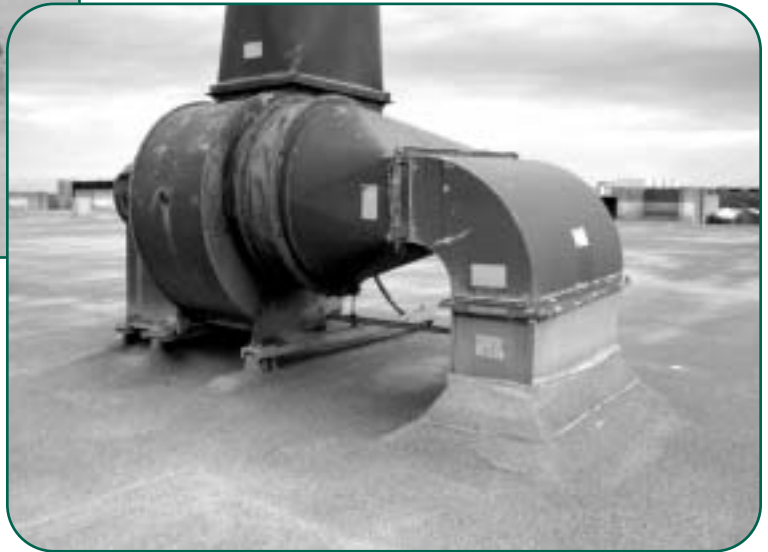
Figure 10 - Equipment support – low curb.

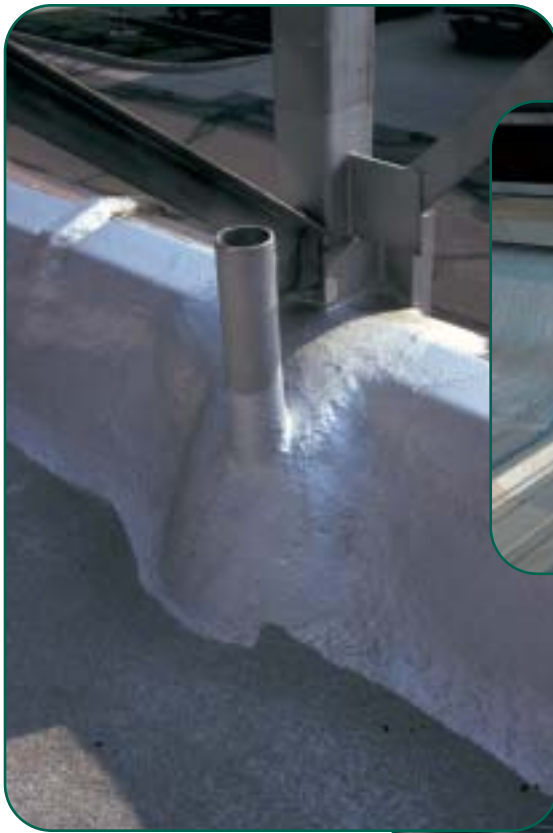
SPF roofs were often found to have no need for pitch pans or for separating support columns that are structurally sound and tied to a wall. *Figure 11* shows a heavy steel support stand that is directly flashed with spray foam and coating into the SPF roof/wall detail. The 1992 flashing installation detail appears to be watertight and serving its intended purpose.

Figure 11 - Equipment support with columns.

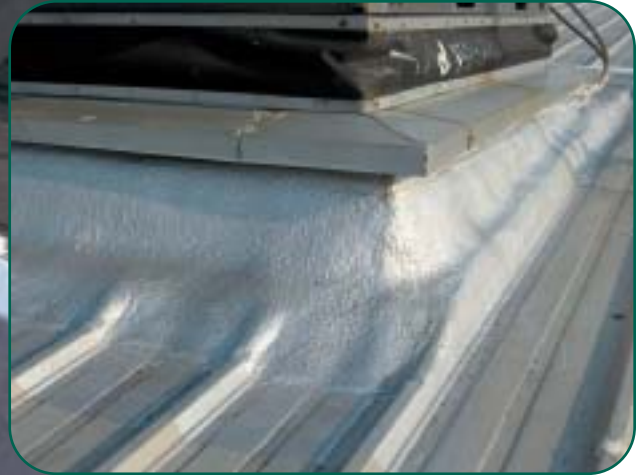
The NRF studies observed numerous flashing details where pre-existing metal flashing had been installed. As shown in *Figures 12* and *13*, SPF can easily adapt to many rooftop details by being overlaid onto the existing prepared substrate. Existing metal flashings may remain and be totally enclosed or left open as the need dictates.

Above: Figure 12 - SPF flashing on a metal roof.

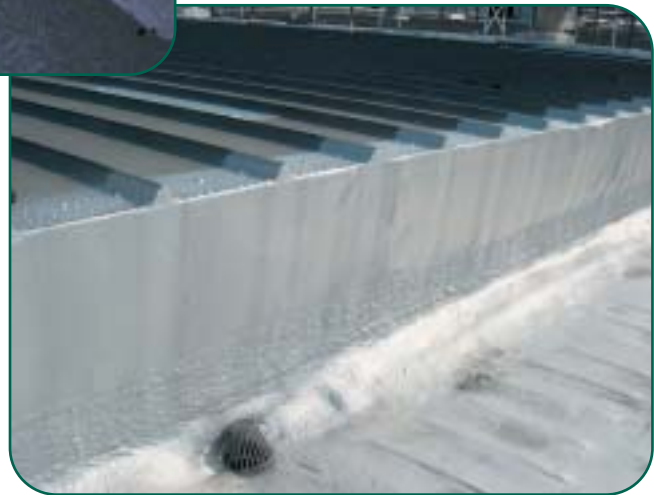
Figure 13 - SPF flashing, roof-to-wall.
