# “Apparent” COLOR VARIATION of Asphalt Shingles

BY RAY CORBIN

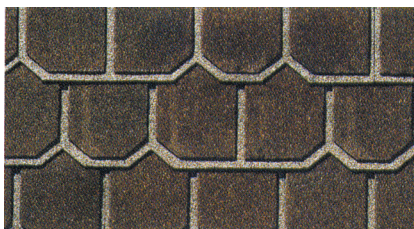
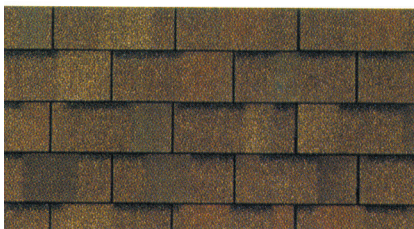
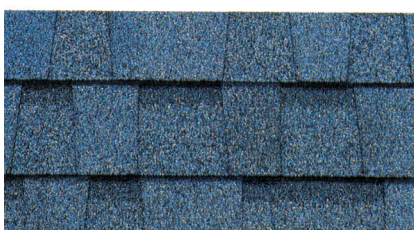
*Figure 1: The Asphalt Roofing Manufacturers Association claims “asphalt color choices are taking roofing to new heights.” Photo, courtesy ARMA.*

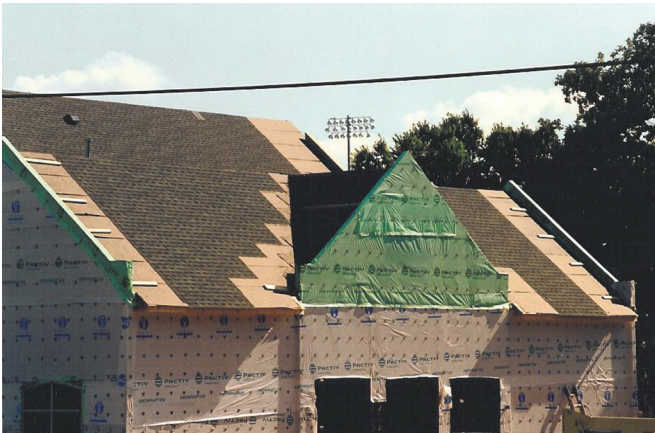
Figure 3 and 4: The photo at left shows racked shingles. The one below shows the correct way to lay shingles.

Racking is when shingles are applied straight up the roof, using a full width shingle in every other course. If there is any tendency

towards “apparent” color variation, the eye will pick up variation between adjacent blocks or rows of shingles that are (incorrectly) applied vertically. The industry recommendation is to apply the shingles across and up, never straight up the roof. Racking also leads to improper fastening, as one out of four nails is typically left out of every other row. This is sometimes referred to as “three-nailing.”
