Lovely Lane United Methodist Church.

By Pauline Harris

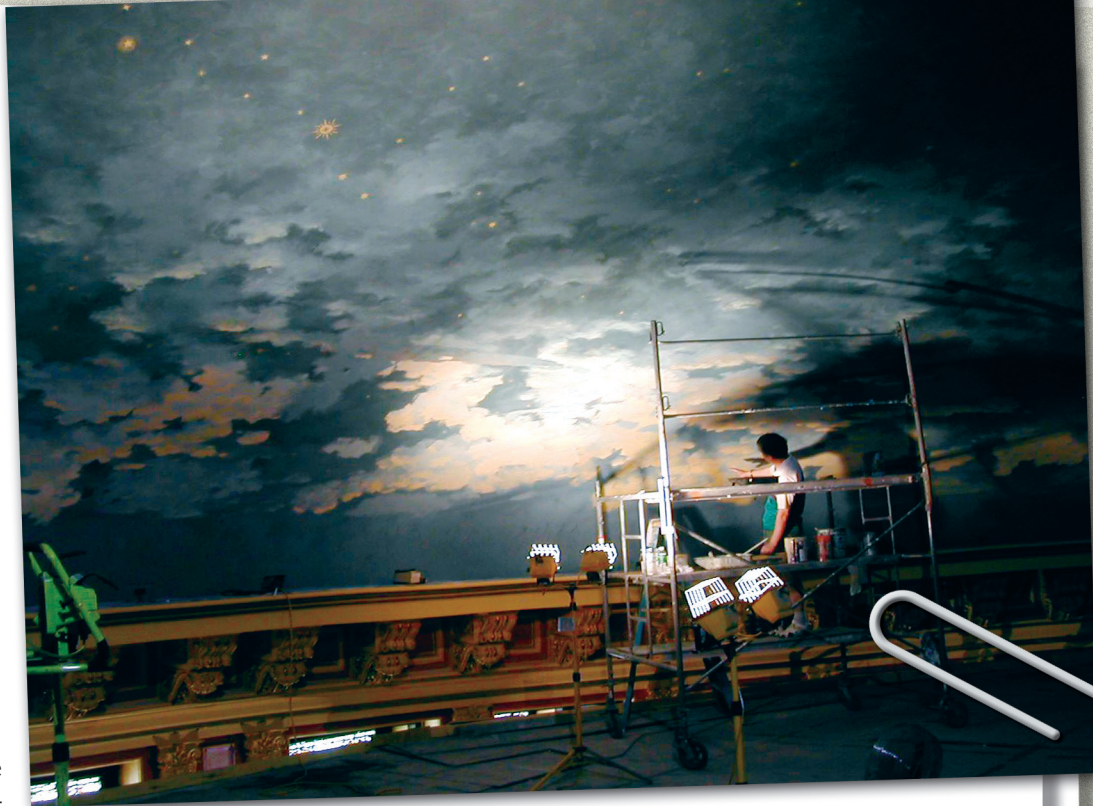
The stars were mapped onto the floor using a laser so their placement could be accurately recorded. They were then remapped onto the ceiling and painted.

Originally painted in 1887, the mural was redone in 1900, and then covered by a painted canvas in 1930. The restoration involved removing the canvas and using the remains of the mural and historic photographs to carefully replicate the original version. Much of the original content was discovered upon removal of the canvas, but the painting had been severely damaged. Remnants of the painting were analyzed by an historic paint specialist to ensure that the colors would match the original masterpiece. The stars were mapped onto the floor using a laser so that their placement could be accurately recorded before the surface was covered in primer. The stars were then re-mapped onto the ceiling again, utilizing laser technology.

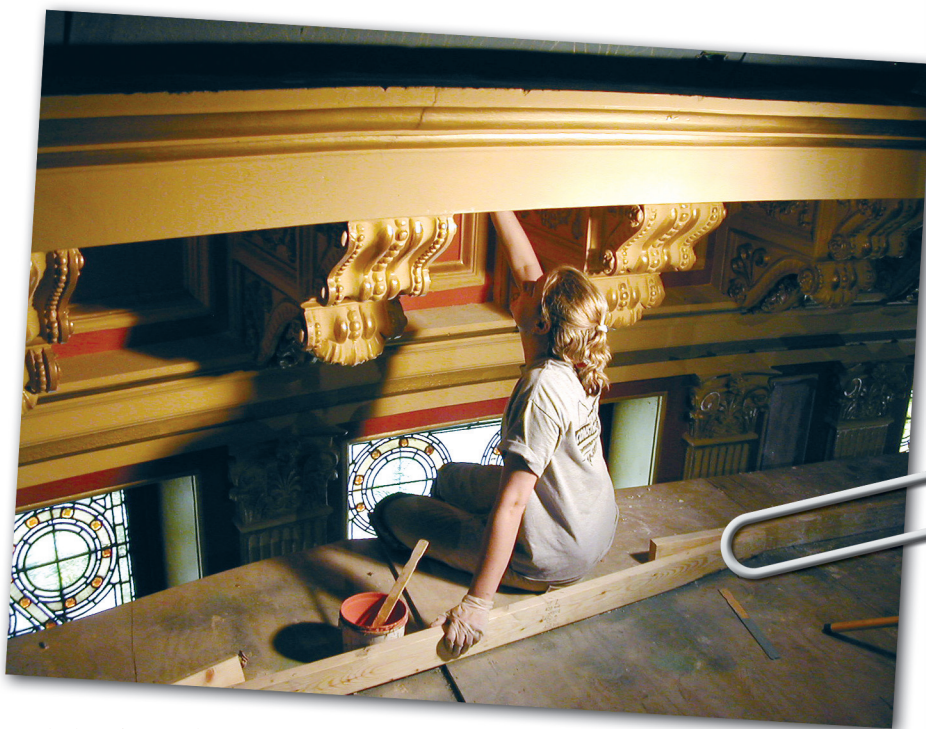
Painting the cornice.

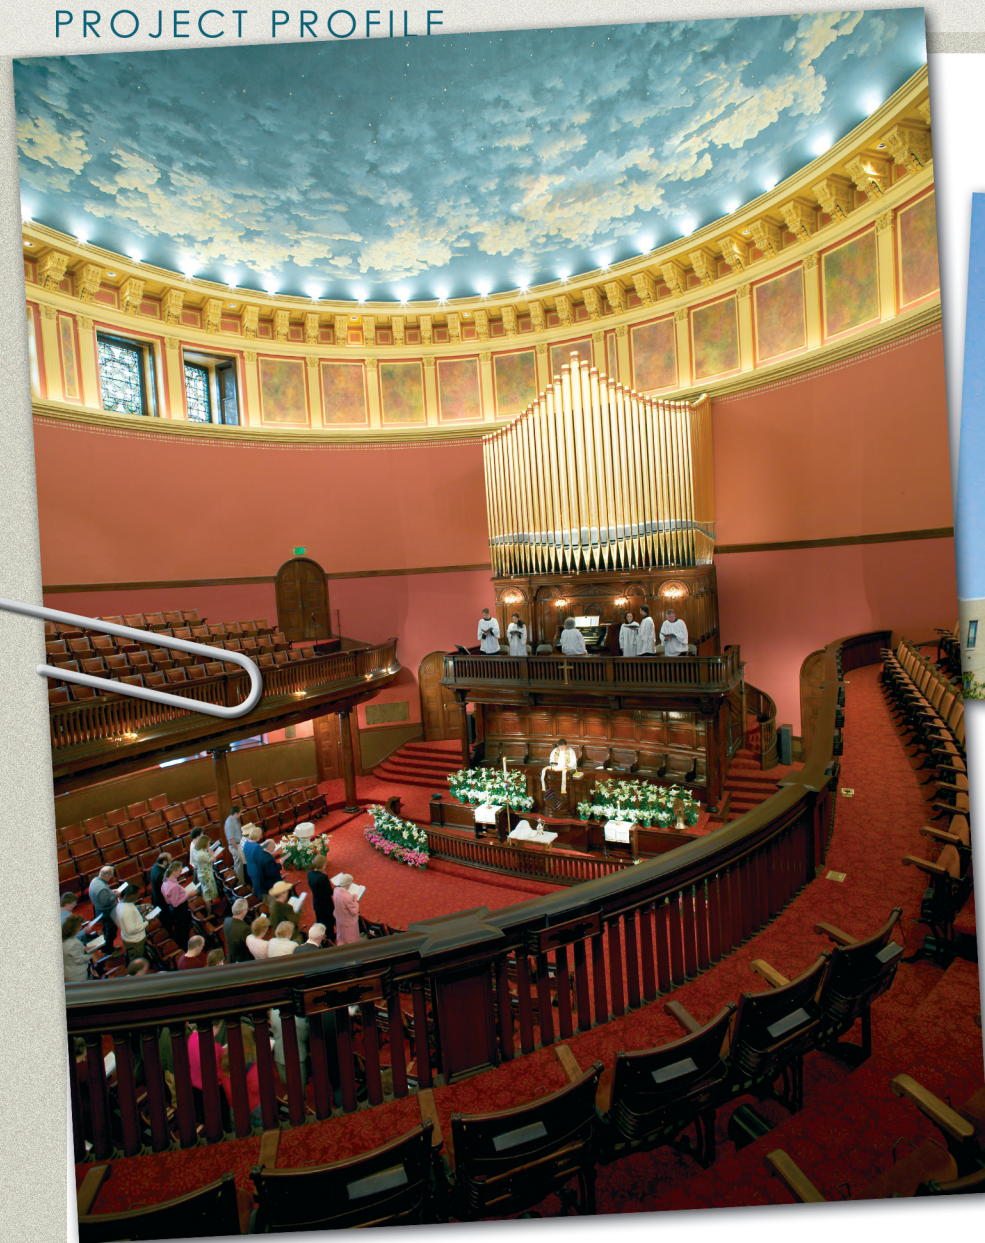
From the balcony, the overall effect can be appreciated.

Inside, everything harks back to the 1880s design. Nothing has been drastically altered. The crowning achievement of this program, a \$1.2 million restoration of the main sanctuary, was completed earlier this year.

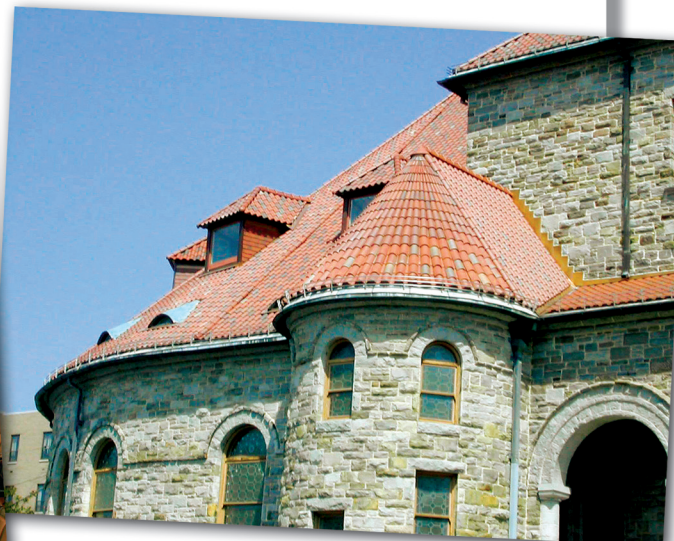
Below: The roof turrets were retiled in Spanish S tile by Ludowici.

Due to the building's curves, the original roof design used ribs to segment the curves, cutting S tiles to create a seam.

Instead of using tapered tiles, six ribs were cut in each curve, creating five different segments of the roof. Standard Spanish S tile by Ludowici were used for the majority of the restoration, excluding the roof over the circular stair on the south side of the

building. Due to its cone shape, towered tile was used for that section of the roof.
