# Asphalt BUR Survives a Tornado in North Carolina

By Reed Hitchcock

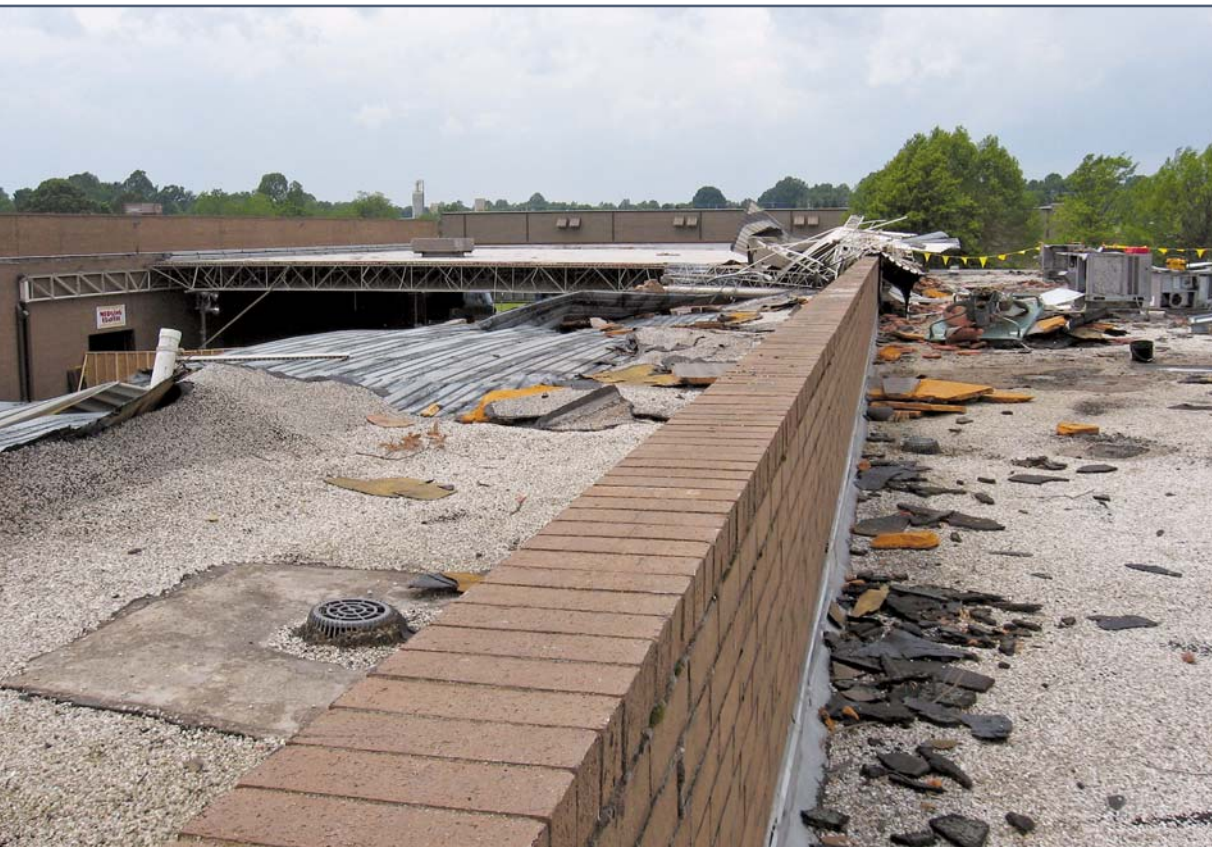
Figure 1 – The warehouse area to the side of the truck bay. Note that the BUR stays intact on the deck even as the deck is bent up by the force of the wind.

the structure remained intact, the roof system remained as well. According to Terry Glidewell, owner of Greensboro Roofing Company, Inc., the asphalt built-up roof was installed on the building over a quarter of a century ago by his company. The iso was strip-mopped to the metal deck, and a 4-ply built-up roof was then installed. Glidewell shared the accompanying pictures with Robert Almon, chairman of the Quality Asphalt Roofing Council.

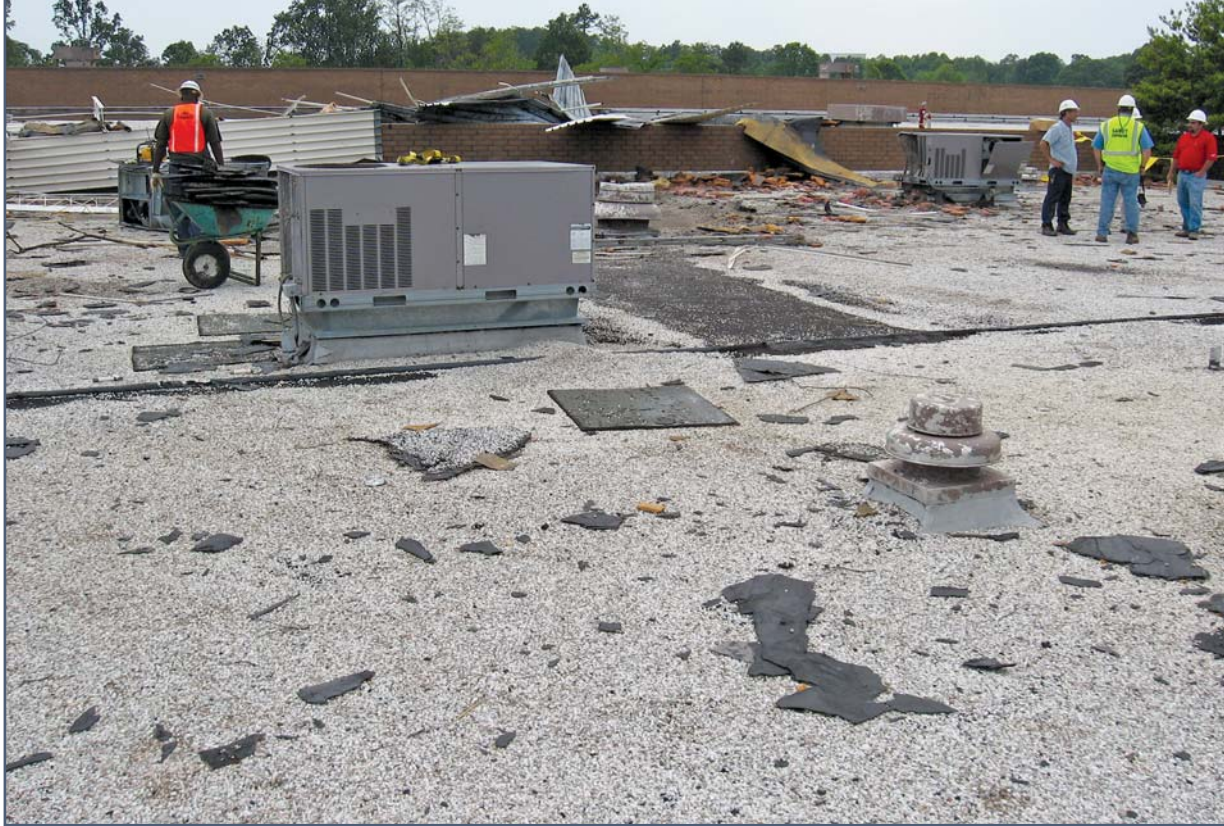
Figure 2 – The roof area on the other side of the short parapet wall from the truck bay. All debris is from the truck bay roof. The roof and gravel on this area stayed intact.

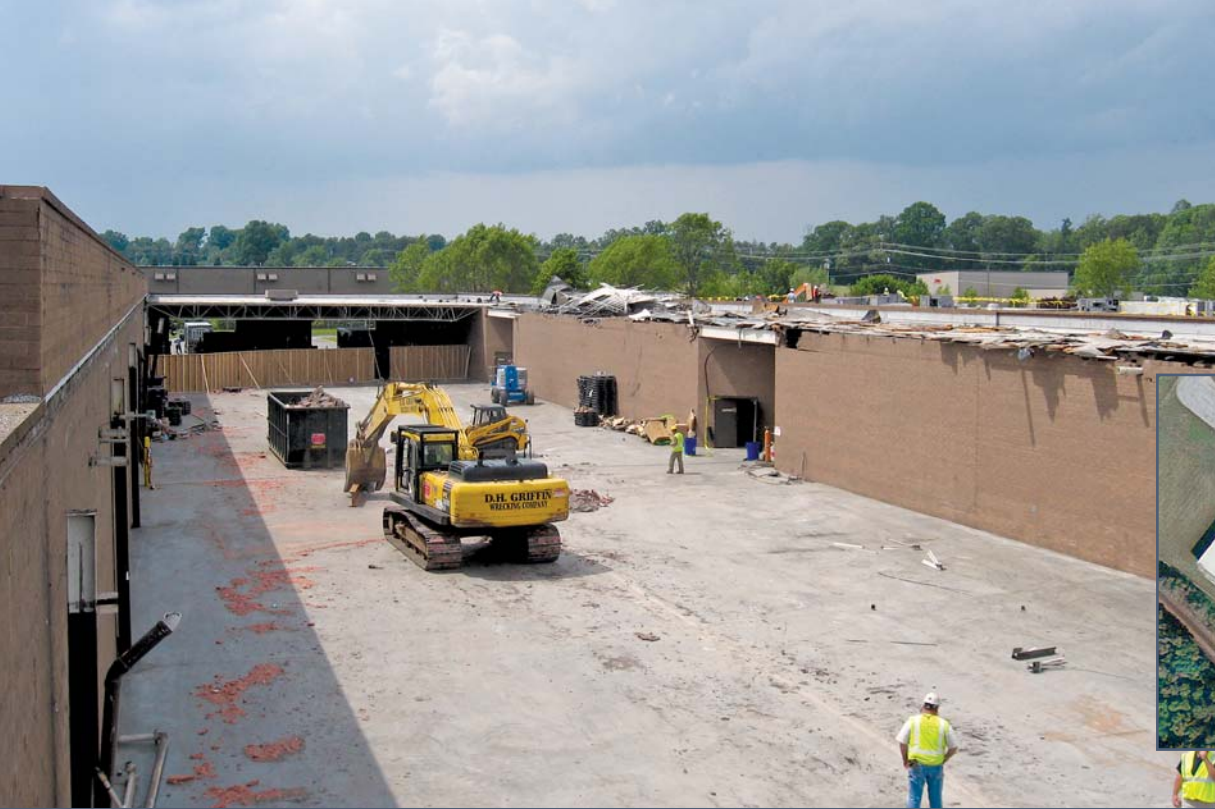
Figure 3 – The entire roof structure over the truck bay, except for the last few feet, was destroyed. Just a few feet from where the structure was ripped away, the 26-year-old BUR remained intact.

The entire roof structure over the truck bay, except for the last few feet, was destroyed. Amazingly, however, the 26-year-old BUR just a few feet from where the structure was ripped away remained intact on its deck. Where

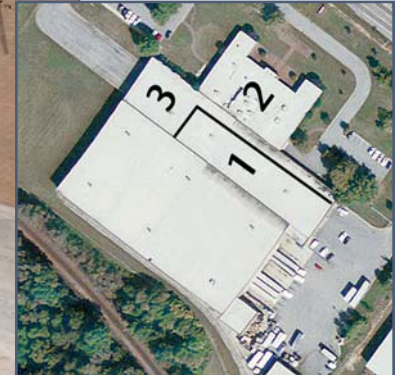
Figure 4 – Aerial view of the building identifies location of the roof areas shown in Figures 1, 2, and 3. The truck bay in figure 3 is numbered as 1; the area shown in Figures 1 and 2 is labeled 2; the number 3 is the area at the end of the truck bay that was not blown off. Satellite photograph courtesy of i-cubed ([www.i3.com](http://www.i3.com)).
