# NEW ROOFING SYSTEM HELPS PRESERVE HISTORIC NEW MEXICO BUILDING

BY CARTER SLUSHER

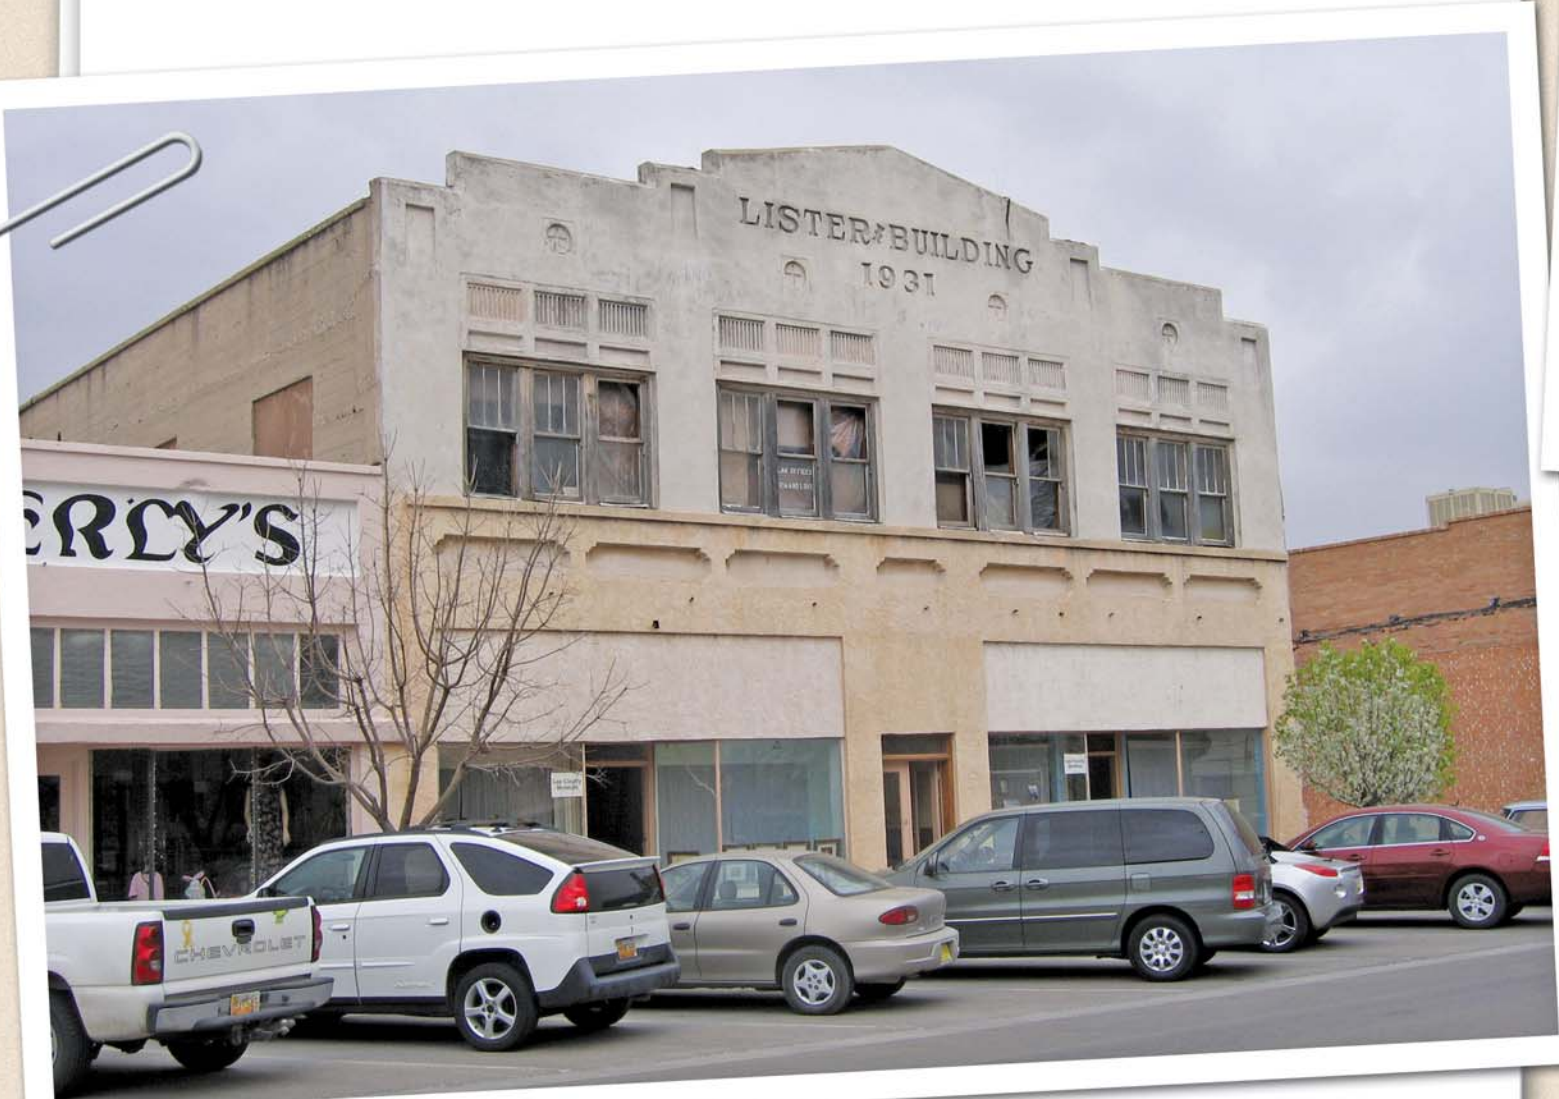
*Built in 1931, the Lister Building in Lovington, NM, features a decorative façade that includes parapet walls ranging from 3 to 7 ft high.*

Constructed with a unique slip-form concrete method of the early 20th century, the building's exterior features a decorative façade that includes parapet walls ranging from 3 ft high along the back and sides to more than 7 ft in the front.

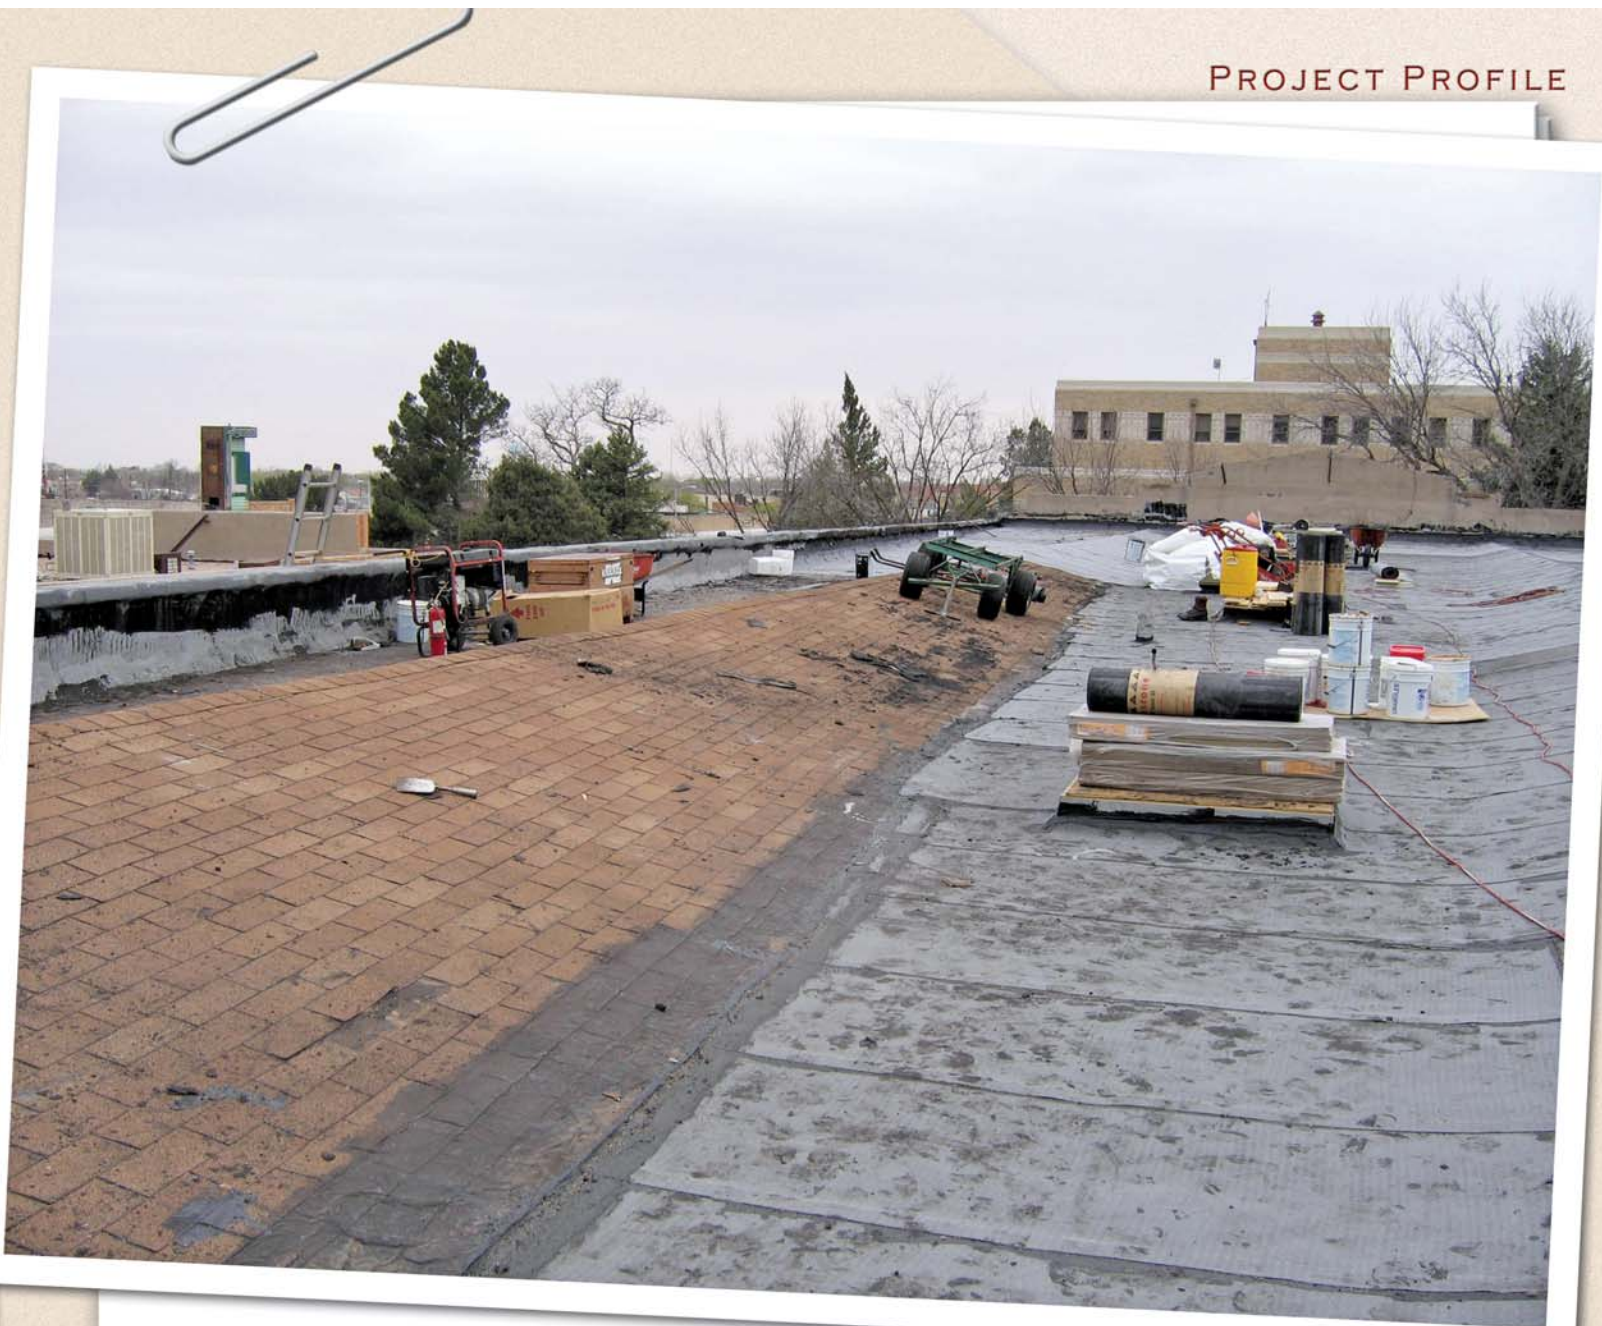
*Among the challenges of reroofing the Lister Building was improving drainage around two unusual and inefficient rooftop saddles. One saddle, shown on left, was covered in shingles.*

Additionally, two peaked, triangular-shaped saddles had been constructed on the rooftop to help move water toward scuppers. Both 130-ft-long structures, which were covered with shingles, are about 10 ft wide at the building's rear and narrow to a

point at the front. Combined, they represent about 30% of the roof surface.

To avoid potential slippage of the membrane on the two peaked roofs at the center of the building, Construction Services saddled an entire roll of SBS modified bitumen over each ridge to ensure both sides had the same amount of material. Since the rooftop can be seen from a nearby building, this procedure ensured no sheet ended at either ridge, making it a more visually appealing roof surface. Honea added,

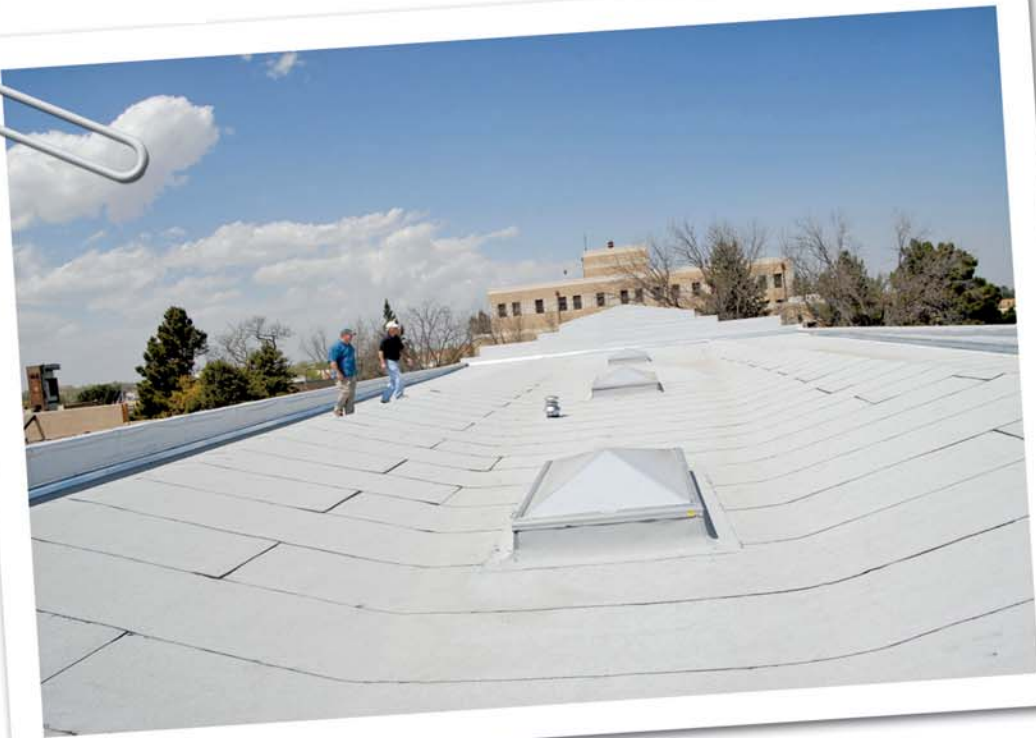
*A cold-applied SBS modified bitumen roofing system was specified to replace an aged, badly damaged, and leaking built-up roofing system on the historic Lister Building.*

Amarillo, Texas-based Construction Services, a Tecta America Company, handled all aspects of the complete tear-off and roof replacement project. After removing the existing system down to the wood deck, Construction Services nailed a Firestone MB base sheet over the deck to establish a good installation surface.

Next, a layer of 2.5-in Firestone ISO 95+™ polyiso was mechanically fastened to the deck. Where needed, tapered insulation was used to add slope and ensure positive drainage. Using multipurpose cold adhesive, Construction Services then adhered a half-inch-thick, high-density polyiso coverboard to the insulation, followed by a Firestone SBS modified bitumen base sheet and a white, granule-surfaced Firestone SBS FR cap sheet.
