“COOL” ROOFS CAUSE CONDENSATION

— Fact or Fiction? —

By Phil Dregger, RRC, FRCI, PE

This article is reprinted, with permission, from the January/February 2012 issue of Western Roofing.

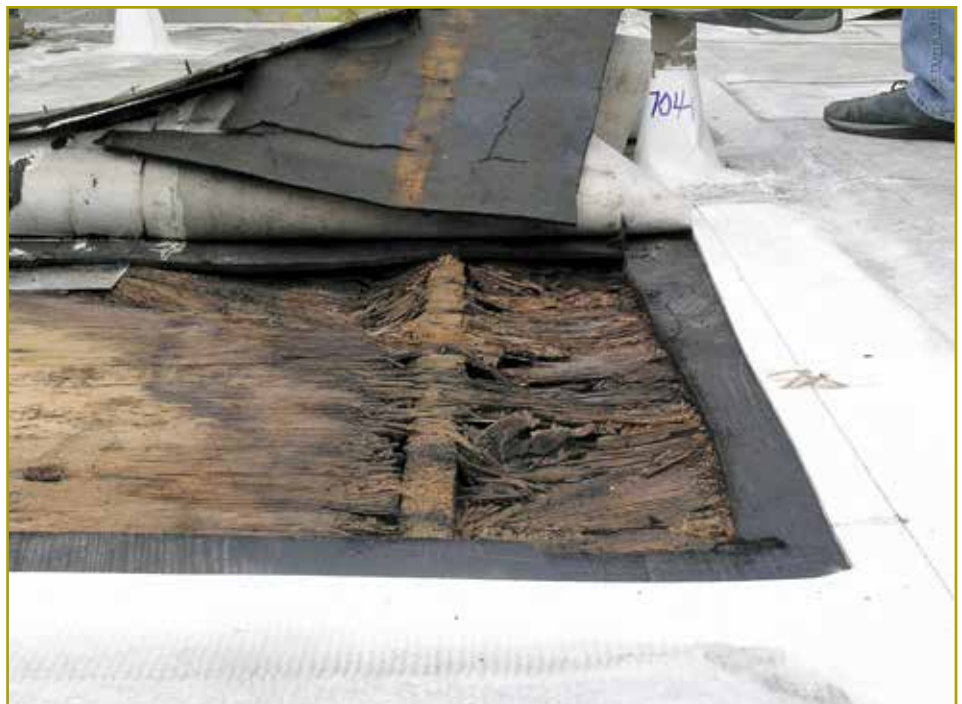
Figure 1 – Severely deteriorated plywood a few years after replacing an old cap-sheet BUR with a white single-ply roof.

Figure 1 shows severely deteriorated plywood discovered a few years after replacing an old cap-sheet built-up roof (BUR) with a white single-ply roof in the San Francisco Bay Area. Workers sent to inves-

tigate reports of the roof dripping found no obvious openings for roof leaks but found many so-called “soft spots.” Before the white single-ply roof was installed, the old BUR had been in place for many years without similar reports of dripping or soft spots. Changing from a noncool roof to a highly reflective cool roof is believed to have at least contributed to these problems.

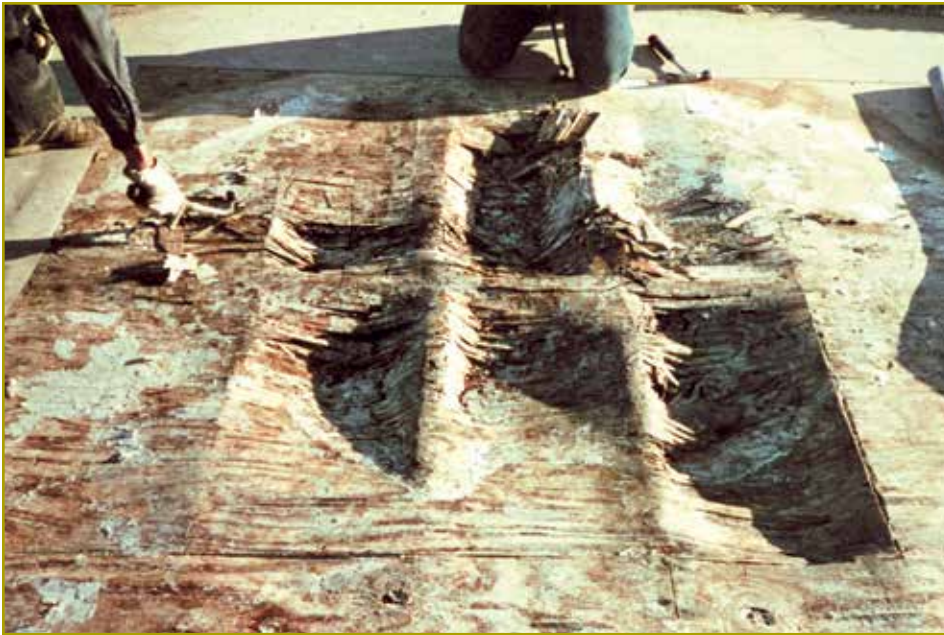
Figure 2 – Severe deterioration caused by water vapor migrating up through the ceiling of a laundry room.

Figure 2 shows severe deterioration caused by water vapor migrating up through the ceiling of a laundry room (with insulated rafter spaces) and condensing on the cold underside of the roof membrane and plywood roof deck. Eventually, the plywood got wet enough, warm enough, and for long enough to support the growth of wood decay fungi.

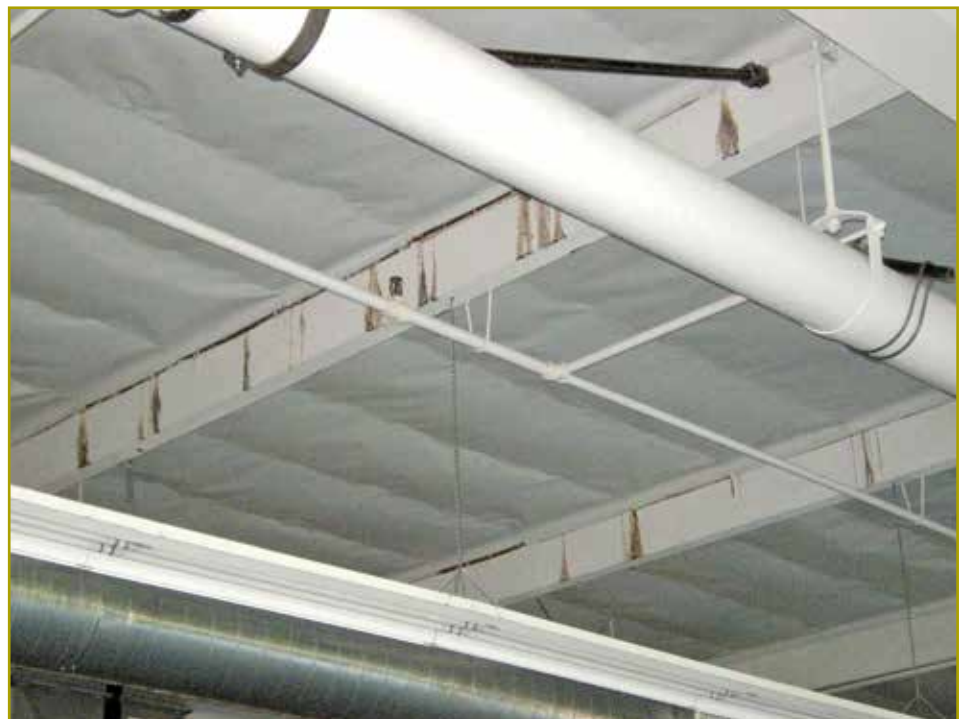
Figure 3 – Stains on the sides of beams in an office/warehouse building in California.

Severe conditions can develop—even in mild climates. Figure 3 shows stains on the sides of beams in an office/warehouse building in California. The owner reported that the BUR was quite old, but it had been

recently overlaid with a highly reflective, reinforced elastomeric coating system. And although he remembers previously getting occasional reports of drips in the spring, the owner was sure he never got the kinds of reports he was getting now of widespread water dripping and even of water-soaked insulation falling to the floor (Figure 4). He mentioned, however, he still was not getting any reports of leaks during rains.

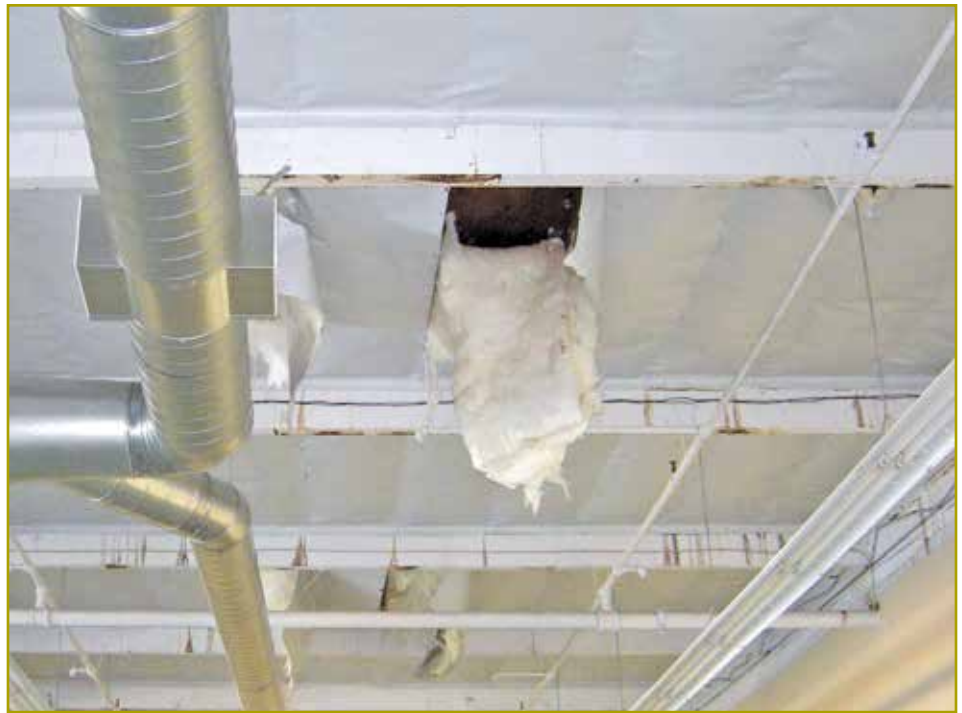
Figure 4 – Water-soaked insulation.

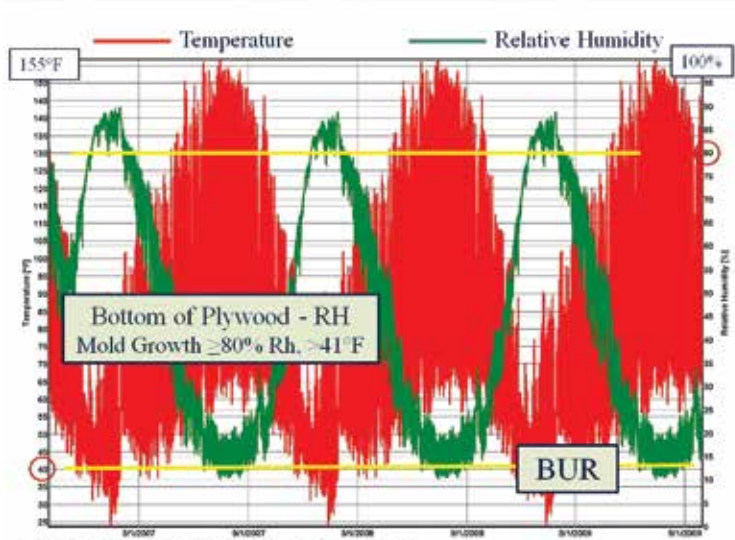
Figure 5 - WUFI-predicted fluctuations in temperature and RH near the bottom surface of the plywood roof deck with the original BUR. The yellow lines represent 80% RH and 41°F temperature.

Figure 5 indicates WUFI-predicted fluctuations in temperature and relative humidity (a measure of the water present) near the bottom surface of the plywood roof

The WUFI graphs indicate that, after installation of the reflective overlay, the plywood did not get as hot (e.g., maximums near 115°F rather than 155°F), accumulated more water (higher RH), and held it longer than it had previously.

ANSI/ASHRAE Standard 160-2009, *Criteria for Moisture-Control Design Analysis in Buildings*, recommends specific performance criteria to “minimize the undesirable effects of moisture in a building or building envelope.” Among other things, the standard recommends roof and wall systems be designed to limit how high the RH of materials like wood gets and for how long. One criterion is that the “30-day running average surface RH <80% when the 30-day running average surface temperature is between 41°F and 104°F.” Again, the yellow lines in *Figures 5* and *6* represent 80% RH and 41°F temperature.

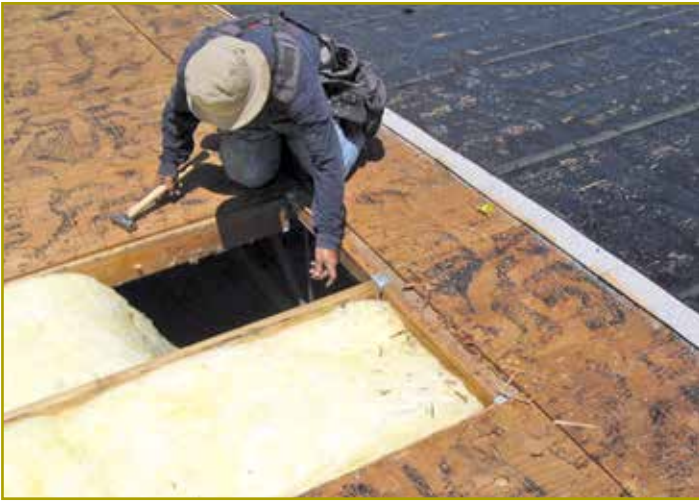
Figure 7 – Roof construction along truss purlins.

Figures 7 and *8* show roof construction along truss purlins where modest gaps in the foil-faced batt insulation allowed interior air to enter, condense, and accumulate on the wood deck during cold weather. In the spring, with higher temperatures and plenty of water to work with, very high vapor pressures were created at wood deck level, forcing water vapor downward where it condensed on nearby metal surfaces and dripped out.
