How Modified Asphalt Tackles Extreme Weather Challenges

By Traci Shaw and Greg Malarkey

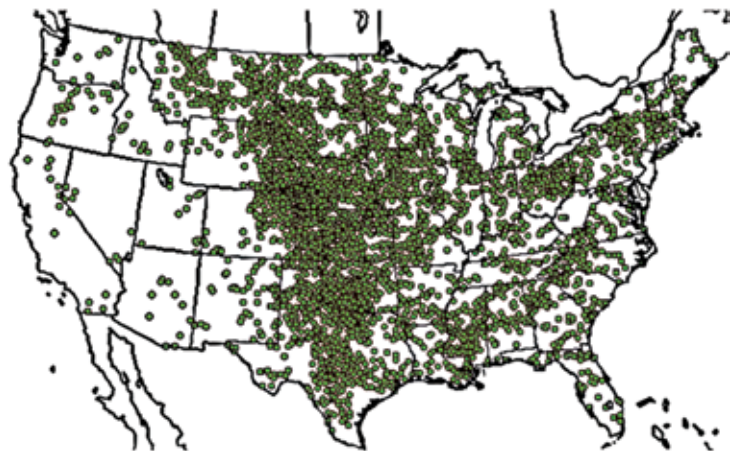
Figure 1 – National Weather Service preliminary severe weather report of large hail events in 2013.

Of the challenges a roof faces, hail is, in many ways, the most devastating. Storms bring in cold rains that thermally shock the roof; then, in this heightened state of stress, hail slams into the shingles. Each year, the National Weather Service's (NWS's) Annual Severe Weather Report records locations of hail with a diameter of one inch or greater. Preliminary reports from the NWS show 7,065 instances of large hail throughout the United States in 2013 (*Figure 1*), with preliminary reports for 2014 showing a similar story.¹ It is no surprise that property damage due to hail reaches an estimated \$1.25 billion annually.² The stress imparted by hail can devastate roof coverings. For asphalt shingles, there are three primary modes of failure: fracturing of the shingle, bruising of asphalt, and removal of surface granules.

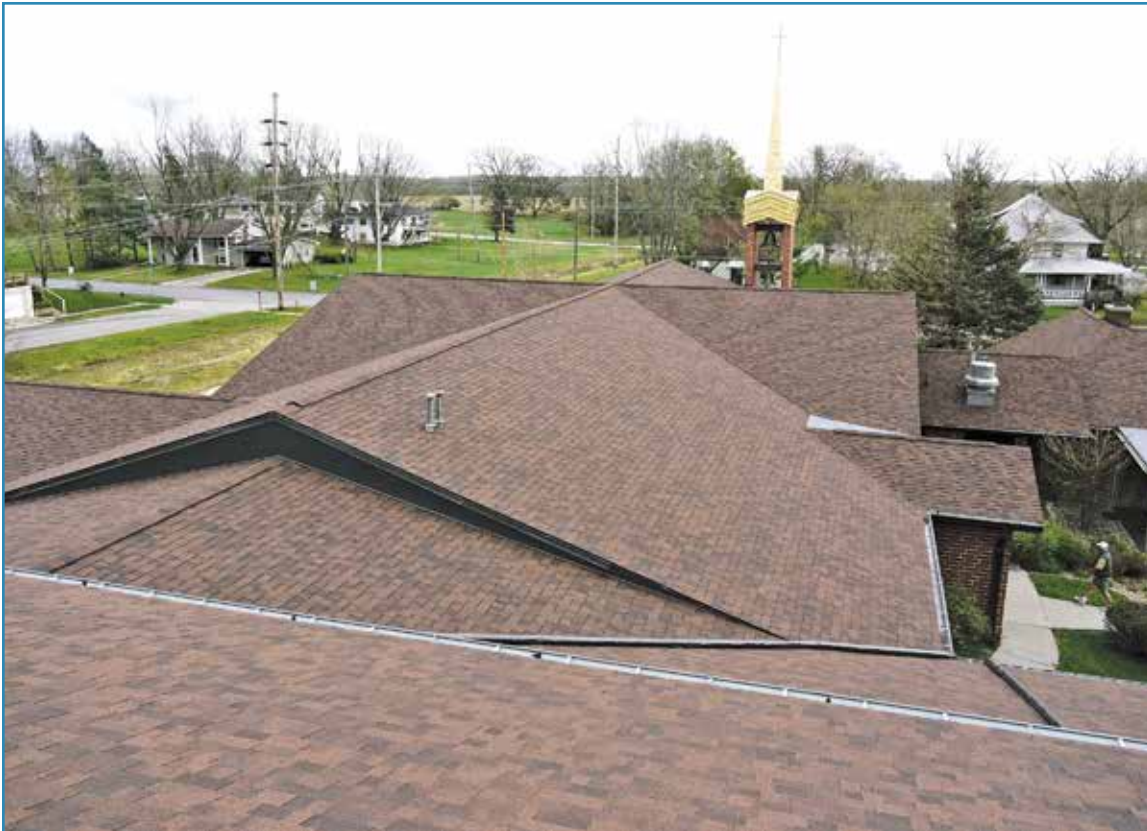
Photo 1 – A roof with Legacy® SBS polymer-modified shingles after a hailstorm in El Dora, Iowa, in August of 2008. The only shingle damage was to the ridge vents, due to the unsupported ridge area.

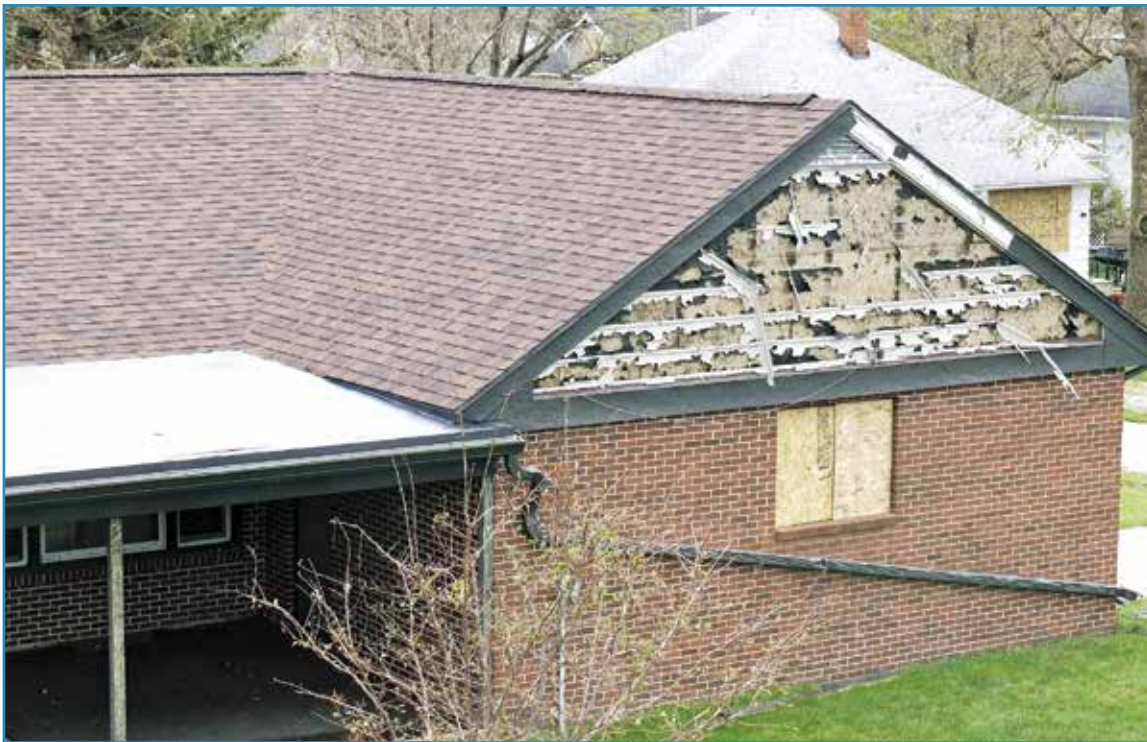
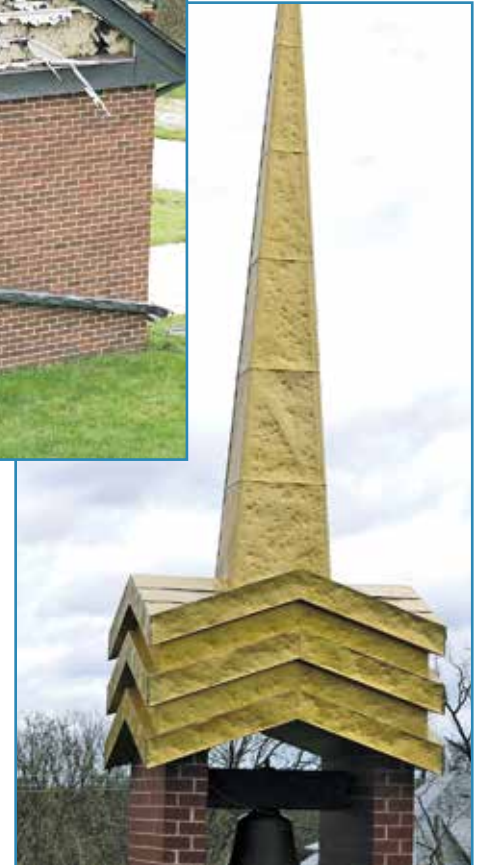
Photos 2 and 3 – Alternate views show destruction of siding and a bronze steeple on the same building during the same hail event.

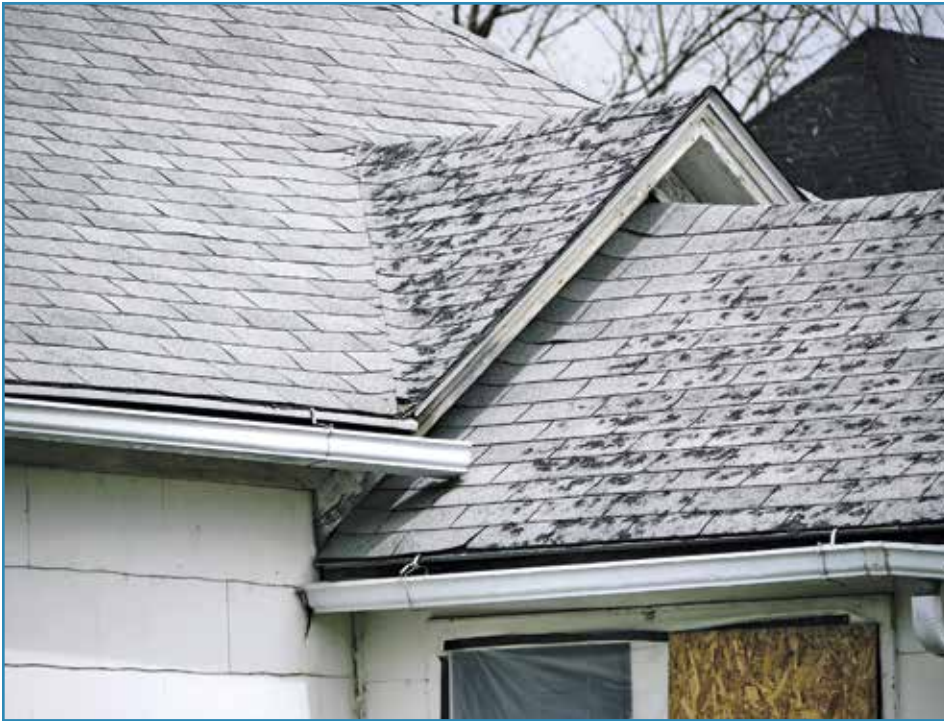
Photo 4 – Untouched photograph of an oxidized asphalt shingle in the same neighborhood after the same hail event in El Dora, Iowa.
