# Fenestration Hurricane Codes Effective, but Irma Illuminates Room for Improvement

By Steven Saffell

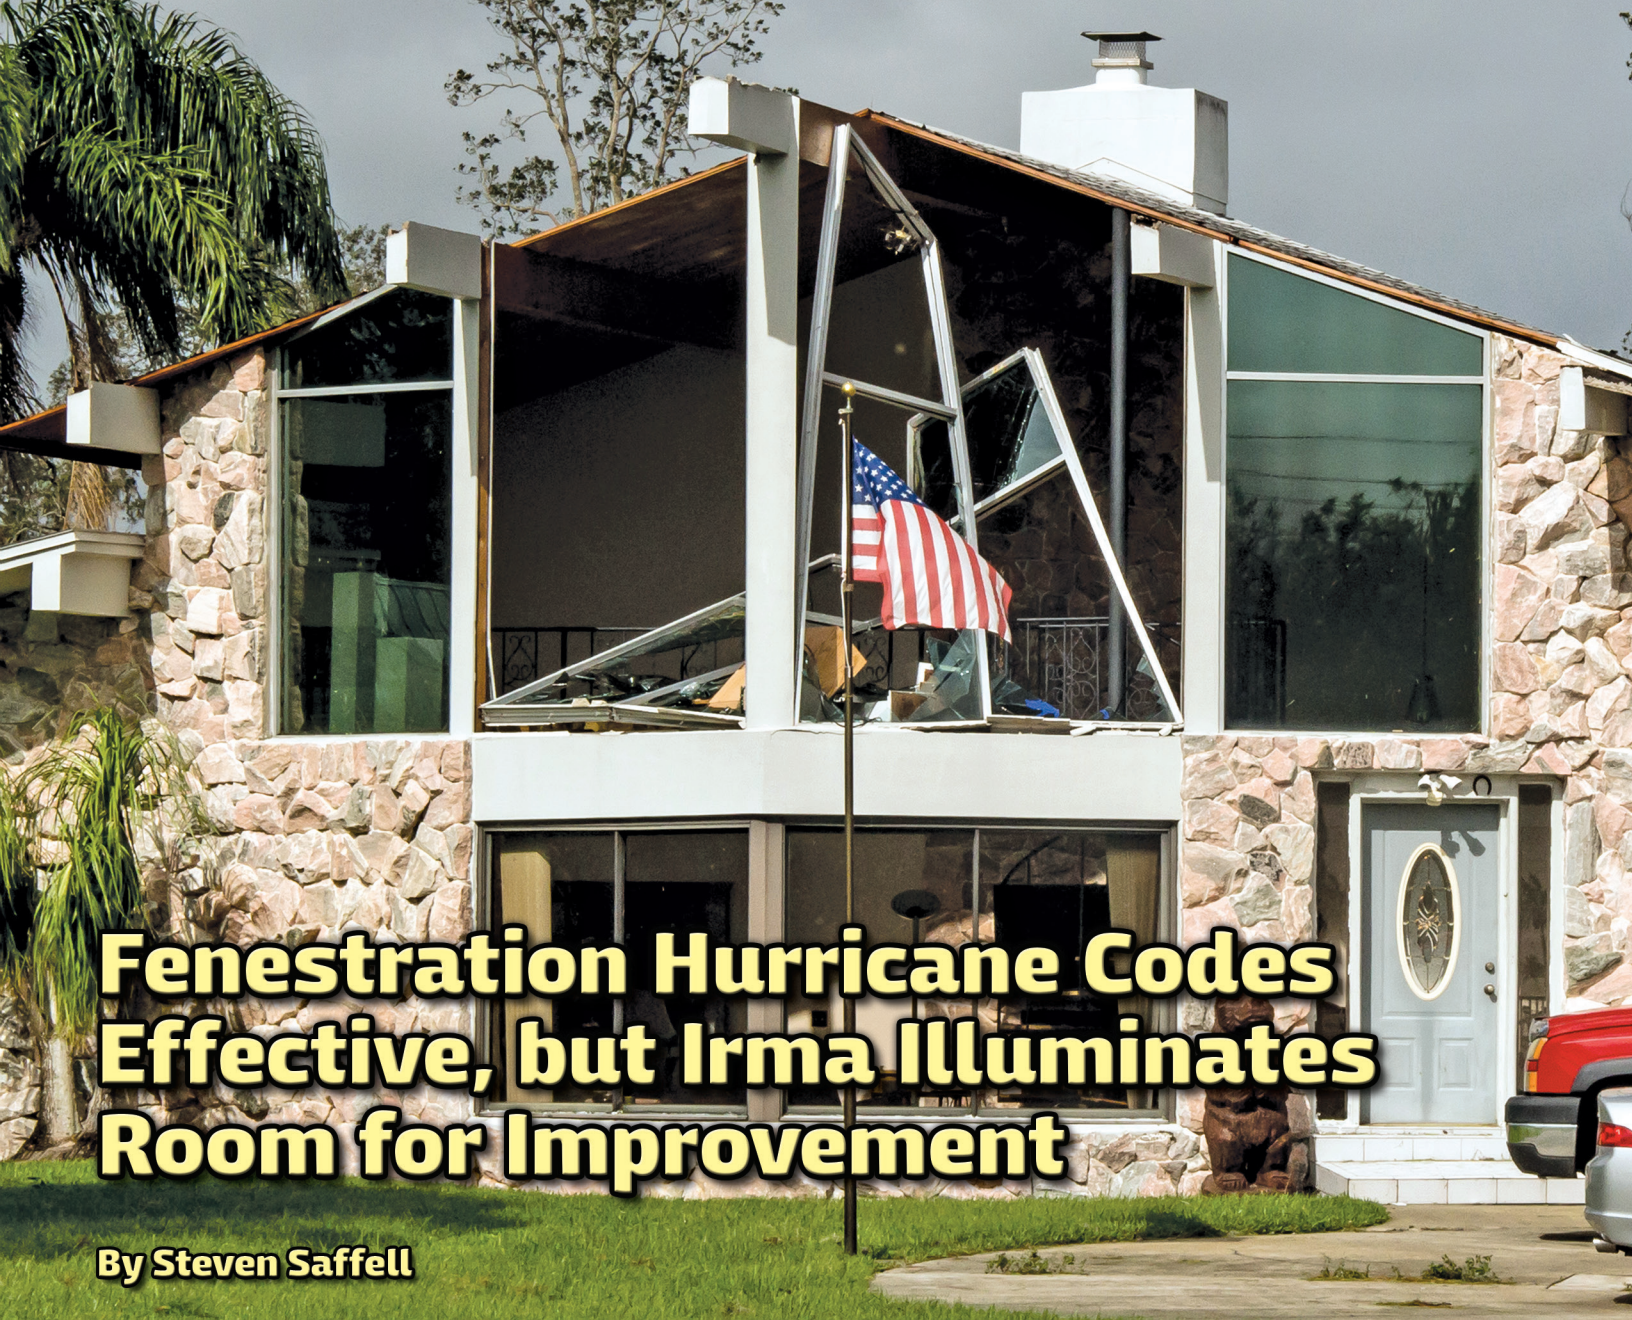
*Figure 1 – A home in Sebring, Florida, after Hurricane Irma hit. According to the Insurance Journal, hurricanes Harvey, Irma, and Maria together caused approximately \$265 billion in damage, with each hurricane joining Katrina and Sandy among the top five costliest U.S. hurricanes on record. Photo by John L. Carkeet IV, LimpingFrog Productions.*

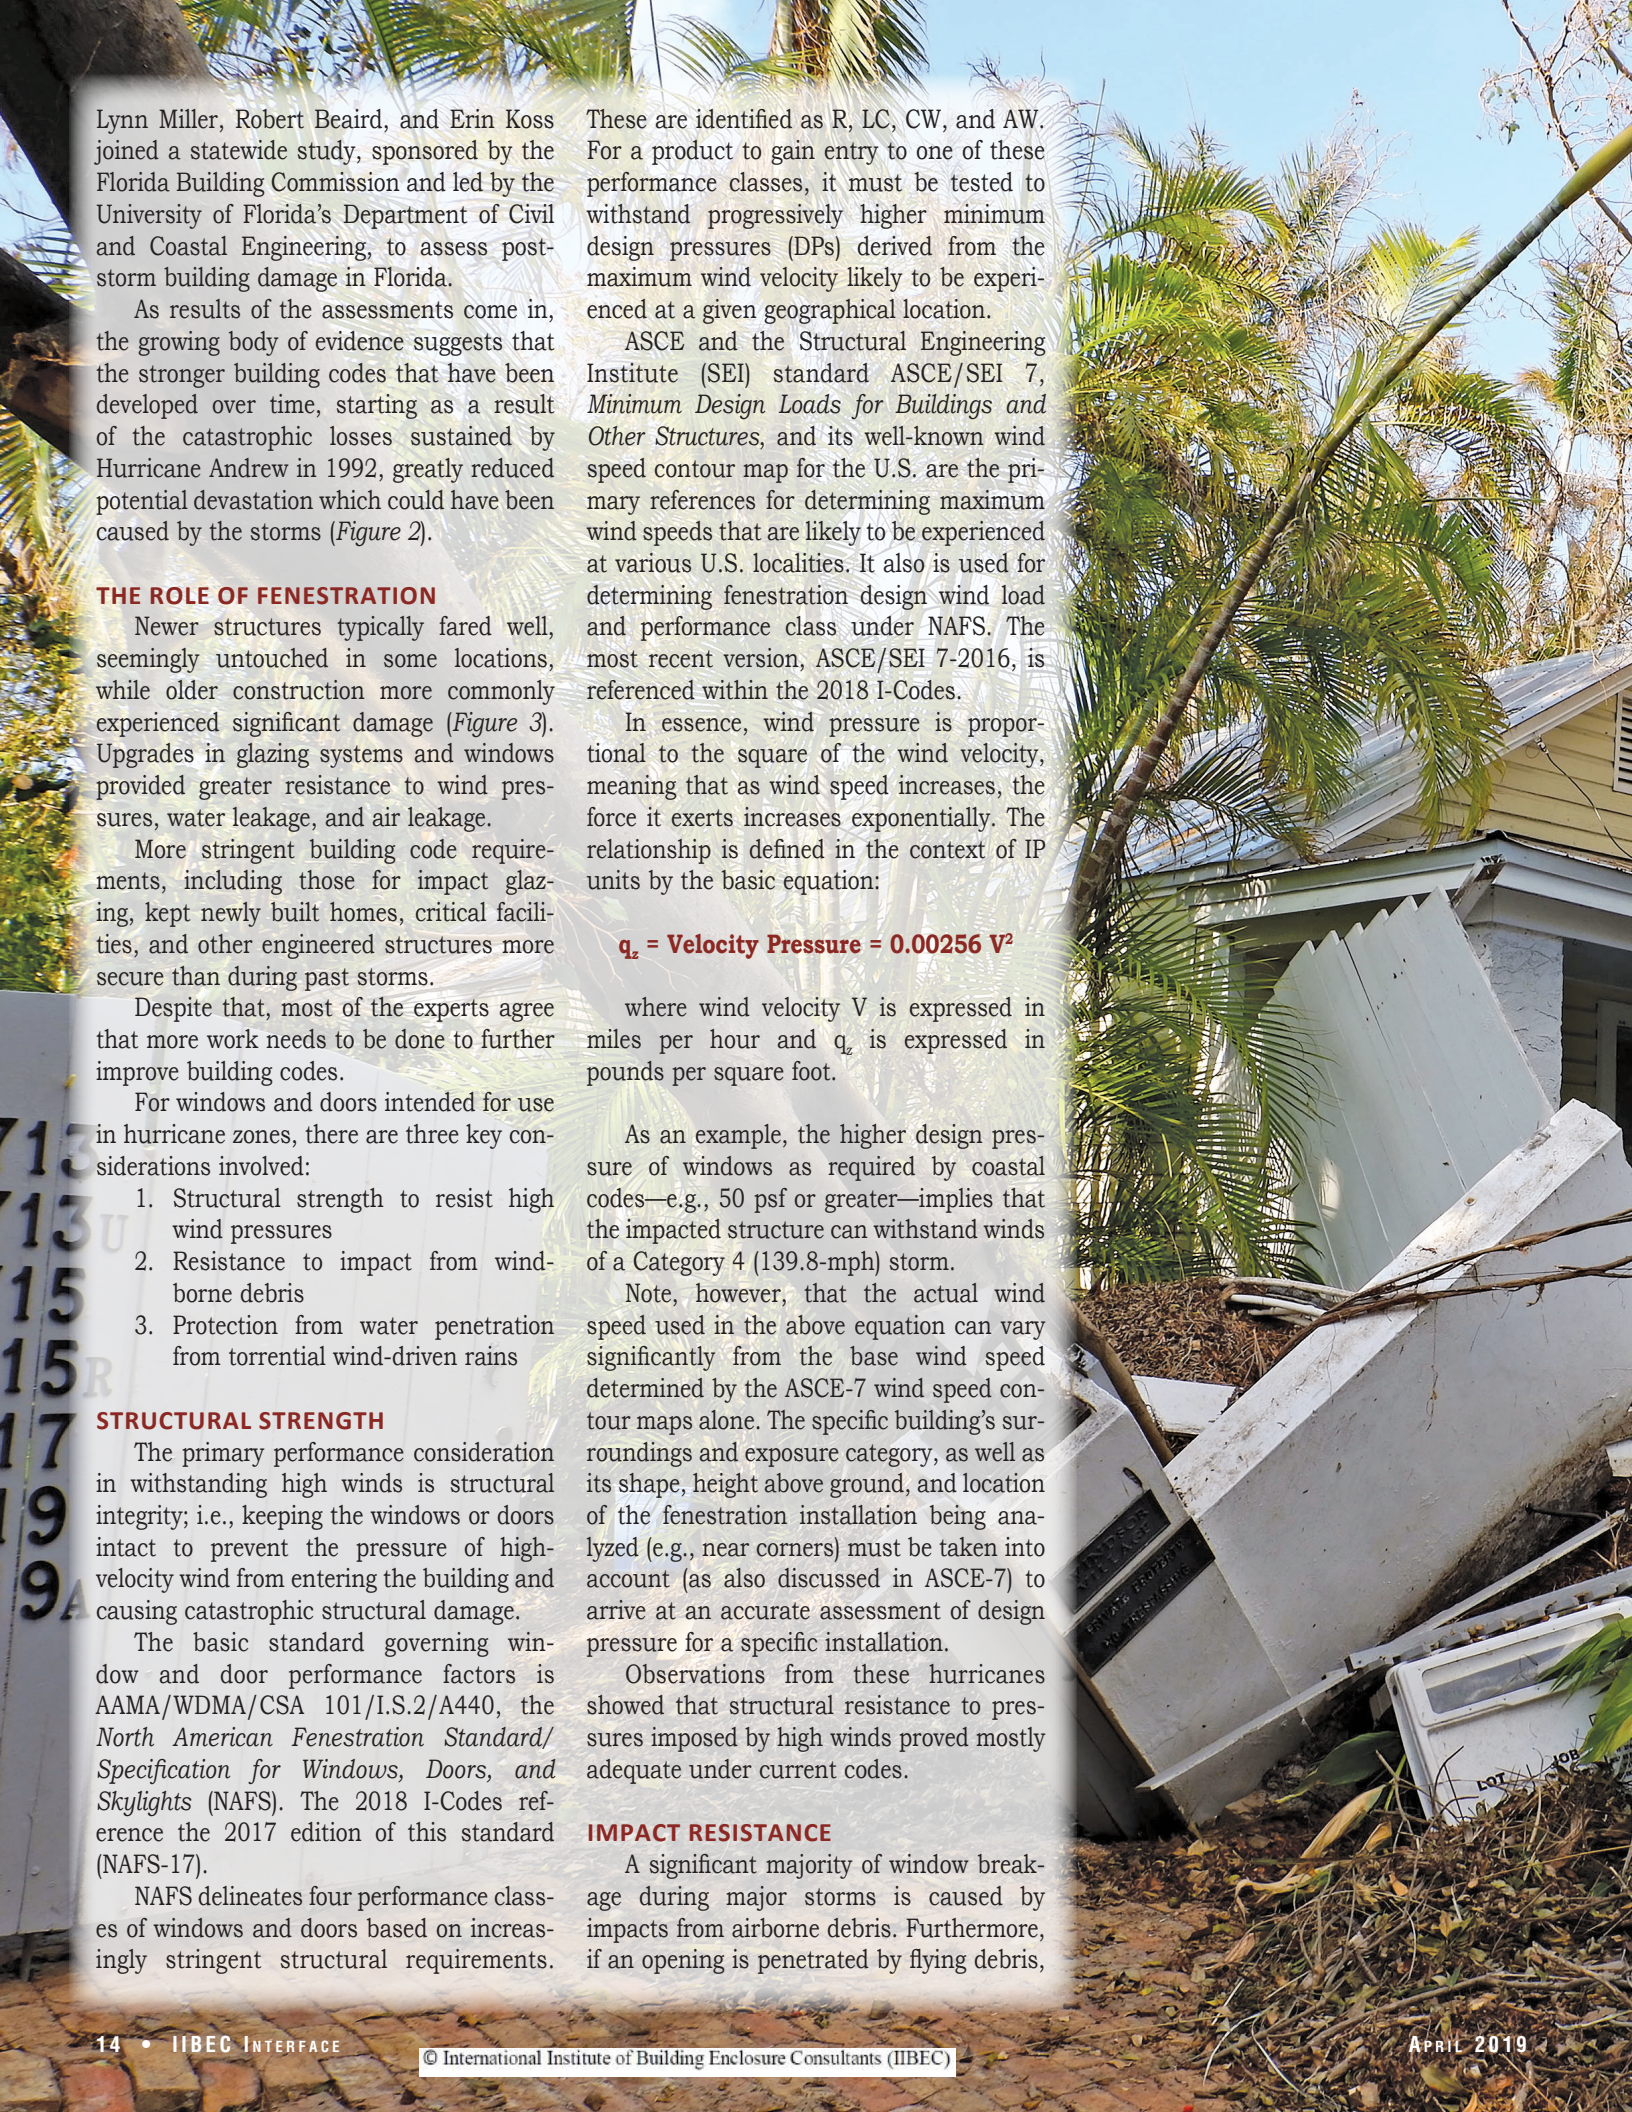
*Figure 2 – As results of the assessments come in, the growing body of evidence suggests that the stronger building codes developed in Florida following Hurricane Andrew in 1992 greatly reduced the devastation caused by the storms. Photo by Cayobo.*

As results of the assessments come in, the growing body of evidence suggests that the stronger building codes that have been developed over time, starting as a result of the catastrophic losses sustained by Hurricane Andrew in 1992, greatly reduced potential devastation which could have been caused by the storms (Figure 2).

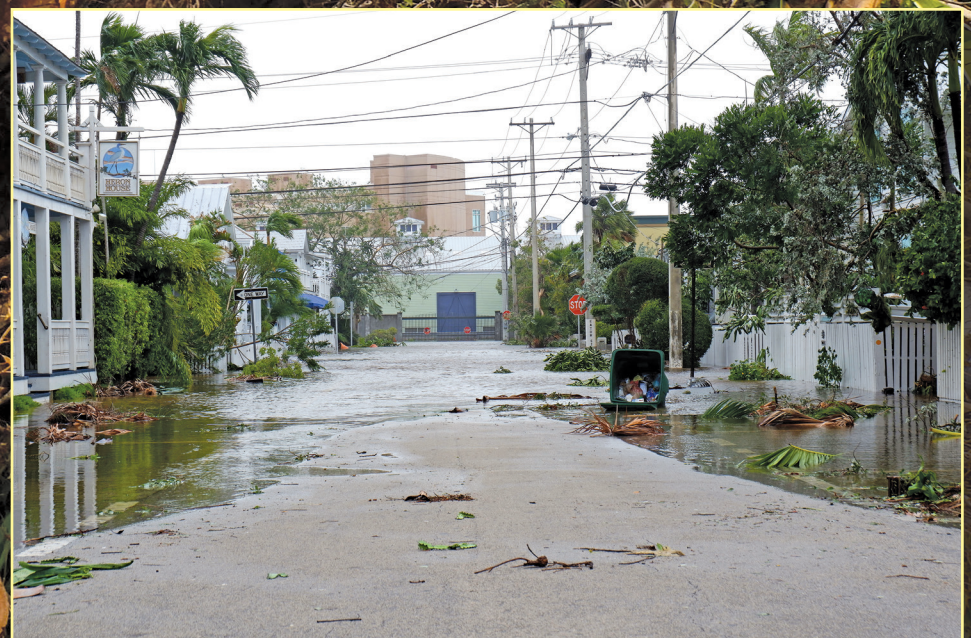
*Figure 3 – Flooding in a residential area. Photo by Cayobo.*

Newer structures typically fared well, seemingly untouched in some locations, while older construction more commonly experienced significant damage (Figure 3). Upgrades in glazing systems and windows provided greater resistance to wind pressures, water leakage, and air leakage.

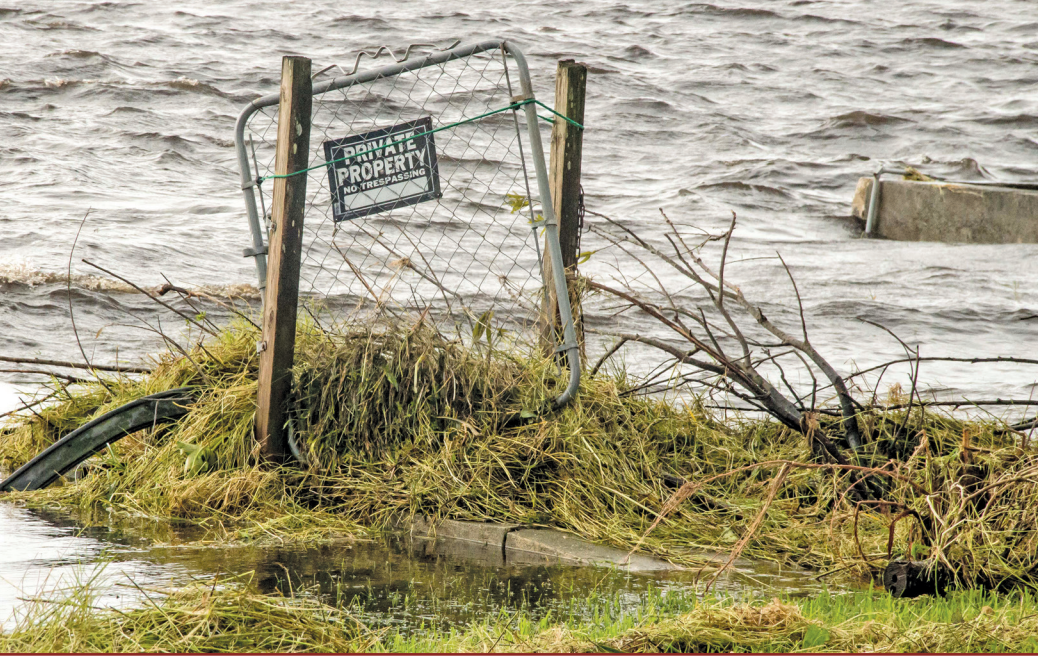
*Figure 4 – In homes that survived and managed well structurally, with impact-rated windows and doors performing as intended against wind and windborne debris, the biggest issue reported was water intrusion that caused damage to buildings’ supporting structures and interior finishes. One of the leading reasons for insurance claims following Hurricane Irma was the cost of such damage and necessary repairs. Photo by John L. Carkeet IV, LimpingFrog Productions.*

In homes that survived and managed well structurally, with impact-rated windows and doors performing as intended against wind and windborne debris, the biggest issue reported was water intrusion that caused damage to buildings’ supporting structures and interior finishes (Figure 4). One of the leading reasons for insurance claims following Irma was the cost of such damage and necessary repairs.

Paul Beers, of GCI Consultants, said, “Often, the cause of the leaks can be attributed to deflection, frame rotation, frame movement, or frame separation, to name a few. The sealing of the windows—like gaskets and weather strips—that were subjected to stress during the violent storm were often compromised.”
