Modified Bitumen Can Both Look Good and Be “Cool”

By Karl Schaack, RRC, PE

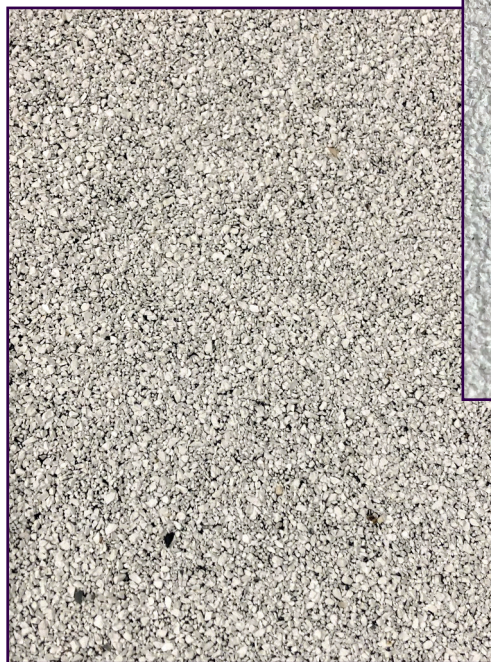
Figure 1 – Close-up of granules on “cool” cap sheet with white-colored granules.

The use of white-colored granules applied on the top of the sheet in the traditional manufacturing process is a more

widespread option in today’s market. These products have thermal reflectivity values that typically range from 0.68 to 0.74 (Figure 1).

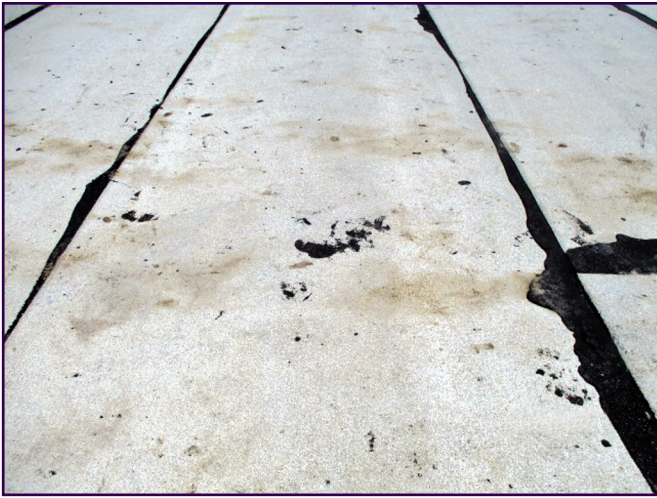
Figure 3 – “Cool” roof cap sheet applied in hot asphalt.

The type of application method utilized for adhering the top ply flashing can have a significant impact on the finish of the cap sheet (Figure 3). Cold-process adhesive or hot asphalt that is mistakenly or carelessly deposited onto the cap sheet will soil the finish and require additional repairs. Placing a bituminous sheet with bitumen surfacing in contact with the top surface of the installed finish ply can result in staining of the white surfacing. Placement of protective material under plastic or metallic pails commonly used for fasteners or adhesives, fire extinguishers, etc., will also prevent circular-shaped ring indentions in the top sheet and corrosion stains from metallic pails on the top sheet.

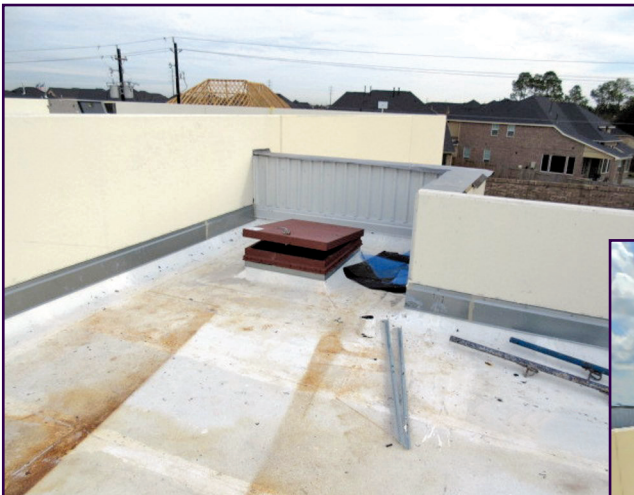
Figure 4 – Corrosion stains from sheet metal storage on cap sheet.

appearance of the roof. Keeping metallic items such as carbon-steel fasteners, shavings from cutting or drilling sheet metal, and other similar items contained and not stored on the roof surface will minimize the possibility of corrosive stains occurring on the finish ply (Figure 4). Obviously, delaying the installation of the cap sheet until other ancillary work can be completed—such as installation of saw-cut reglets in masonry work (which results in masonry-colored dust deposits); sheet metal flashing installation; mechanical-, electrical-, and plumbing-related rooftop work, etc.—will pay dividends toward achieving a clean finish ply. The use of disposable “booties” on workers’ shoes can also aid in maintaining cleanliness of the finish ply.

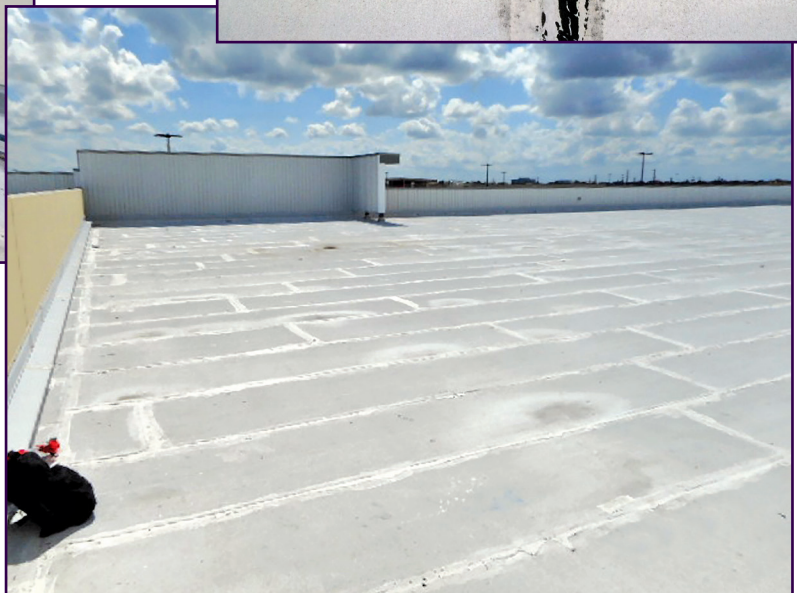
Figure 5 – Bleed-out along laps of cap sheet treated with coating.

While most manufacturers do not require (though several do recommend) the application of a supplemental finish material on the bituminous bleed-out that occurs along the edges of side and end laps, the author believes addressing the bleed-out achieves the optimum monolithic surfacing and best long-term performance. Manufacturers of the pre-coated sheets and film-surfaced sheets typically provide a coating product that can be applied on the bleed-out or other blemished areas of the surfacing. However, applying coatings directly over bleed-out on a pre-coated granule-surfaced sheet results in a slick or smooth surface and visually appears different from the pre-coated granulated sheet (Figure 5).

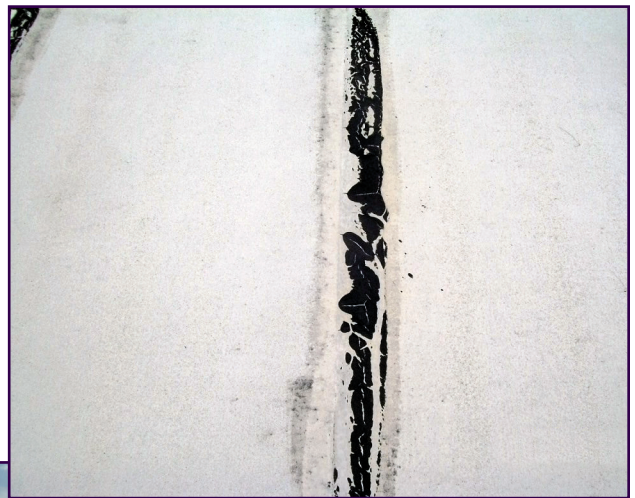
Figure 6 – Typical view of coating applied on asphalt bleed-out.

a practice similarly used with traditional cap sheets. The process used for applying the coating on bleed-out can also have varying results. The author has observed contractors using narrow napped rollers (2 to 4 inches) to apply coating over the bleed-out—commonly for improved production purposes; however, the new coating typically has a significantly brighter white color than the cap sheet and can result in visually obvious “stripes” on the finished product. While some in the industry indicate that

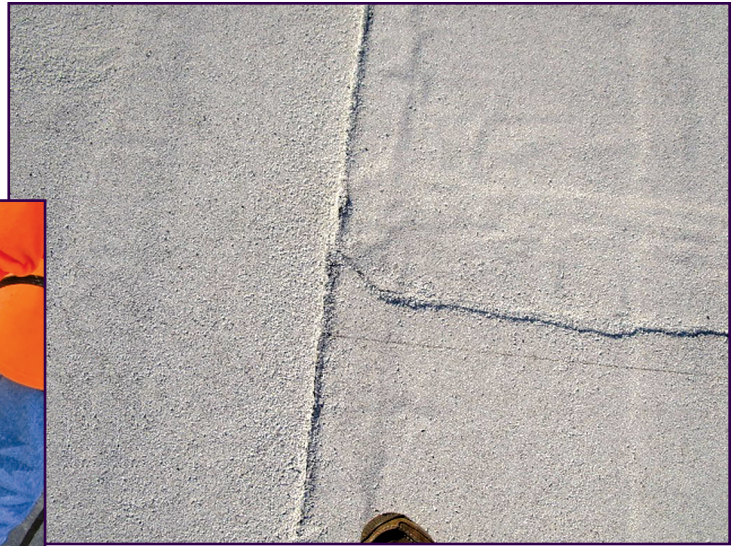
Figure 7 – Torch application of white-colored granule-surfaced cap sheet.

Using proper torching techniques and application procedures during installation helps to maintain a uniform color to the finish ply (Figure 7). As the torch is drawn across the width of the sheet and beyond the side of the sheet (to accomplish fusing the side laps), the flame can cause “scorching” of the surfacing of a previously installed adjacent sheet. Although these “scorch” marks will most likely diminish with time after exposure and weathering, they will be evident at the time of completion and during the final walk-through performed by project personnel. This condition most likely will be considered unacceptable and aesthetically displeasing—especially because the white-colored finish is the desired end product. A torching technique of directing the flame toward the subject sheet (i.e., extending the arm/torch over the adjacent

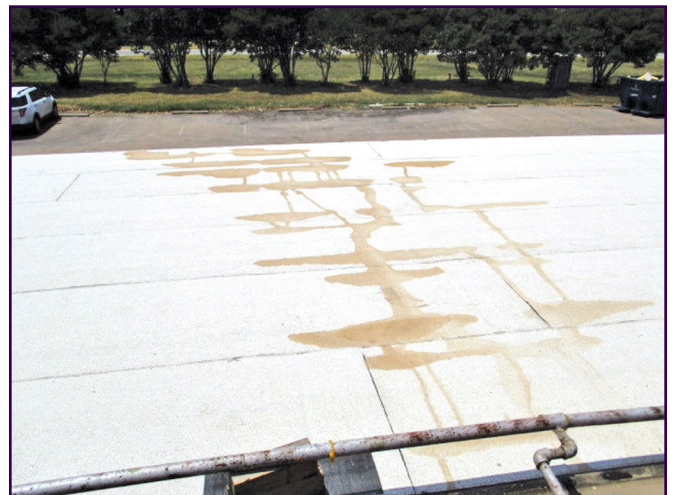
Figure 9 – Stained cap sheet from water draining across sheet.

Another concern or condition that can cause staining of the cap sheet involves properly sequencing and coordinating roofing work to minimize trafficking and storage of materials on a newly installed white cap sheet, which could lead to significant staining and marring of the finish. Additionally, water or morning dew draining or running across a previously installed smooth-surfaced modified-bitumen base ply from an adjacent or higher roof and discharging onto a newly installed cap sheet can result in staining (Figure 9). The light oils contained in the top surfacing of a base ply can be captured by the moisture, and as the moisture travels across a cap sheet, the light oils are deposited

onto the top surfacing, leaving bituminous stains, often called “tobacco juicing”¹ (due to its light brown appearance).

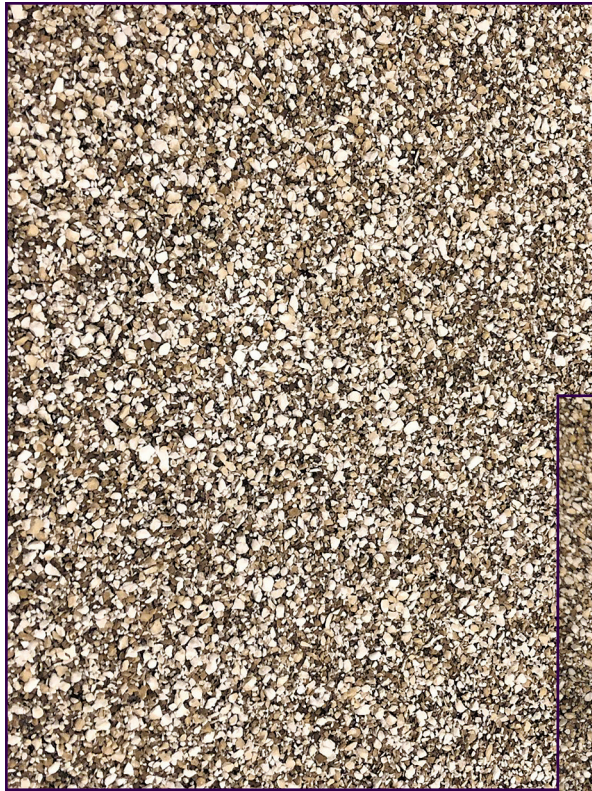
Figure 10 – Close-up of stained white-colored granules of cap sheet.

A similar condition has also been observed on these white-colored granule-surfaced sheets when visible brown-colored stains are found on the white granules on products that have been removed from manufacturers’ wrapping upon delivery to a job site in preparation for application (Figure 10). This staining is very prevalent and widespread throughout the sheet. Manufacturers have indicated that the staining is due to light oils from the bitumen migrating from within the sheet and depositing on the granules during storage of the materials—commonly within unconditioned spaces/warehouses or job sites where elevated temperatures can cause the light oil migration (Figure 11).

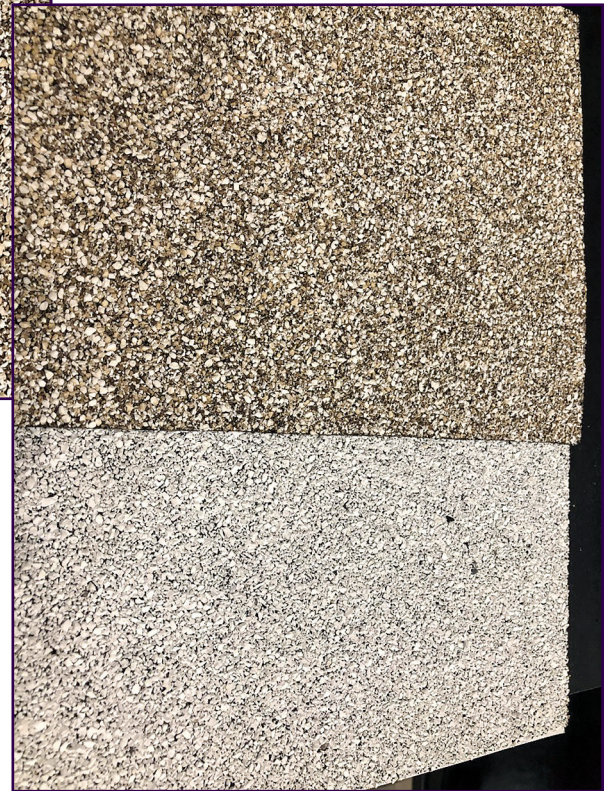
Figure 11 – Close-up comparison of stained granules vs. non-stained.

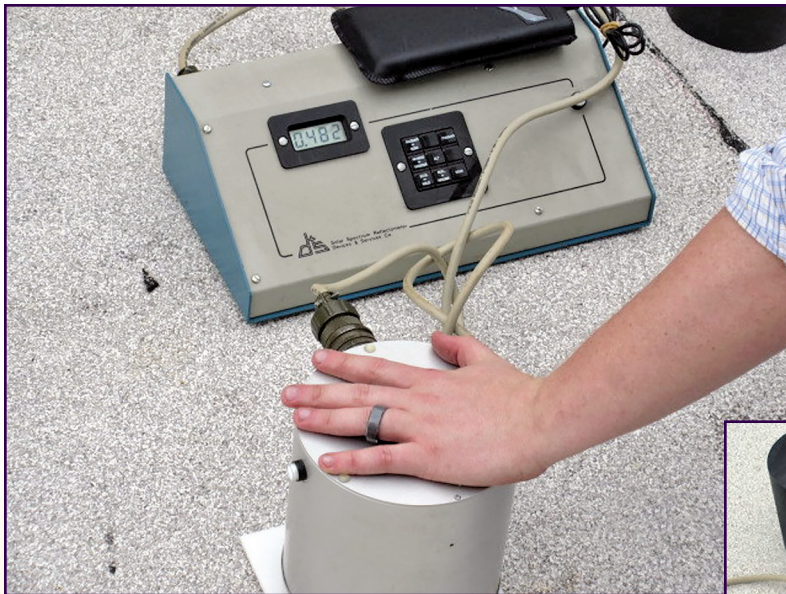
Figure 13 – Reflectivity reading of 48 on cap sheet with stained granules.

staining. Testing of a newly installed stained cap sheet revealed solar reflectance values on the order of 0.40 to 0.50, and testing of previously installed sheets (in place for two to three months) revealed solar reflectance values on the order of 0.50 to 0.60, with neither value at the published value of 0.70 for the respective products (Figures 13 and 14).

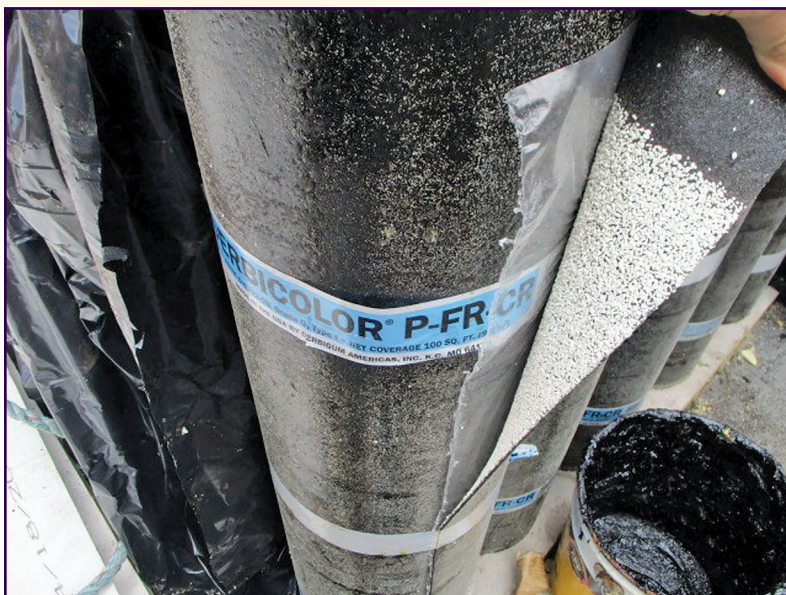
Figure 15 – Film on roll to prevent staining of granules.

One practice by one manufacturer that appears to be successful in maintaining the white color of the granules is the placement of a thin plastic film over the granule surfacing when the material is rolled up following completion of the manufacturing process (Figure 15).

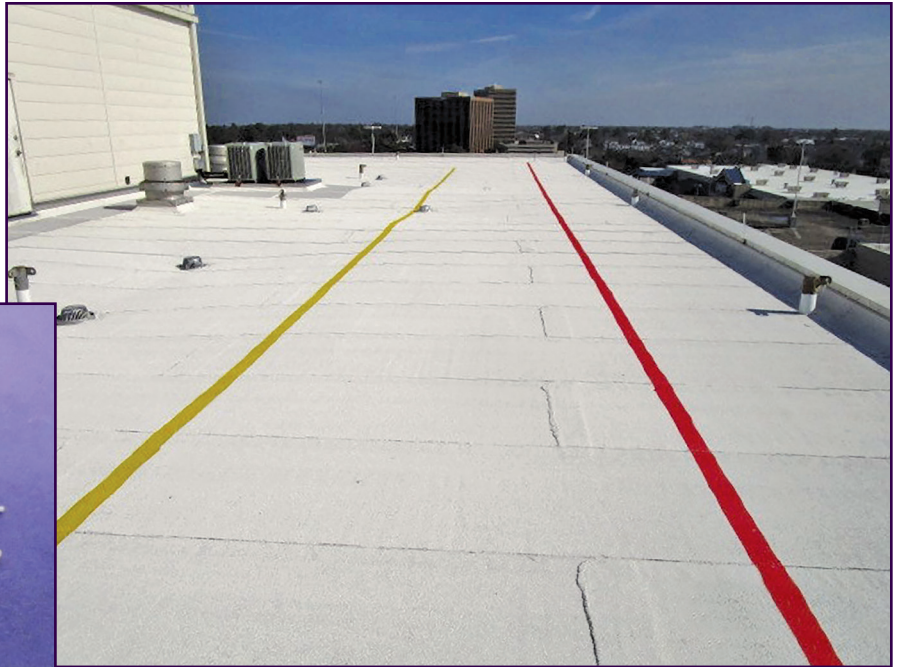
Figure 16 – Round-shaped granules.

be lighter in weight, and achieving proper embedment was more difficult with excessive granule loss occurring with in-place products. A similar condition occurred with a polymeric granule that looked like small-sized paint chips. A modified-bitumen sheet product that has recently been introduced utilizes small circular or ball-shaped granules, and the manufacturer believes, based on initial studies, that this will provide better long-term performance compared to conventional angular-shaped granules (Figure 16).

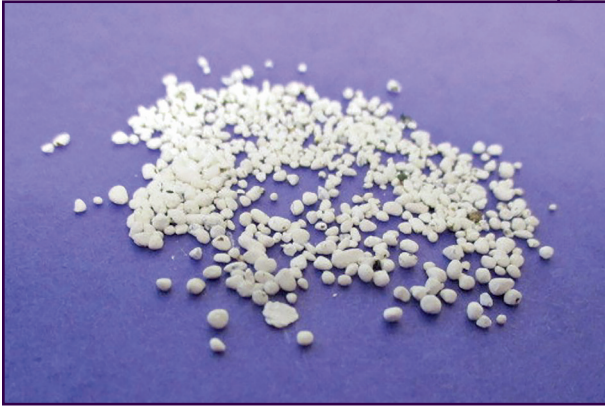
Figure 17 – Overview of installed white-colored granule-surfaced cap sheet.

In summary, these modified-bitumen sheet materials are specified and installed to achieve a desired end product and resulting finished surfacing for the building owner. By identifying the requirements within the scope of work or specifications and by implementing certain procedures and protocols during application, this can be reasonably achieved while meeting the expectations of the individual parties and the building owner associated with the project (Figure 17).
