# Potential Issues Encountered During Installation of Air and Weather-Resistive Barriers

By Karl Schaack, RRC, PE

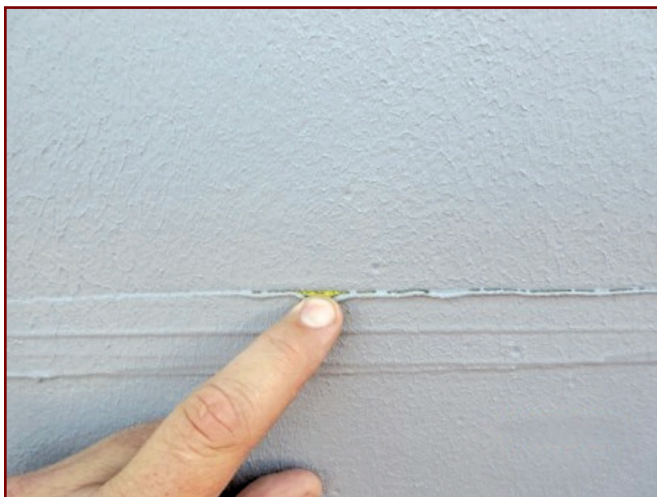
Figure 1 – Exposed face of sheathing along heavy build of sealant at joint.

result in heavy applications of the product with profiled (thick) edges, in lieu of feathered edges. When the fluid-applied air barrier is applied over the heavily treated joints—particularly during spray-applied applications—the heavy-build treatment can act as a shield, blocking the fluid from reaching the surface of the sheathing, unless the applicator takes the time to apply the material in a multidirectional method (*Figure 1*). Even during roller applications, the high-build edges can act as a bridge when the roller is brought across the material, and the sheathing facer—located directly along the sides of the sealant—does not receive a proper application of the fluid material.

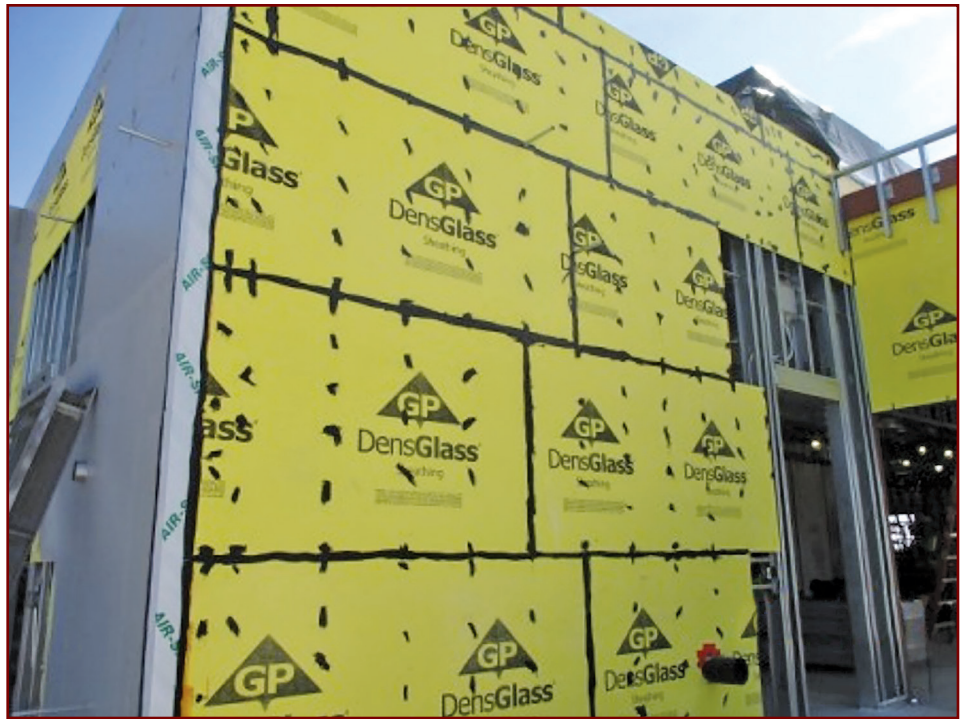
*Figure 3 – Pretreatment of sheathing joints and fastener heads.*

Pretreating heads of fasteners used to secure sheathing to framing is commonly recommended by air barrier manufacturers when the fastener is overdriven and fractures the fiberglass facer on the sheathing. Even when the fastener head is properly seated flush with the surface of sheathing, the formed indentations in the head of a Phillips screw can draw the fluid material down into the indentations, pulling the material from the screw head and resulting in small voids around the perimeter of the head (*Figure 2*). Since holes in the air barrier due to inconsistencies at fastener heads are found to be very prevalent, pretreating of each and every fastener head is highly recommended so as to alleviate judgment calls by the applicator on which specific fasteners need treatment. Furthermore, since sheathing joints are required to be pretreated, applying additional material over fastener heads at that same time does not involve significantly more time and material compared to the effort required to go back and search and identify voids at heads and then to perform respective repairs (apply additional material). See *Figure 3*.

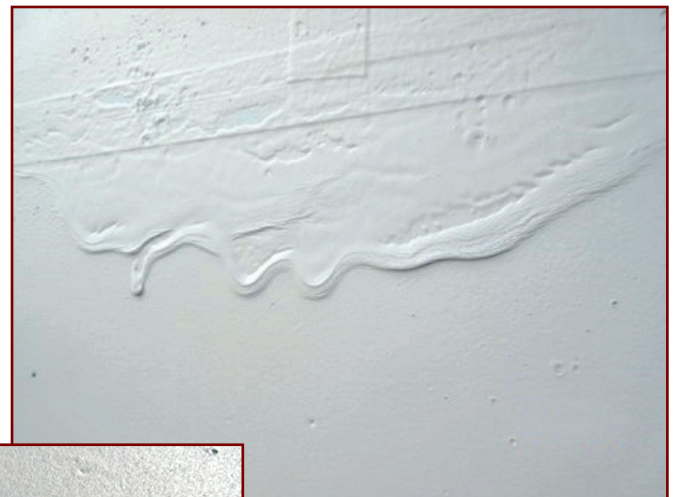
*Figure 4 – Sloughing of excessive application of fluid-applied air barrier.*

cause the material to become “heavy” and run or slough off of the substrate (*Figure 4*). Applying an inadequate amount of material will obviously result in a finished product that does not meet specifications or performance requirements. Spray equipment is often utilized by contractors for enhanced production during application. A condition observed with spray-applied products is the creation of “craters” in the applied barrier material (*Figure 5*). This condition occurs when globs or

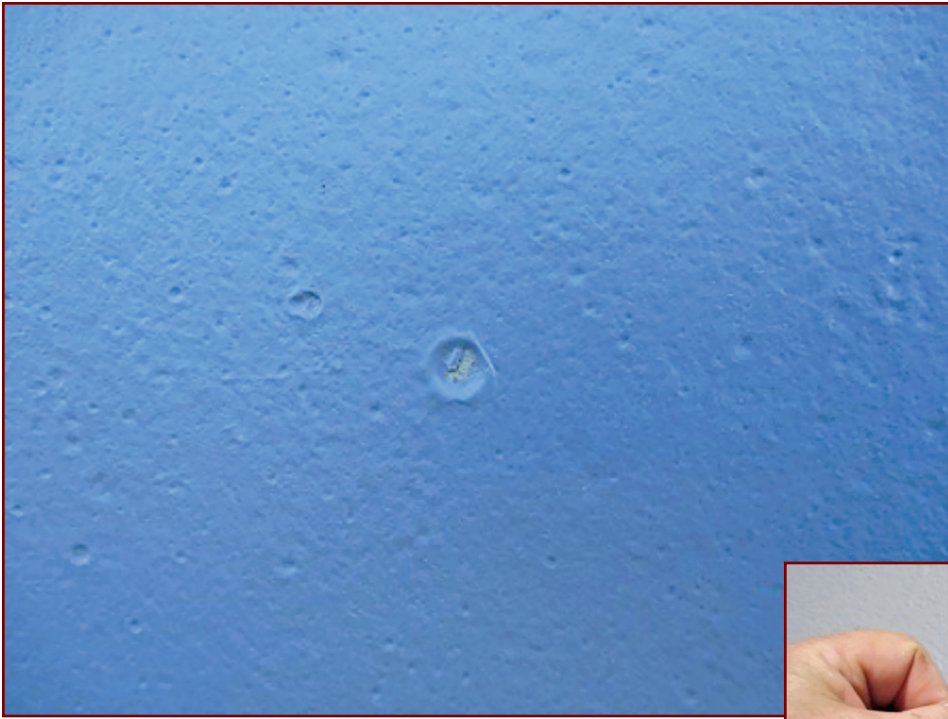
Figure 6 – Close-up view of a crater in surface of fluid-applied air barrier.

exposure of the underlying facer of the sheathing (Figure 6).

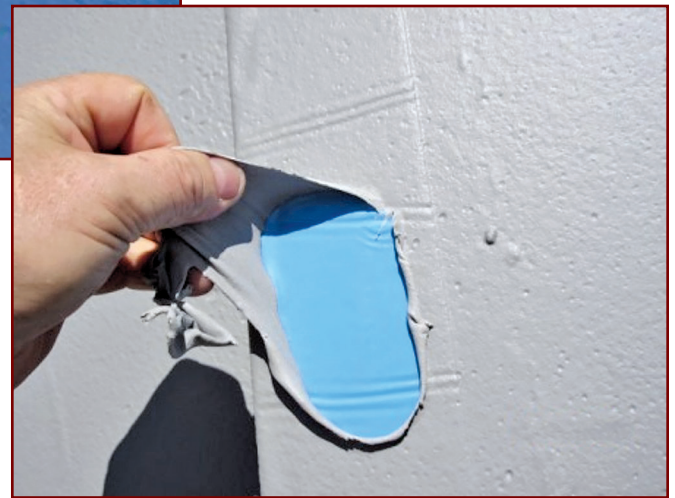
Figure 7 – Delamination of fluid-applied air barrier from transition membrane sheet.

without the use of primer applied onto the surface of the film. Without proper preparation, the fluid-applied air barrier can easily be peeled off of the sheet membrane (Figure 7). Another material option to enhance the opportunity to achieve proper bond of the air barrier could involve the use of a transition membrane with a metallic-film (aluminum or stainless steel) facer, in lieu of the polyethylene-faced membrane, so that the fluid-applied material will readily bond to the metallic face.

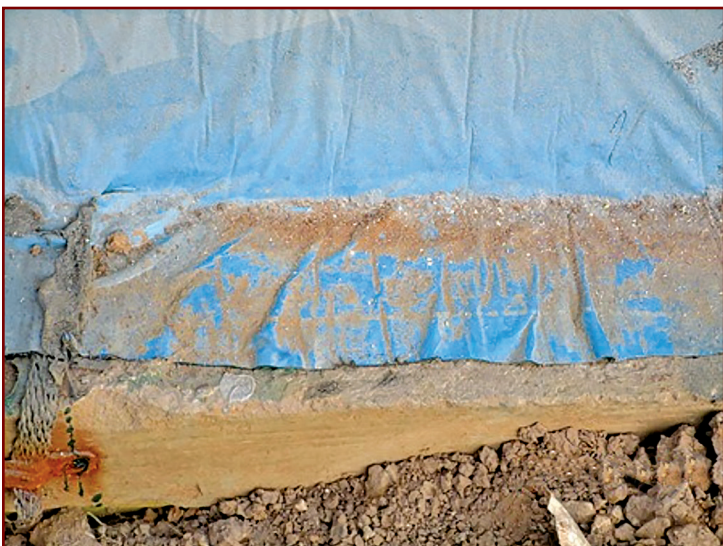
Figure 8 – Soil-contaminated base of wall.

Gypsum Sheathing.”<sup>2</sup> Sheathing soiled with dirt or other contaminants does not provide a good substrate for achieving proper adhesion of the air barrier. During new construction projects, sheathing that is installed on exterior walls of a building will commonly become contaminated with dirt along the base of the wall due to wet weather and exposed soil conditions. Water that drains freely from the structure and down to the ground can result in splashing of muddied water and dirt up onto the surface of sheathing. This results in an unsatisfactory substrate to receive an air barrier/WRB (Figure 8). Improperly stored sheathing or over-exposure after installation on new construction sites are other common events that result in contaminated products resulting in undesirable conditions to receive applications of new air barriers.

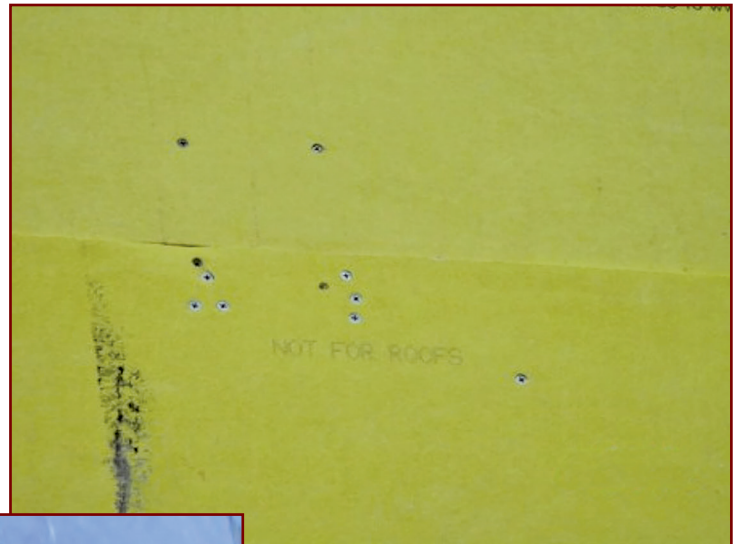
Figure 10 – Improperly positioned fasteners in sheathing.

center and no less than ¾ in. from the edges and ends of the panel. Proper attachment and fastener placement rely on the proper positioning of the panels so that the edges are centered over the underlying framing member. Then it is up to the installer to secure the fastener in the proper location. Commonly, fasteners are haphazardly placed too close to the panel edges, which can pulverize the gypsum core, resulting in an inadequate substrate to receive an air barrier/WRB (Figure 10).

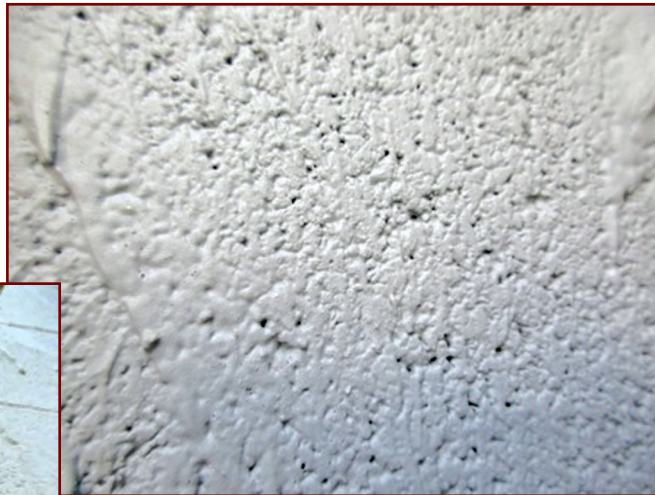
Figure 11 – Void in fluid-applied air barrier at eye hooks of pintle masonry anchor.

face of the CMU. This results in a rough substrate on which it is difficult to properly apply a fluid-applied air barrier, often resulting in voids in the material (Figure 11).

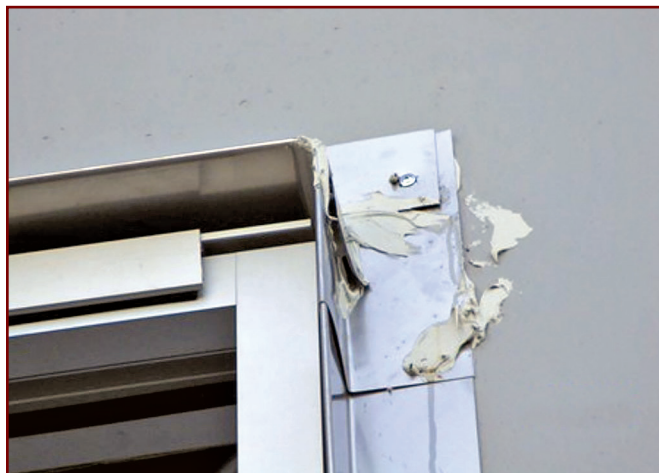
Figure 13 – Corner joint of sheet metal flange installed around window opening.

opening to provide a substrate to receive the sealant beyond the opening. The sheet metal angle is installed on top of the WRB applied around the opening, secured to the framing around the opening, and then the flange is stripped into the WRB—typically with a self-adhering transition membrane. A concern with this type of detail is achieving a proper watertight seal at laps and corners in the sheet metal angle (Figure 13). Utilizing pop rivets and sealant sandwiched in the laps may not provide an adequate seal when subjected to testing with a spray wand, and it will definitely not maintain a seal in a pressure chamber. Using stainless steel sheet metal, pop riveting, and soldering the joints can result in watertight joints but requires highly skilled technicians to properly achieve this result.

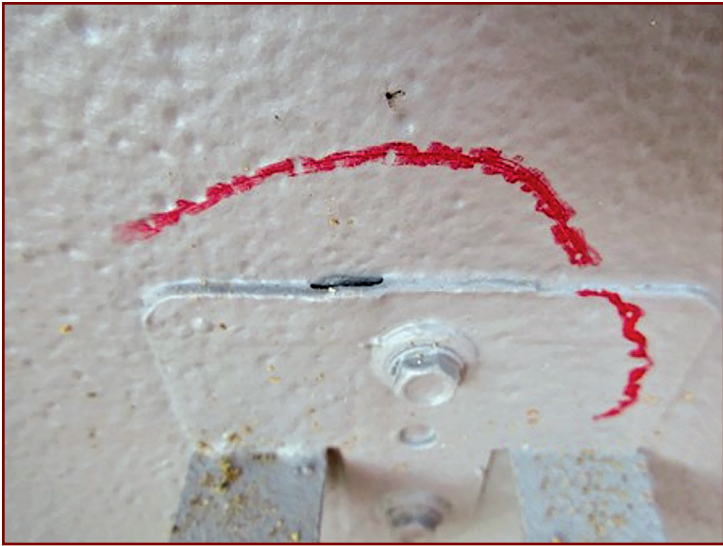
Figure 15 – Void in fluid-applied air barrier at top edge of masonry anchor plate.

somewhat warped. Because of these factors, achieving a compressed seal against the vertical face of the air barrier is extremely difficult, if not impossible. Even though many of the fasteners used to secure these items have gasketed washers, the seal that is achieved is between the fastener and the outer face of the flange, and the back of the flange may not be completely compressed to the WRB. So, if water enters into

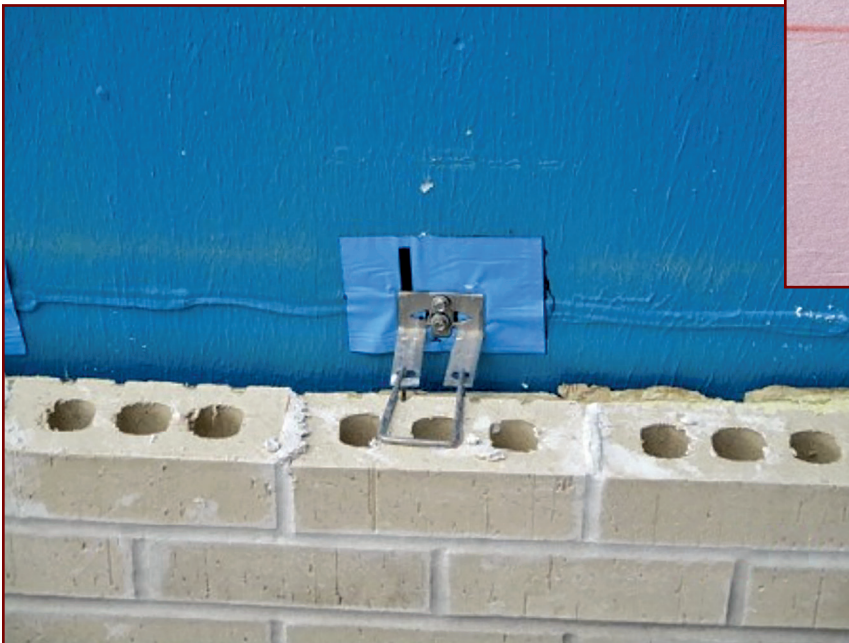
Figure 16 – Cut strip of self-adhered membrane applied on top of fluid-applied air barrier at masonry anchor.

Installation of cut strips of self-adhering sheet, sized to match the compression surface, between the steel girt or tie and the fluid-applied air barrier, can aid in achieving seals at fastener penetration (Figure 16). Additionally, the heads of fasteners may need to be treated with a dollop of compatible sealant or a trowelable version of the liquid membrane to provide a more desirable seal. Another practice could include setting the masonry tie in “wet” fluid-applied WRB when securing to the substrate. Issues are

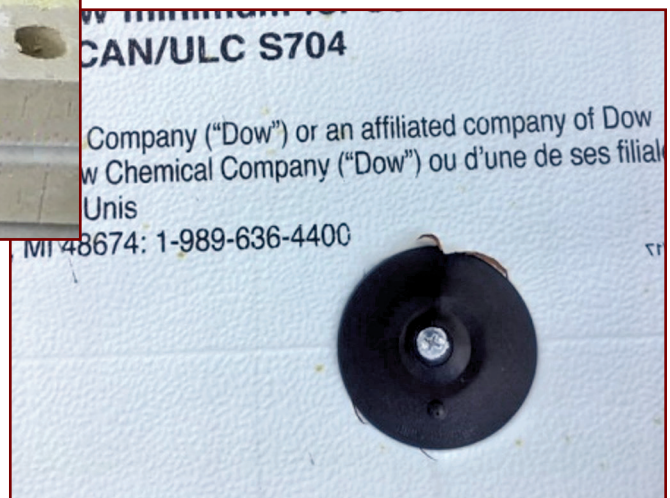
Figure 18 – Damaged foil facer on insulation used as WRB around over-driven fastener.

ucts can readily occur due to either physical impact or overdriving of fasteners (Figure 18). Another condition that can occur is voids present at joints between adjacent insulation boards. The treatment of joints in the insulation boards can include either applying a self-adhering tape or a liquid-applied flashing (typically unreinforced) over the joints. Use of a preformed tape achieves a more positive result, as voids can manifest in the liquid flashing as the material sags down into the joints or an inadequate amount is applied by the technician.
