# Assessing the Performance, Application, and Cost of Retrofit Wall Systems for Residential Buildings

By André Desjarlais, F-ASTM

This paper was originally presented at the 2022 IIBEC International Convention and Trade Show.

This article describes a three-year DOE-funded project to identify high-performing wall retrofit systems and provide a real-world context for their thermal, moisture, and economic performance that can aid decision makers in balancing various goals for DERs.

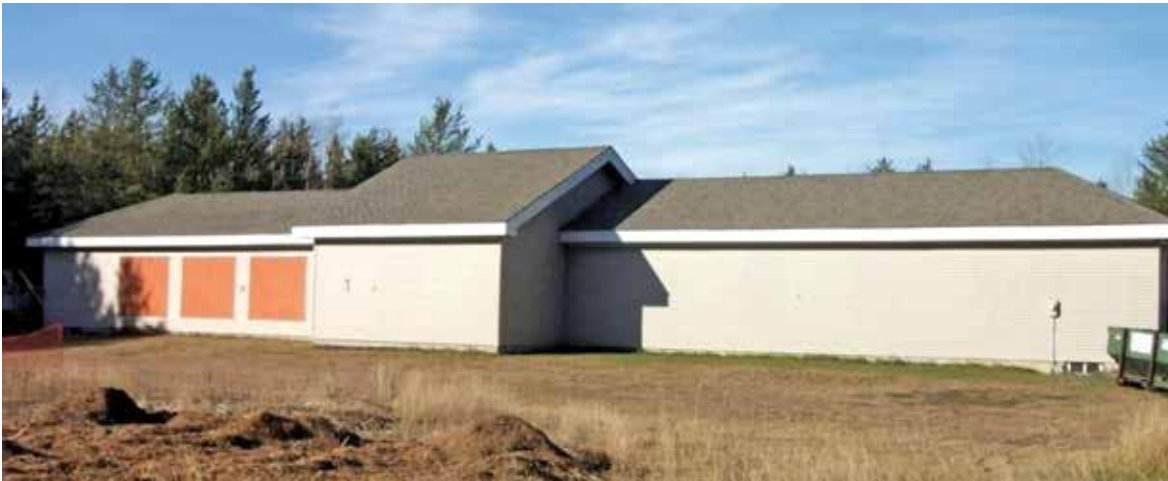
**Figure 1.** The Cloquet Residential Research Facility was used for the in situ testing of retrofit wall assemblies.

The experimental portion of this project was carried out by the University of Minnesota at the Cloquet Residential Research Facility (CRRF), which is located on the Cloquet Forestry Center near Cloquet, Minn., approximately 20 miles (32 km) west of Duluth and in DOE Climate Zone 7. The CRRF building (**Fig. 1** and **2**) is elongated along an east-west axis to maximize the northern and southern exposures. It sits on a full basement with 12 independent above-grade test bays protected by two end-guard bays. The eight test bays that have both north and south exposures (Bays 1 to 4 and 9 to 12) were selected to conduct in situ testing for this project.

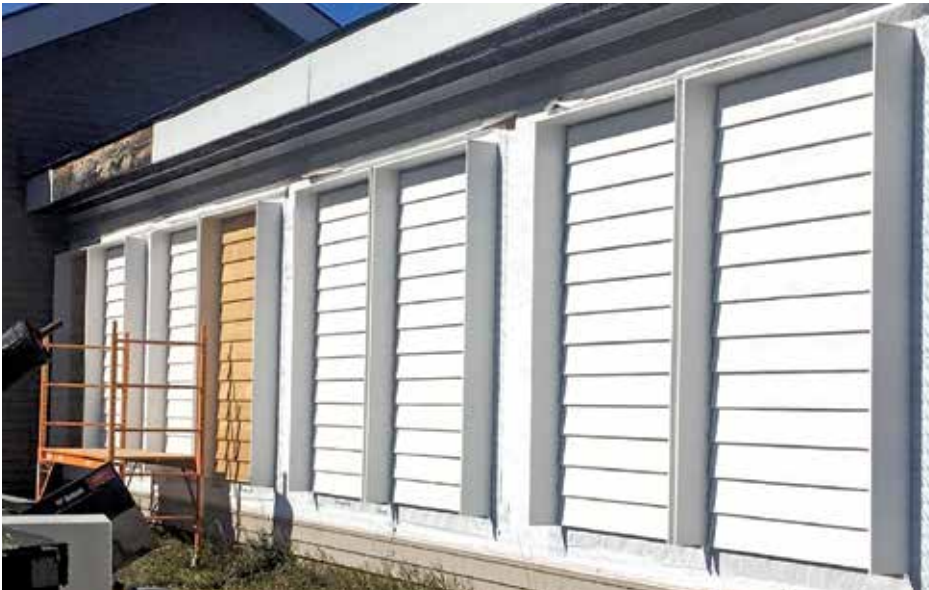
**Figure 3.** Exterior view of baseline walls depicting cedar siding before wall retrofits.

To assess the impact of wall retrofits, a baseline wall assembly was designed and used as the starting point for each wall assembly and 16 identical test walls were constructed for each phase. The baseline test walls were constructed of 2 × 4 in. (51 × 102 mm) spruce, pine, or fir wood studs with 1 × 6 in. (25 × 152 mm) pine board exterior sheathing. The pine sheathing was loosely fit to reflect older construction. The sheathing was covered with a heavy no. 30 building paper lapped and stapled to the sheathing followed by 8 in. (203 mm) cedar lap siding finished with an oil-based primer, vapor-retarder primer, and latex topcoat. This exterior finish was selected to represent an older house with several coats of oil-based paints. Once the test panel was installed in the test opening and the instrumentation array was installed, an interior finish of 5/8-in.-thick (16-mm-thick) gypsum board with a vapor-retarder primer was added. The interior finish was selected to

represent an older house with heavy drywall or plaster and several coats of paint. The south-facing baseline walls from Phase 2 are shown in **Fig. 3**. Team members familiar with construction practices in the local climates indicated that vapor retarders were not historically included in construction practices for the time period that was being considered for initial constructions. Since the majority of retrofits were to be performed on the exterior side of the wall assembly, access to the interior side of the cavity was unavailable and therefore vapor retarders were not included in most of the retrofits.

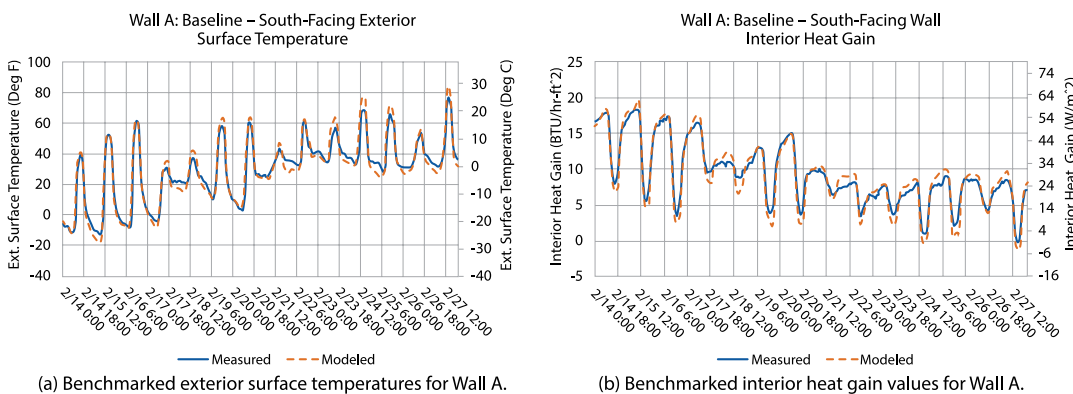
Figure 5. Energy modeling outputs compared with measured experimental data for Wall A.

Figures 5 and 6 present benchmarking plot examples. In Fig. 5, the exterior surface temperature and interior surface heat-flux values for Wall A, the baseline wall, are displayed, and the measured and modeled data can be compared. For the displayed data set, the root mean square error values are 4.7°F (2.6°C) and 1.10 Btu/hr-ft<sup>2</sup> (3.47 W/m<sup>2</sup>) for exterior surface temperature and interior heat-flux comparisons, respectively. Similar data are depicted in Fig. 6 for Wall J, the dense-packed fiberglass drill-and-fill wall.

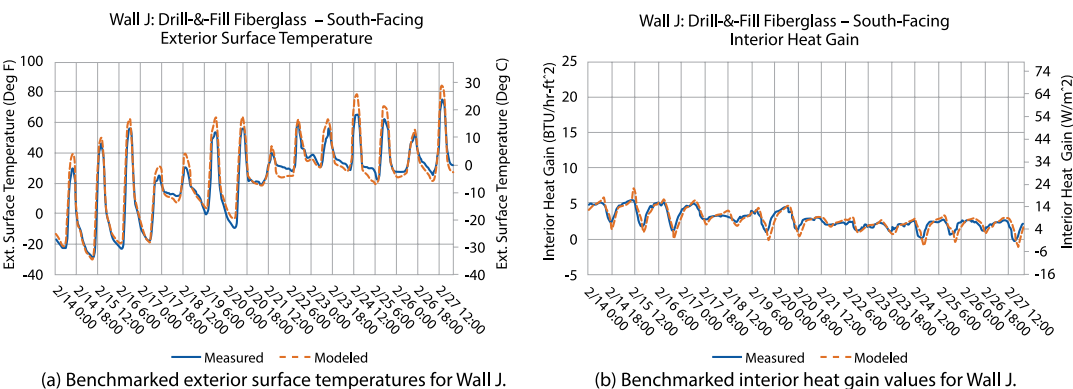
Figure 6. Energy modeling outputs compared with measured experimental data for Wall J.

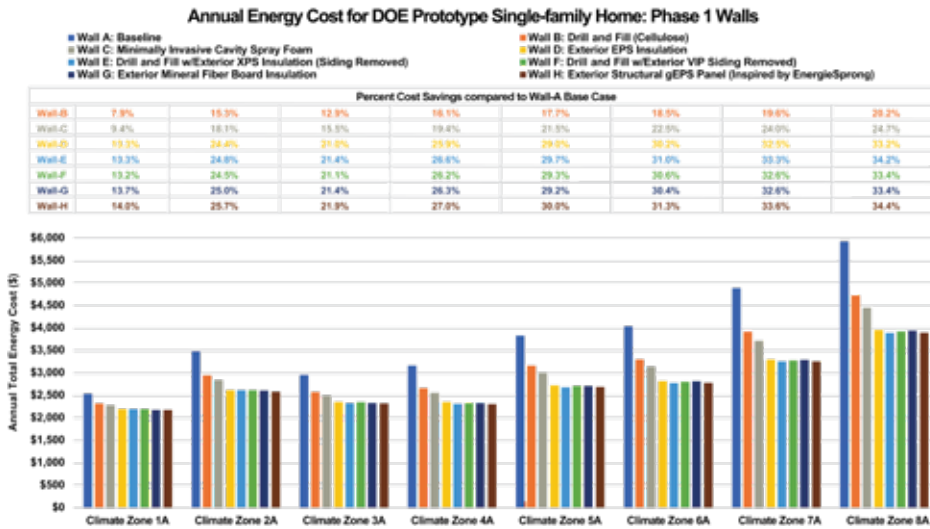
**Figure 7.** The annual energy costs for the modeled residential prototype building with the Phase 1 wall retrofitted assemblies.

Figures 7 and 8 depict the annual energy costs for the simulated prototype house for Phase 1 and Phase 2 walls, respectively. Broad conclusions related to the potential savings and cost-effectiveness of climate zones can be

drawn. For Climate Zone 1, the average savings for all simulated retrofit options is 12%. Wall performance for this climate zone is led by Wall H, which is also the assembly with the highest effective *R*-value. Average cost savings continue to increase from Climate Zones 1 to 8, with Climate Zone 8 having an average savings of 31%. From a national scale, these results suggest that the most influential climates for enclosure retrofits are those that are heating dominated (Climate Zones 5 through 8).

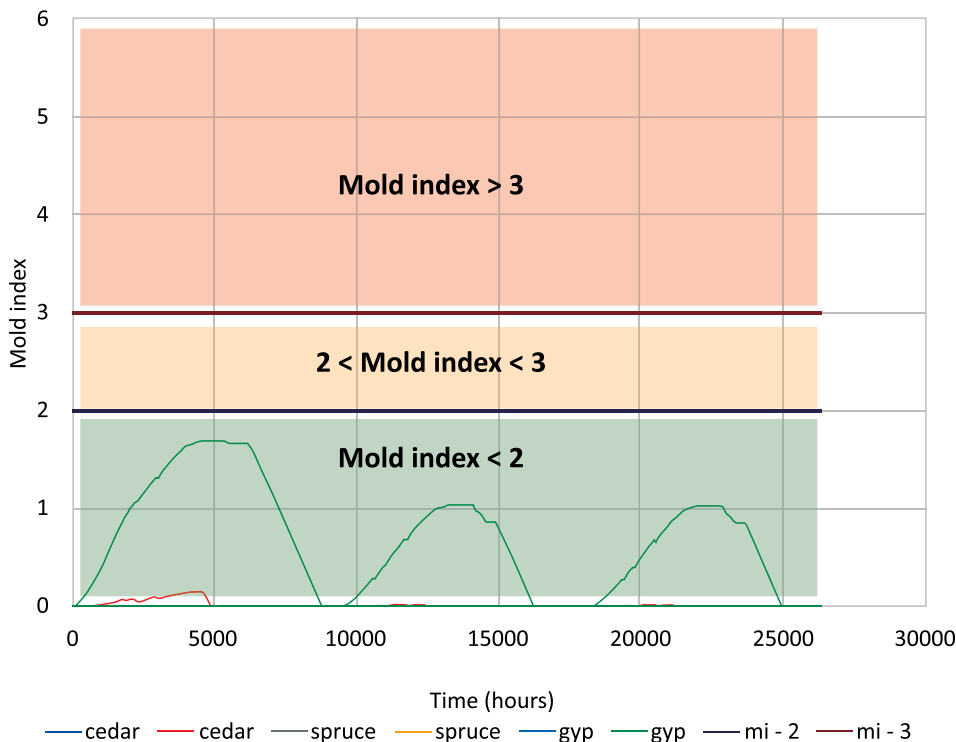
**Figure 10.** Classification scheme for the mold index values (left), and a wall assembly schematic showing locations where the mold index calculations were carried out (right).

In the wall in Fig. 10, a line runs through the "x"s that mark the locations where mold index calculations were carried out. The mold index is calculated on all surfaces except for weather-resistant barriers. Using the VTT model in WUFI (which is the model used in ASHRAE 160), the mold index is calculated for all surfaces. The surface with the highest value is then used as the representative value for the wall assembly, and a color is assigned accordingly. To compare assemblies in all climate zones, a matrix is developed where the columns are assigned the climate zones and the rows represent the wall assemblies. **Figures 11** and **12** are the matrixes for all Phase 1 walls and all Phase 2 walls, respectively.

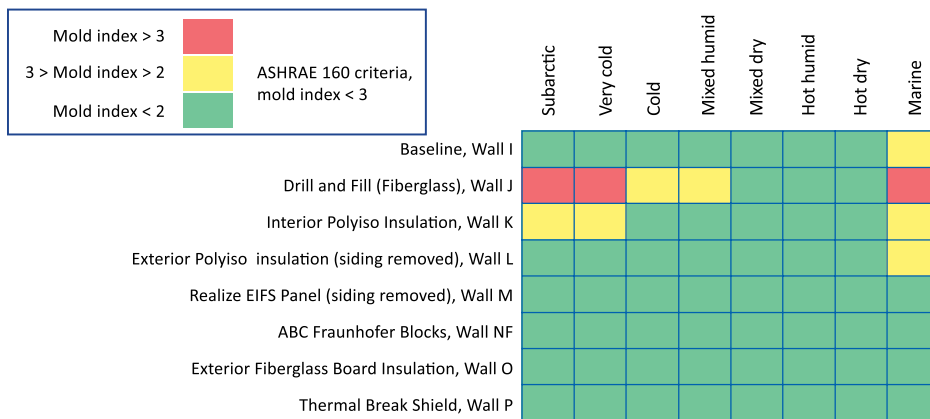
**Figure 12.** Mold index measures for Phase 2 walls in all eight US Department of Energy climate zones.

In most cases, all walls have building components where the mold index is less than 3; exceptions are Walls B and J, the walls that contain insulation in the wall cavity with no

exterior or continuous exterior insulation. In the absence of any form of interior vapor control, the addition of exterior insulation, especially with moisture-tolerant materials, is expected to improve the hygrothermal performance of the wall assembly by pushing the point of condensation to the exterior side of the sheathing.
