Snow Guards for Metal Roofs

By Wayne Tobiasson, M.ASCE, James Buska, M.ASCE, and Alan Greatorex

This study was first published by the American Society of Civil Engineers for its 8th International Conference on Cold Regions Engineering in August 1996 and is reprinted by permission.

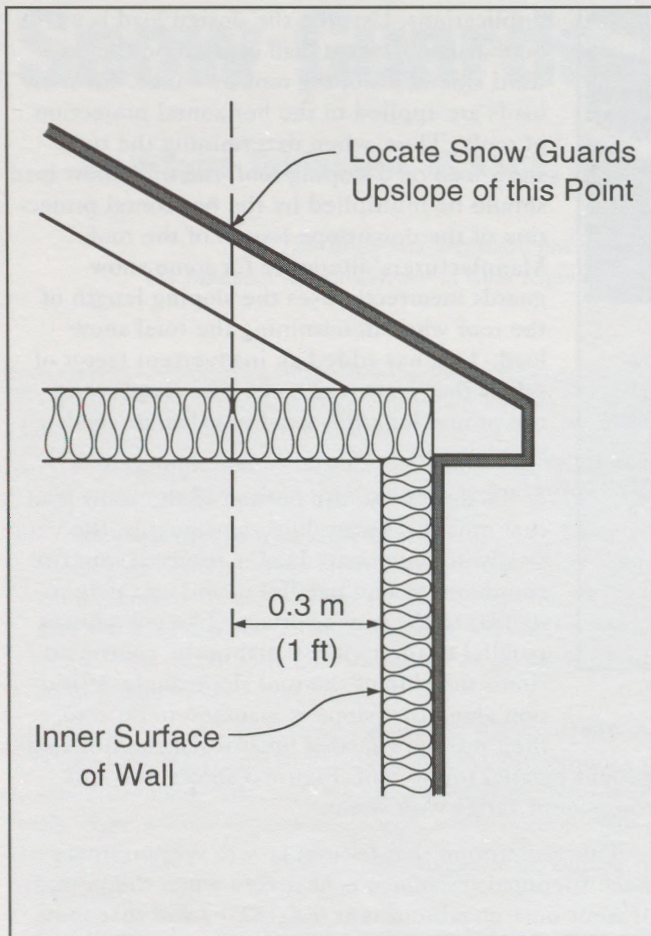
Figure 4: Snow guards should be kept some distance above eaves to keep ice from accumulating on them.

If one row of snow guards is strong enough to resist the expected loads, it should be placed near the eaves but not on the overhanging portion, since there it could aid in the formation of ice dams. A reasonable rule of thumb is to keep the lowest row of snow guards upslope of a vertical line drawn 0.3 m (1 ft.) inside the inside surface of the heated wall as shown in Figure 4. However, Taylor (1993) shows barriers out on overhanging eaves and on a fascia directly above a gutter. Such guards may exacerbate ice damming and formation of icicles, but, located there, they are better able to prevent such ice from falling off the roof if they are strong enough.

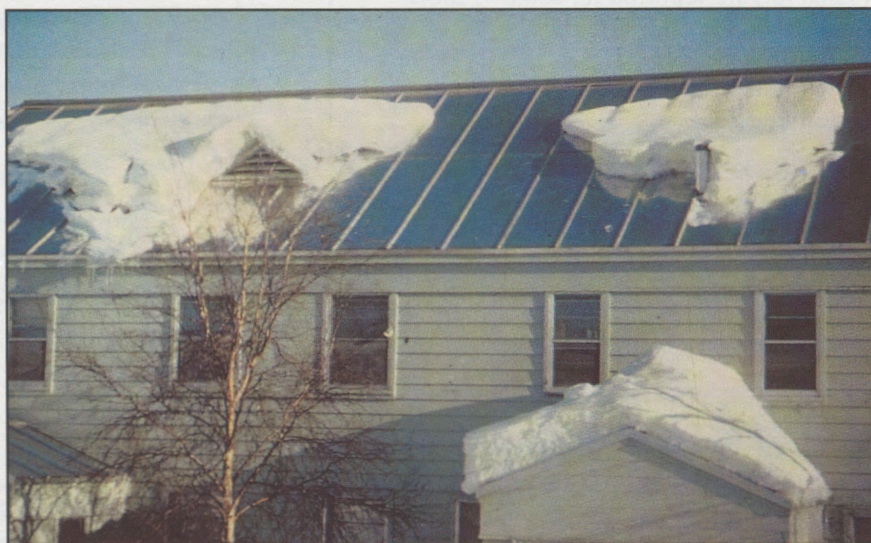
There are situations where snow guards are desired for only a portion of a metal roof. They might be installed just to prevent snow from falling at an entrance located below the eaves, to prevent snow from creeping down a valley, or to prevent snow from shearing off a plumbing vent that penetrates the roof. In these situations, snow alongside the guarded area is free to move, adding substantially to loads on the guards. Figure 5 illustrates this point. It shows a wedge of snow held in place by a single plumbing vent. To account for this effect, we assume that a series of snow guards must be able to sustain all the snow located within outward 45° angles upslope of their location plus all the snow directly above as shown in Figure 6. Paine (1989) also uses "a wedge about 45 degrees each side" to estimate snow loads on obstructions.

Figure 5: A small object such as a plumbing vent can hold back a large wedge of snow.

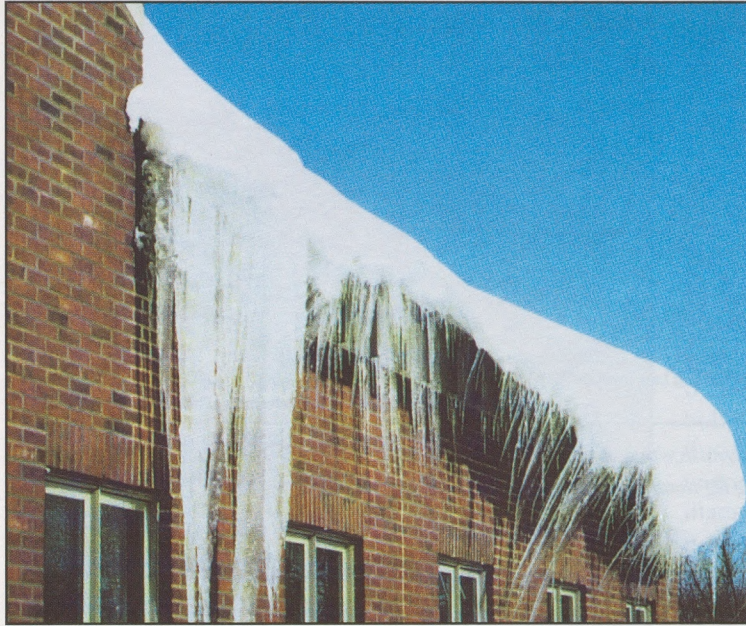
Figure 7: *Icicles will form on an overhanging, creeping mass of ice and snow.*

Meltwater tends to follow the underside of such ice and snow cantilevers instead of flowing off the roof along the heat traced path. This results in the formation of dangerously large icicles at the end of the ice and snow cantilever as shown in Figure 7.

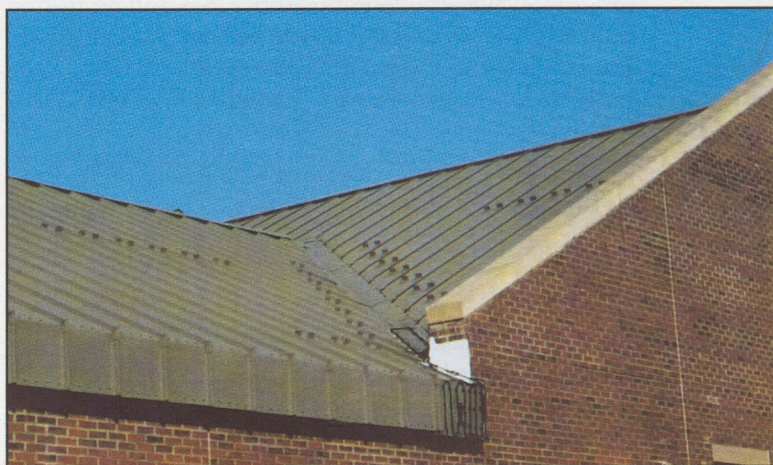
Figure 9: *Individual aluminum angle snow guards attached with butyl-based peel-and-stick adhesive.*

We also wished to evaluate snow guards attached with adhesive, but because we would be installing them in the late fall, our adhesive choices were limited to those that did not require many weeks of warm-weather curing before their first winter of use. We selected a snow guard made from 89-mm- (3 1/2-in.-) long pieces of 3-mm (1/8-in.-) thick, aluminum angle with unequal legs 64 mm (2 1/2-in.) and 102 mm (4 in.) long. A butyl-based peel-and-stick tape had been attached to the longer leg in the factory. We cleaned the painted metal roof with alcohol and applied a primer to the contact area before peeling and sticking the snow guard to the metal. These guards were attached to the base of the metal pans, not to the standing seams. Some are shown in Figure 9.

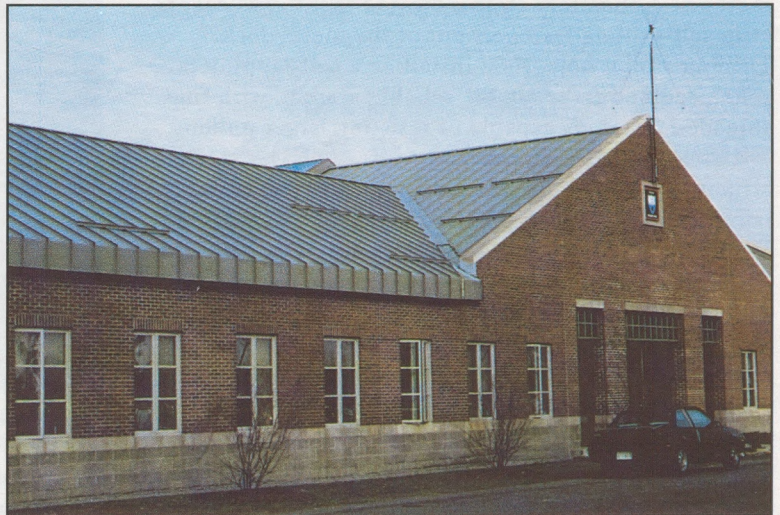
Figure 8: *Array of six aluminum angle snow guards used to protect a valley and, to the left, a single guard to study "worst case" loading.*

Figure 8 shows one valley protected by six such angle snow guards and a single angle guard along the eaves away from the valley.

The aluminum angle snow guards mechanically attached to the seams of metal roofs have performed reasonably well but some problems have occurred. One of the lower angles shown in the Figure 8 valley was ripped off during the first winter. Our examination of it caused us to conclude that the butyl-based tape placed between the metal seam and the base of the guard was thick enough to prevent complete mushrooming of some rivets. We also determined that the pullout load on the upslope rivet could be reduced by placing the upstanding leg of the angle on its downslope side instead of on its upslope side. Figure 10 illustrates this point.

Another valley was protected with a three-bar array configured like the three on the left side of the valley in Figure 8. Those bars were also attached with stainless steel structural blind rivets. Butyl-based tape was not used here. Periodic inspections have uncovered no signs of any loosening.

Single angles were installed near the eaves on three roofs. One is shown in Figure 8. Each one is heavily loaded as is described in Figure 6. All were installed with their upstanding leg upslope (i.e., as shown in Fig. 10a). One of these bars was riveted as described above with butyl-based tape placed between it and the metal roof. One of its upslope rivets subsequently loosened. We believe that the butyl-based tape and its effect on rivet mushrooming were the probable cause. The loose rivet was removed with a grinder and a larger rivet installed. This bar failed during the 1995-96 winter. All rivets were pulled up through the metal roofing. One of the other single bars was installed with self-drilling screws and the third was installed with self-tapping screws. We had no trouble installing the self-drilling screws and none have become loose. We have noticed some slight corrosion on these screws and the neoprene washer of one is cracked, but those defects have not yet created any real problems. We stripped the metal roof when installing two of the self-tapping screws. Our lab-

The failed angle was replaced with a new angle. It was turned so its upstanding leg was on its downslope side (i.e., as in Fig. 10b), and no butyl-based tape was installed between it and the metal roof. That snow guard has suffered no problems since. The other five angles in that array have remained in place.
